## Technical product information

| <b>Topic</b> | New Continental GT, GTC, New Flying Spur - Blind spot monitors not functional DTC C1114F3 logged in address 003C or 00CF |
| <b>Transaction No.</b> | 2062884/3 |

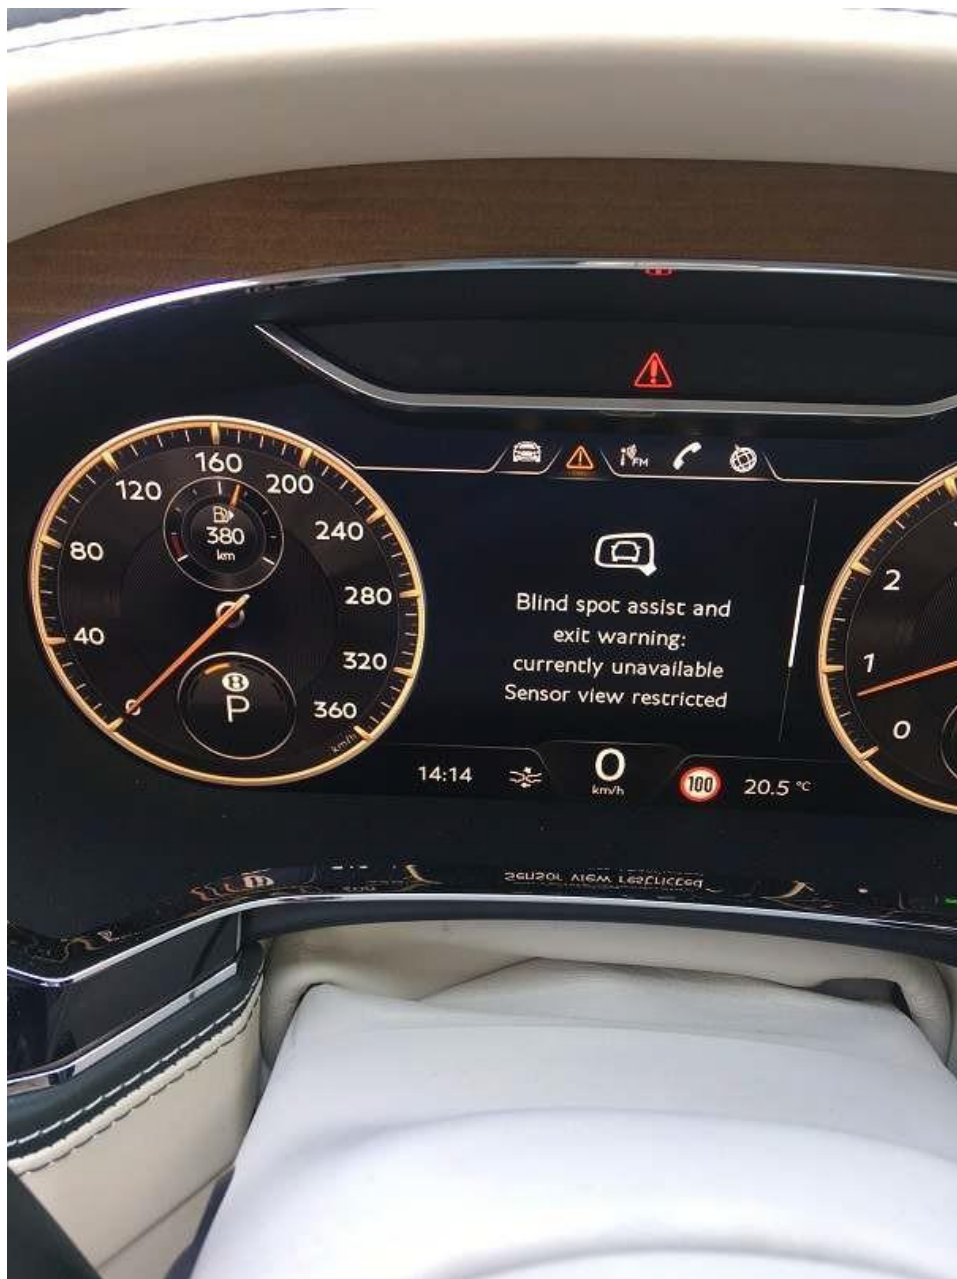
Figure 1

Blind spot monitors (Wing mirror illuminations) are not functional in conjunction with sporadic Bentley assist warnings present in the DIP (Figure 1)

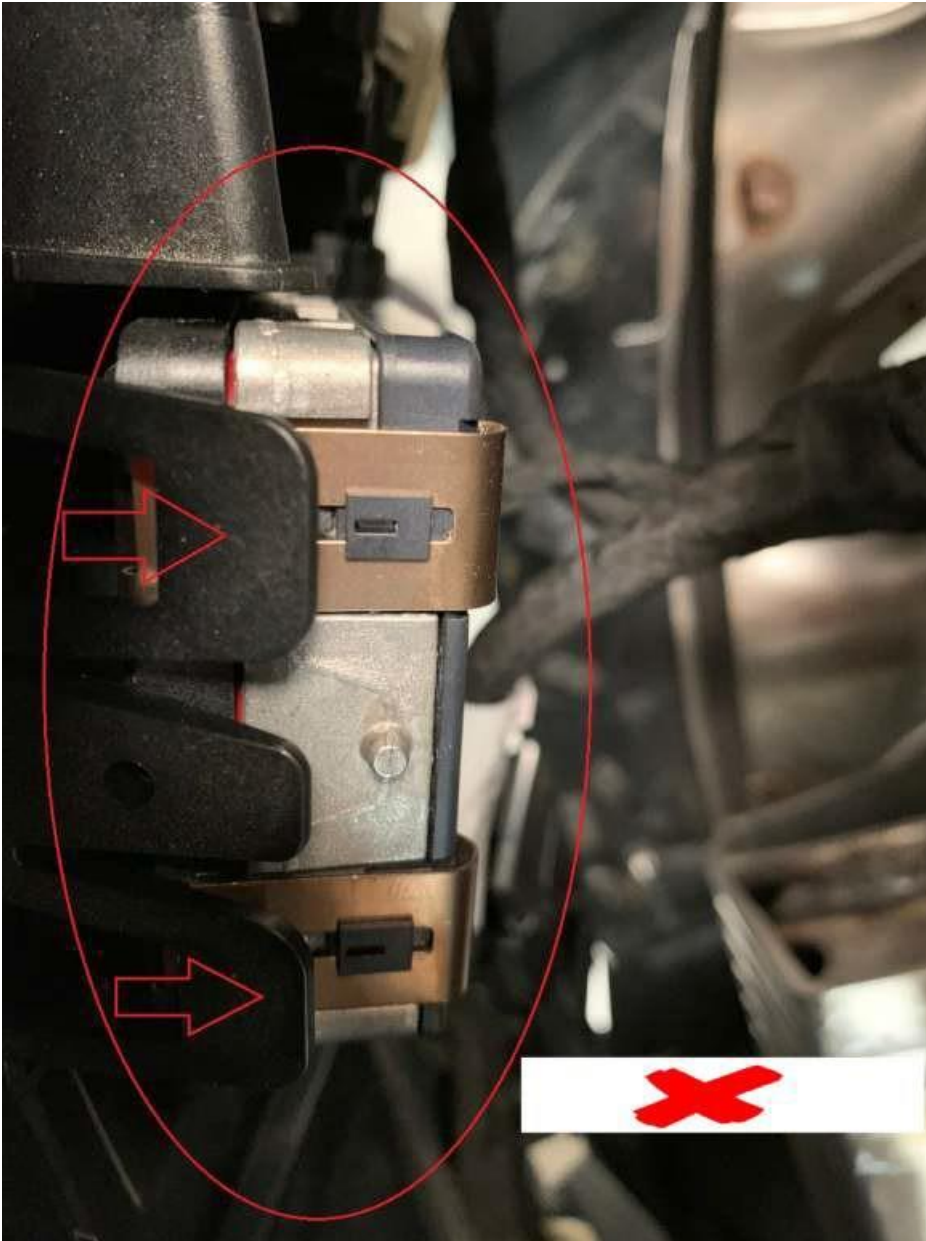
Figure 2

Master or slave rear radars are not fitted correctly (unclipped or poorly installed)

3) In the event one or both control units are loose/detached - Refer to Figures 2 (Before adjustment) and 3 (After adjustment) and also reference Rep. Gr - 44 Lane change assist control units (J769 and J770) - To remove and fit
