Preliminary Information

PIP5812B Diagnostic Tip: Potential For Oil/Moisture Condensate Freezing Up in Turbocharger Wastegate Regulator Solenoid Valve (TCV)

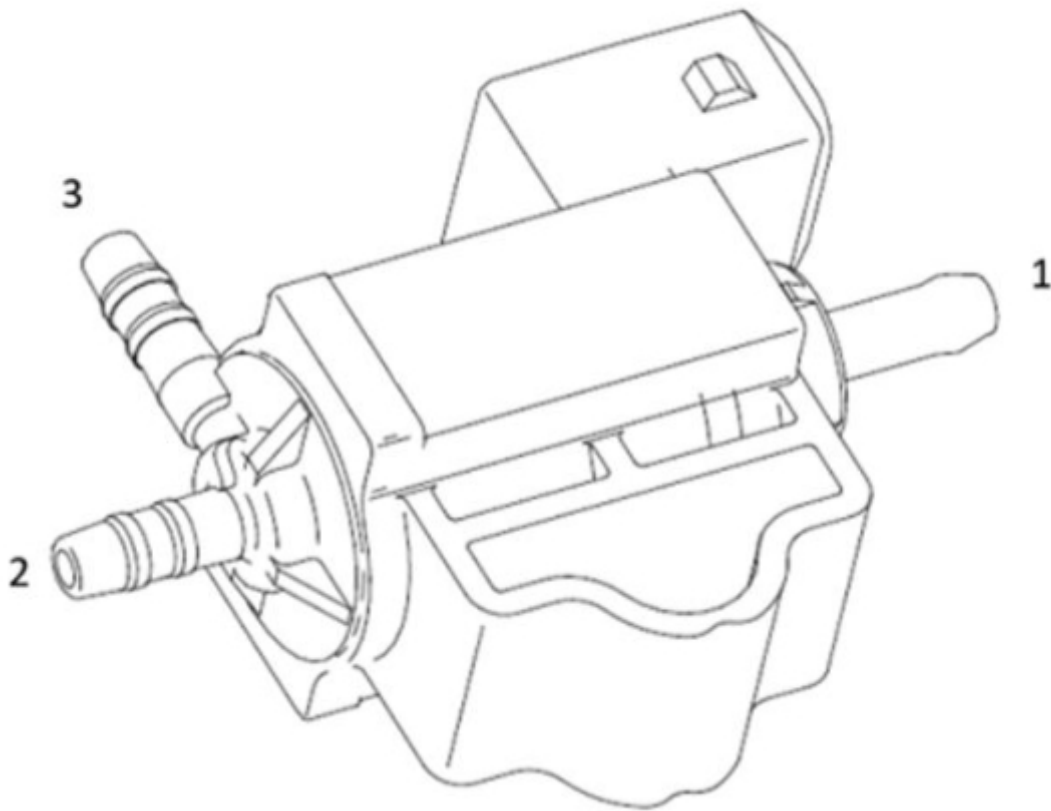
| Condition: | Possible DTC P0234 P0299 that can occur during cold weather driving. |
| Cause: | Oil/moisture condensate freezing up in Turbocharger Wastegate Regulator Solenoid Valve (TCV). |

**Note: Check port #2 to assure the spring gets lifted off the seat. This will be determined by the compressed air not dead-heading when applied to port #2. When applying air to this port a small amount of air should be observed at port #3 and even less air will be noticed at port #1. If this does not happen, the TCV plunger may have hardened deposits from hot operating conditions which will impede TCV plunger movement and the Turbocharger Wastegate Regulator Solenoid Valve should be replaced.**

1. Remove Turbocharger Wastegate Regulator Solenoid Valve
2. Drain Turbocharger Wastegate Regulator Solenoid Valve (TCV) by turning valve upside down.
3. Using clean shop air regulated to 15-20 PSI (103kPa), blow through all three ports (1, 2 &3) for 5 seconds each. Repeat twice.

**4. Reinstall Turbocharger Wastegate Solenoid Valve (TCV) using the latest service information and clear all DTC's using GDS and evaluate.**
