## SERVICE BULLETIN

**APPLICABILITY:** Legacy & Outback 2010-19MY Equipped with CVT  
 Forester 2014-22MY Equipped with CVT  
 (Except Wilderness)  
 Impreza 2012-22MY Equipped with CVT  
 Crosstrek 2012-19MY Equipped with CVT  
 WRX 2015-21MY Equipped with CVT

**NUMBER:** 16-102-16R  
**DATE:** 07/11/16  
**REVISED:** 10/15/21

**SUBJECT:** DTC P0841 Diagnostics

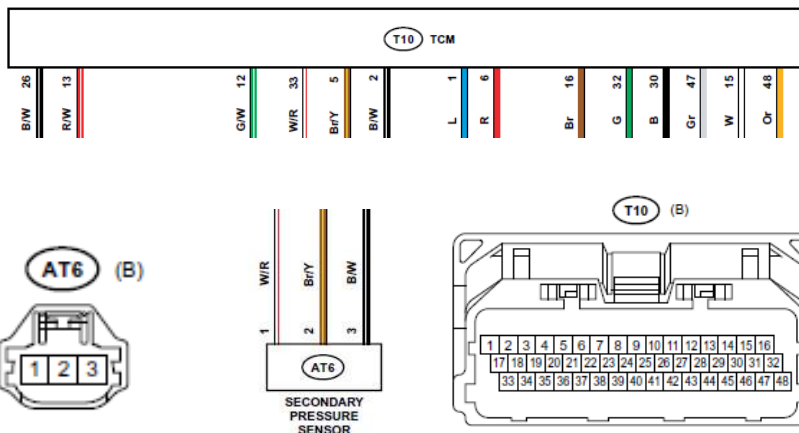
18460AA040 CHECK BOARD

Used for measuring the TCM terminal voltage.

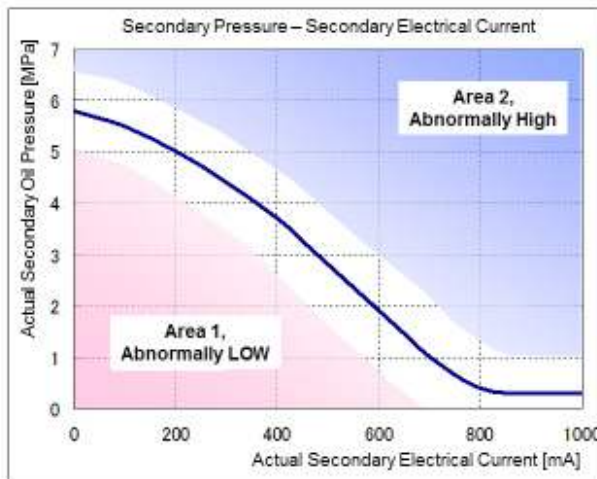
The condition causing P0841 is either:

1. The Secondary Oil Pressure is abnormally low (lack of necessary pressure)
2. The Secondary Oil Pressure is abnormally high (excess pressure occurs as compared to necessary pressure).

Check the Actual Secondary electrical current [mA] and Actual Secondary oil pressure [MPa] stored in the FFD then determine if P0841 has set because of:

1. abnormally low
2. abnormally high Secondary Oil pressure.

**TIP:** Consider performing the pressure testing using a mechanical pressure gauge **BEFORE** electrical testing and compare the test results (between the gauge and SM4 displayed values). Both test results should be very close. If there is a significant discrepancy between them (e.g. the (known good) gauge results are significantly higher than the SM4-supplied values), the pressure sensor would be suspect.

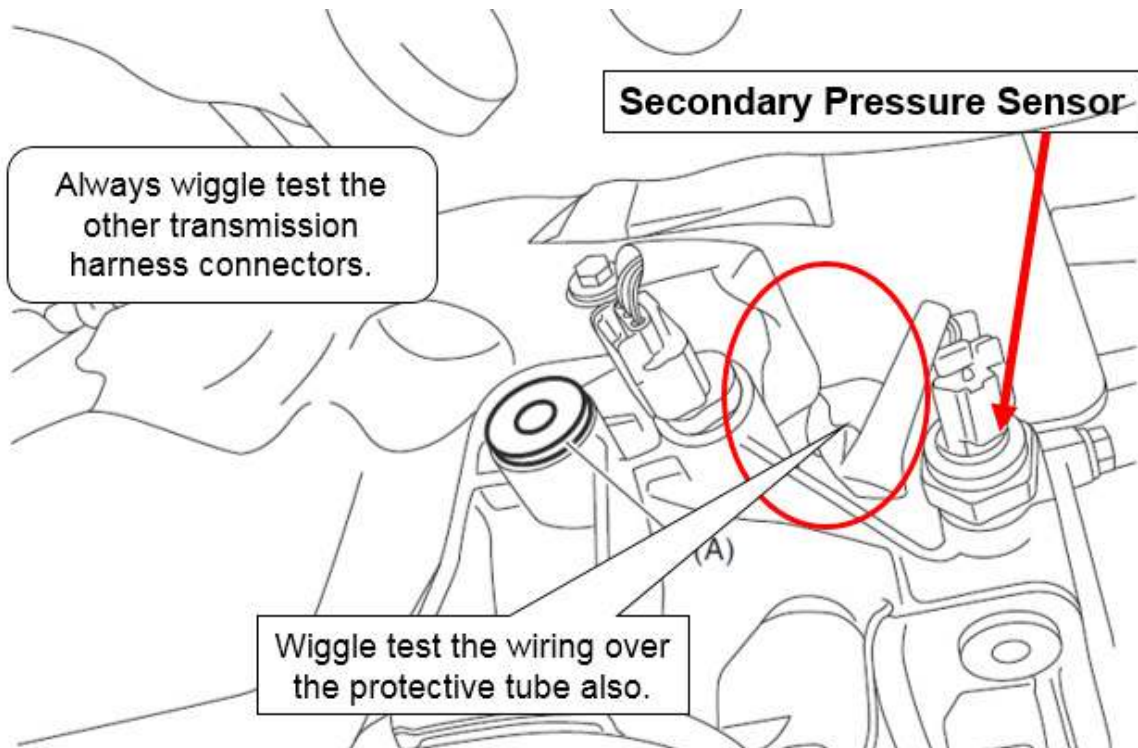
## “Wiggle-Testing” Wiring:

(1) The pin for the secondary oil pressure sensor is located at the end of connector and can be affected by ambient temperature. The sensor wiring can develop an open circuit when cold caused by freezing but be normal at normal temperatures. Keep temperature conditions in mind when testing. Always wiggle test the wiring and connections when testing and watch for any fluctuations.

(2) Check, record and confirm the "Secondary Oil Pressure A/D Value" is correct with SSM while wiggling the T/M wiring, TCM connectors and the Secondary Oil Pressure sensor harness connector.

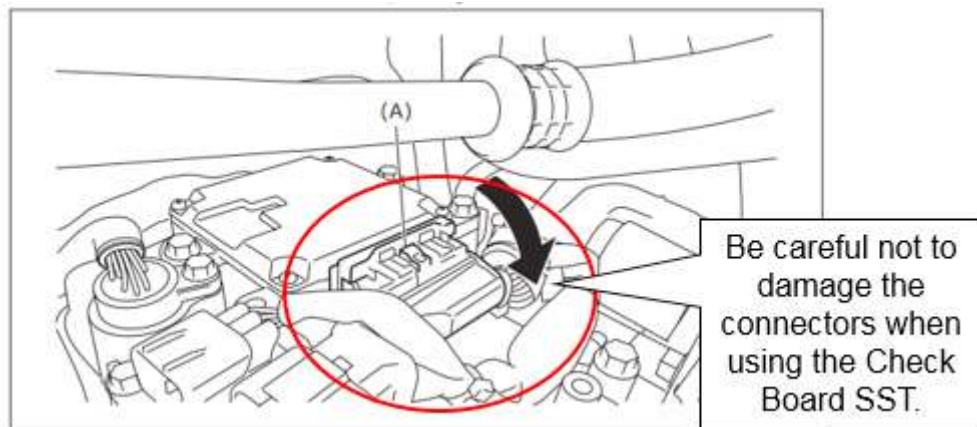
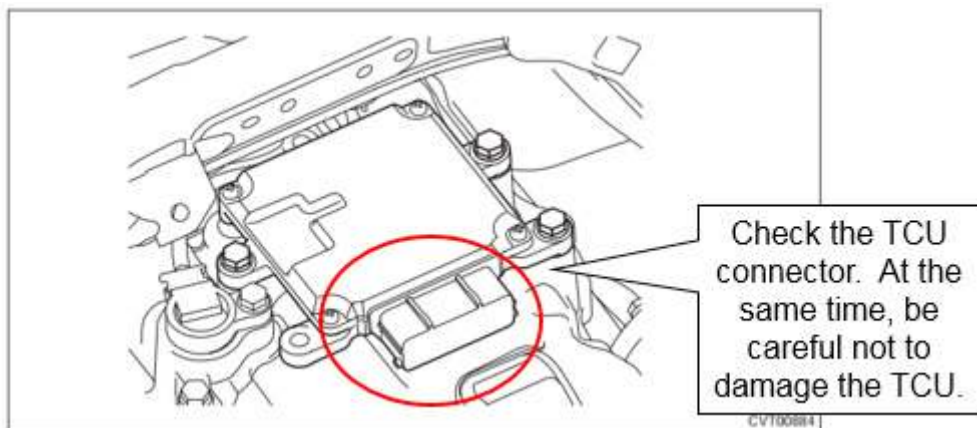
## Other Points to Inspect:

(1) Contacts between broken wiring and the transmission case are the most common. However, small scrapes or abrasions to the wiring insulation can also cause short circuits to ground.

(2) The wiring and pins are bound inside the connector. If the binding is too tight, it can cause small scrapes or abrasions to the wiring insulation resulting in a short circuit between wires. Please check wiring inside the connectors also.

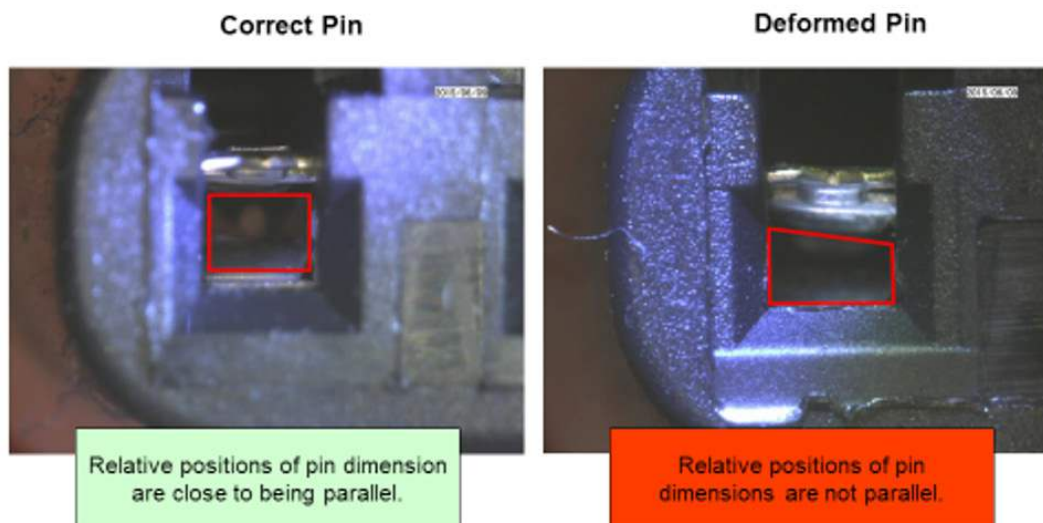
## Example of a Deformed Pin Terminal:

(1) Inspect for any abnormalities with the pins like: deformation, scratches, discoloration or evidence of any foreign materials inside them or the connectors.
