## Automated Manual Transmission Gearbox Will Not Shift To High Range After Gearbox Repair; MID 130 PSID 24 FMI 1, P1072-92 Unintentional Disengagement Of High Range - US07 And Newer Emissions, Model Year 2008 And Newer

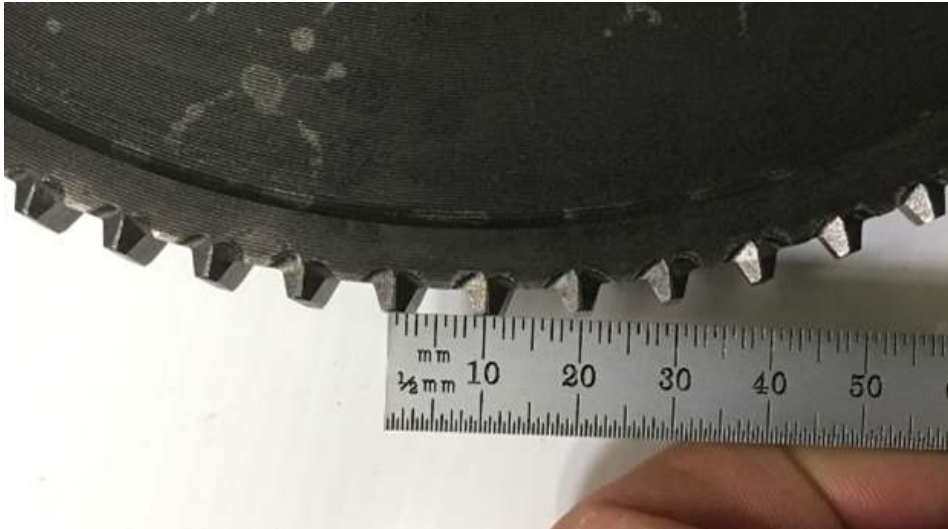
**The correct tooth spacing is approximately 10 millimeters from the center of each tooth on the high range synchronizer center hub.**

Inspection of the tooth spacing for the components prior to installation will eliminate any potential mismatch of components and extended diagnostic time resulting from the incorrect components.

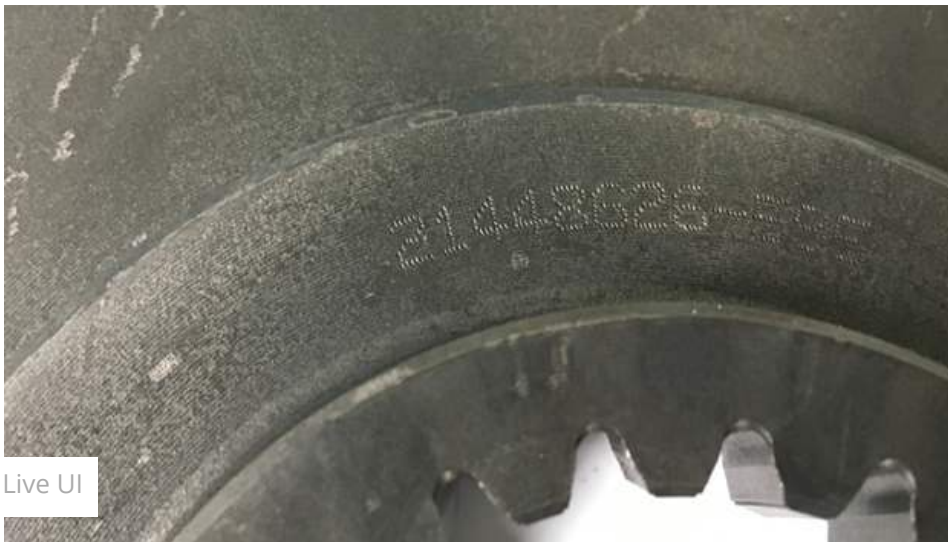
**The Part Number for the correct center hub is 21448626.**

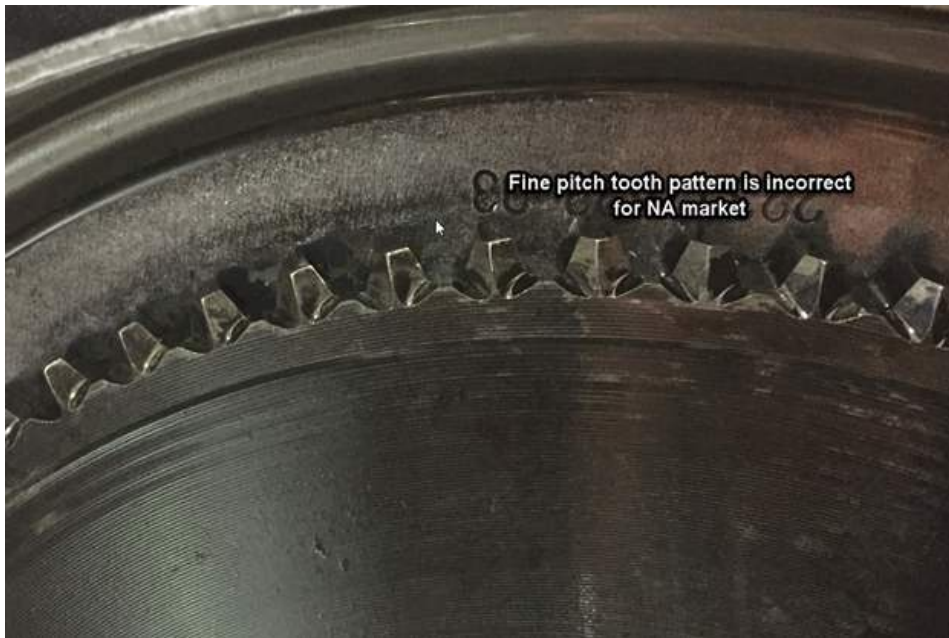
The incorrect fine tooth hubs have a Part Number of 21753650.

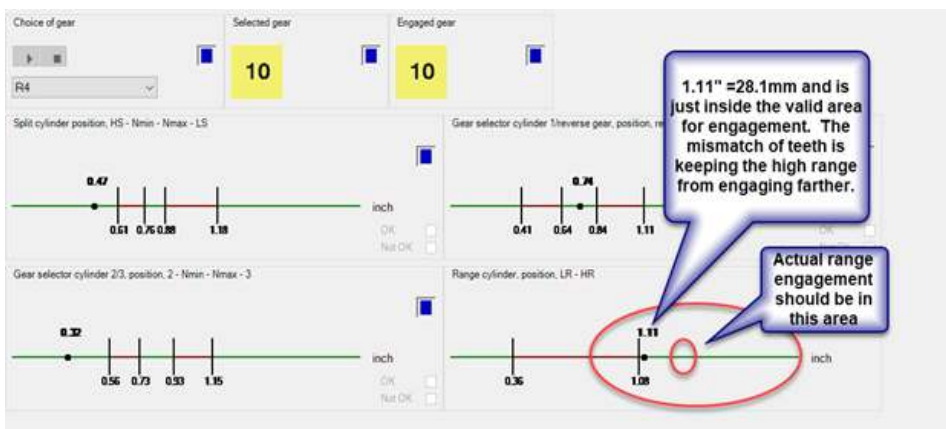
What you will see in Tech tool if the unit gets assembled this way.

Reviewing the Gears Test ( 4311-08-04-01 ) , calibration values ( 4320-07-03-01 ) or the Range Solenoid Test ( 4320-08-03-02 ) screens, the high range engagement will show to be barely within the valid calibration/engagement area. The teeth will mesh just enough to allow a good calibration and test results however the teeth are not engaged and the torque applied to the unit will force the range out of gear.

The average high range engaged position is 33 mm (1.31 inches) range.
