## Technical product information

| <b>Topic</b> | W12 Engine management light on - Turbocharger speed sensor DTC's stored |
| <b>Brand</b> | Bentley |
| <b>Transaction No.</b> | 2053348/5 |

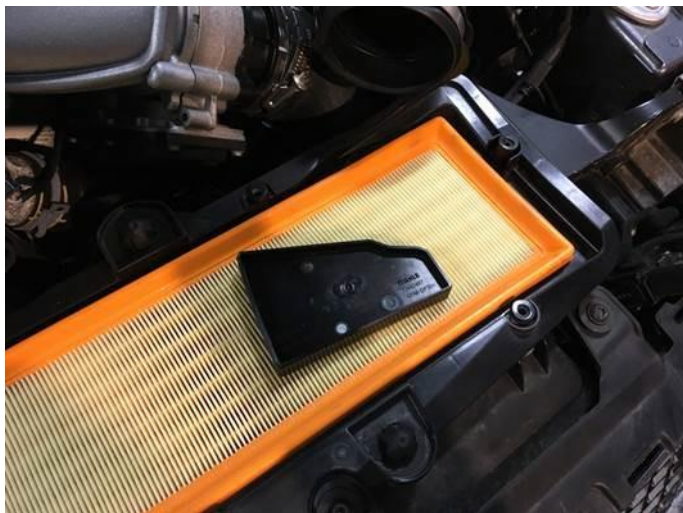
- Inspect for damage or missing components NOTE: The example in Figure 1 shows an air filter box divider that has become detached, causing DTC-P259400: Turbocharger Speed Sensor "B" – Circuit Range/Performance
- Reattach the divider and retest the vehicle if this particular fault is found
