NUMBER  
PI1802Y/Z (Rev 5, 11/04/2021)

## PRODUCT IMPROVEMENT CAMPAIGN

### ENGINE REPLACEMENT INSTRUCTIONS FOR DTC P1326 (PI1802Y/Z)

This bulletin provides information related to the Technical Service Bulletin previously published [PI1802](#) titled "Knock Sensor Detection System - ECU Logic Improvement" equipped w/THETA II engine. Specifically, this bulletin provides instructions on which procedures to follow if, after installation of the KSDS, any one of the subject vehicles below returns to the dealer with Diagnostic Trouble Code (DTC) P1326 (Knock Signal Range/Performance).

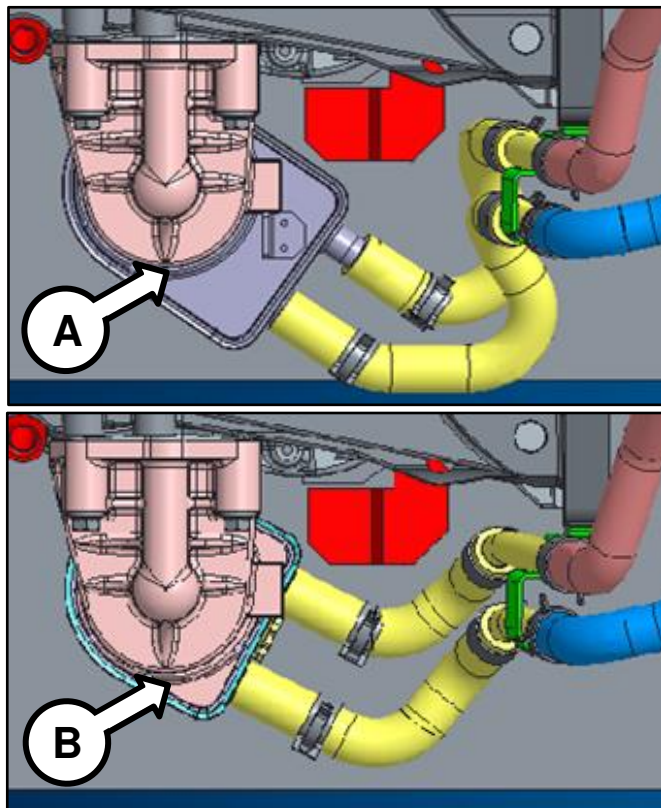
New engines may be supplied with a different oil cooler. Use steps below to determine the need for a replacement oil cooler tube assembly.

- If the new engine's (bigger) oil cooler (A) does not match the old engine's (smaller) oil cooler (B), replace the oil cooler tube assembly with the improved part. See parts table on page 16.
- If the new engine's (bigger) oil cooler (A) matches the old engine's (bigger) oil cooler (A), reuse the old engine's oil cooler tube assembly.
- If the new engine's (smaller) oil cooler (B) matches the old engine's (smaller) oil cooler (B), reuse the old engine's oil cooler tube assembly.
