# Technical Service Bulletin

## 94 Reverse lamp is inoperative, DTC(s) B12CB15 or B12CC15 stored in the comfort system control module

94 21 51 2063766/2 November 30, 2021. Supersedes Technical Service Bulletin Group 94 number 21-45 dated September 2, 2021 for reasons listed below.

| Model(s) | Year | VIN Range | Vehicle-Specific Equipment |
|---|---|---|---|
| Q5, SQ5 | 2018 - 2020 | All | Not Applicable |

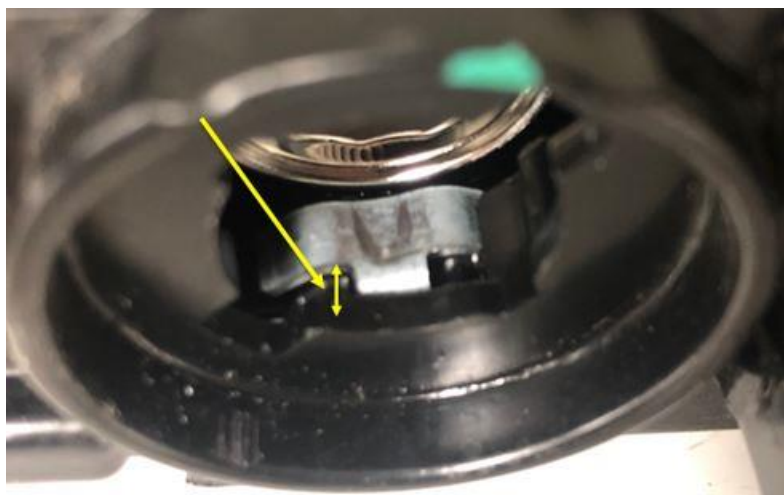
**Figure 2.** Lamp contact has separated from housing.

2. If the bulb socket contact is flush with the housing then no repair is needed (Figure 2).

Continue with normal diagnosis outside of this TSB.
