## STAR ONLINE PUBLICATION

**Case Number: S2121000017 REV. A**

**Symptom/Vehicle Issue:** Drivetrain Control Module (DTCM) Diagnostic Trouble Code (DTC) C2201-49 – FDCM/DTCM Internal Electronic Failure, set.

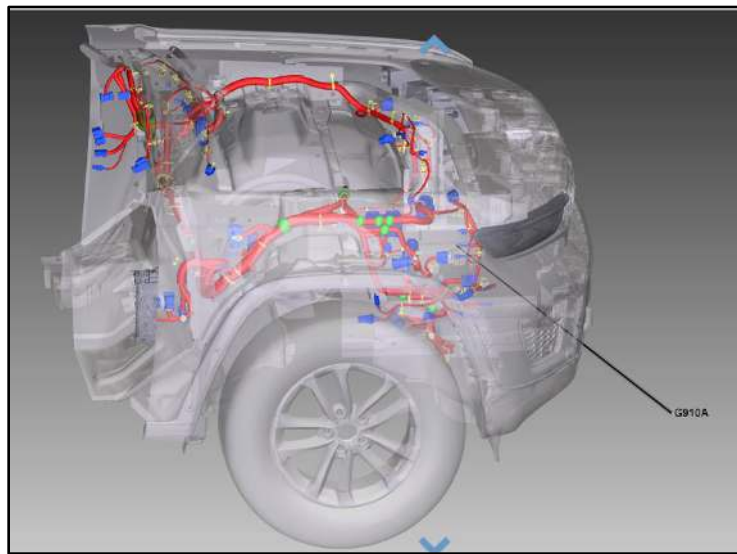
**Figure 1.**

A loose ground G910A connection, which can cause this DTC, may also cause one or more of the following DTCs to set.

1. Closely inspect ground G910A for being loose, and repair as necessary. Ground G910A is located on the passenger side of the engine compartment, on the outside body rail. It can be identified by the green tape wrapped around the harness. Please see (Figure 1 & 2). G910A can be accessed through the passenger front wheel well.
