**NUMBER:** 18-034-21 REV. A

**GROUP:** 18 - Vehicle Performance

**DATE:** November 10, 2021

P203E and P203F Additional Diagnostic Information

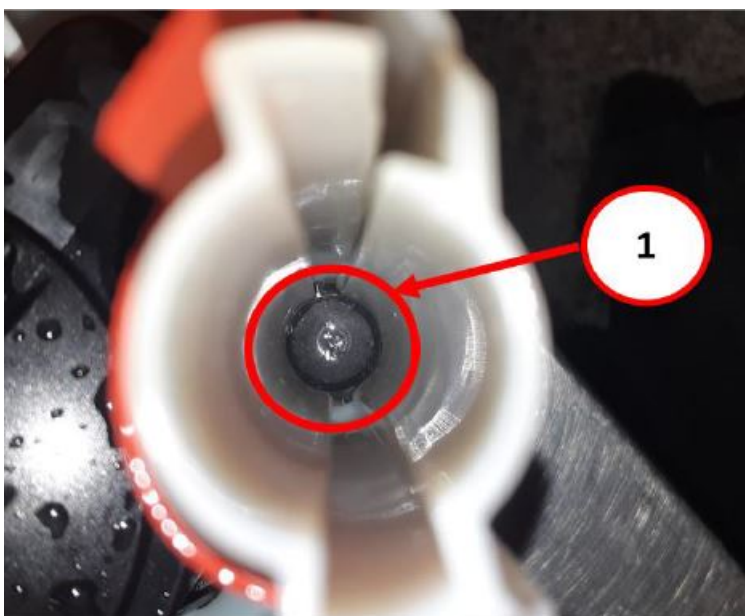
Fig. 1  
DEF Pump Assembly

Another cause of P203E and P203F is residual ice in the DEF tank. Once ambient temperatures reach approximately 12°F (-11°C), the DEF fluid in the tank will freeze. The P203E diagnostic will not run if the DEF tank, and ambient temperatures stay below 39°F (4°C). However, as the ambient temperature warms up, and the tank begins to thaw, the DEF tank may not be completely thawed by the time the P203E DTC enabling criteria are met. If there is a residual layer of ice in the tank, the ice will cause the “no echo” condition setting P203E. Vehicles are especially susceptible to having residual ice in the tank, in areas where there is a large swing in temperatures (from extreme cold to warm), in a short period of time. Additionally, if ice is covering the sensor (Fig. 1) when the temperatures are too cold to run the P203E monitor, it could lead to P203F. Even if there is sufficient fluid level in the tank.

To correct this scenario, the DEF tank must be fully thawed out. Allow the vehicle to sit in a heated shop or garage overnight to thaw. If necessary, remove the DEF pump to drain the fluid, and remove all residual ice. Take care when removing the DEF pump to avoid damage to the pump, and heater mat. Once all the ice has been removed or thawed, follow the **P203E Drive Cycle** below.

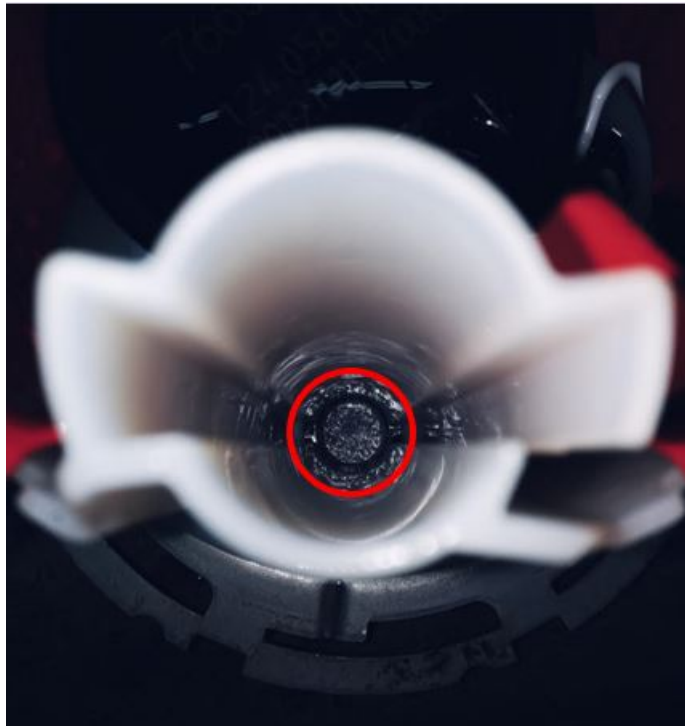
Fig. 2

Another cause of P203E and P203F is the DEF level sensor being covered in a layer of DEF crystals, or ice (Fig. 2) . Vehicles that are in extreme cold for long periods of time can start to have a buildup of DEF crystals on the bottom of the tank. When DEF tanks are completely frozen for long periods of time, evaporation will start to occur. This evaporation of the ice will leave DEF crystallization.

DEF Crystallization Buildup In Level Sensor Focus Tube

**NOTE:** Do NOT clean DEF system components using regular tap water. The mineral content in tap water can cause issues with the system. Only use fresh DEF fluid, or warm, distilled water to clean crystallization from the DEF components.

Unless the DEF fluid shows signs of contamination, crystallization that has formed in the tank, and on the pump components can be cleaned without having to replace any parts. Flush the tank, and clean the pump components using fresh DEF, or warm distilled water. In some instances, it may be necessary to remove the DEF tank, and agitate the fluid by shaking the tank. Thoroughly drain the DEF or distilled water used to clean the crystallization, and add fresh DEF. If P203E was set, follow the **P203E Drive Cycle** below.
