# Technical Service Bulletin

## 66 Rear spoiler is inoperative

66 21 79 2065220/1 December 7, 2021.

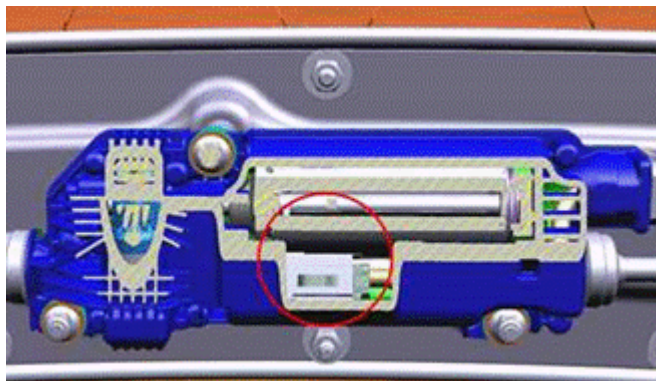
Due to insufficient pressure of the carbon brushes to the motor commutator in the spoiler drive motor a loss of contact may occur and cause intermittent or permanent loss of spoiler operation.

Figure 2 shows the spoiler drive motor area of brush to commutator contact.

**Figure 2.** Cutaway view of the motor brush to commutator area.

The rear spoiler drive motor has been redesigned. An increase in brush to commutator pressure has been implemented in production.

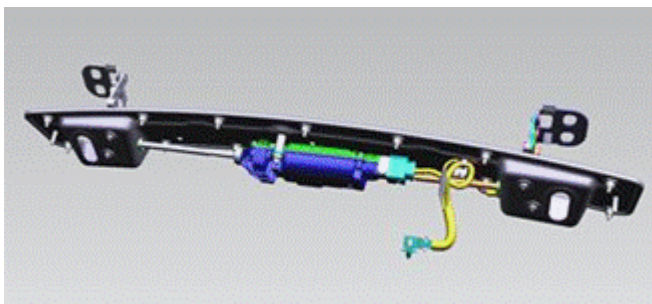
**Figure 3.** Rear spoiler drive assembly.

1. Should the vehicle exhibit the symptom profile described in this TSB, replace the rear spoiler drive unit. Figure 3 shows the rear spoiler drive assembly.

2. Complete the ODIS test plan and clear DTC(s).
