# TECHNICAL BULLETIN

## LTB00606NAS1

Engine MIL Illuminated with DTC P0505-8F and P2282-00 Stored and Misfire DTC May Be Stored

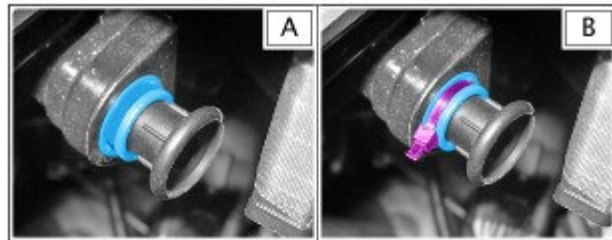
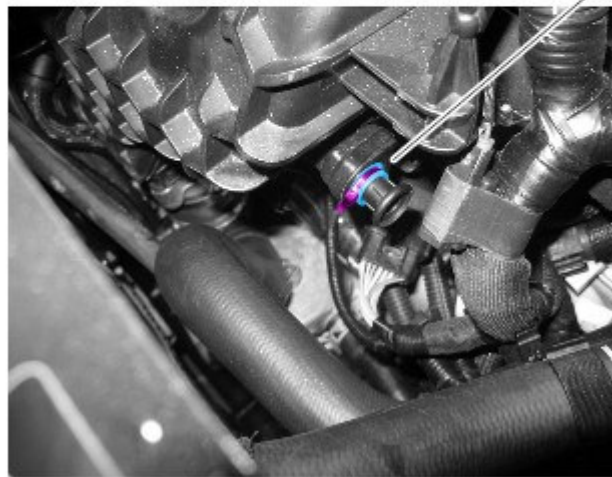
E160401

**Situation:** The engine Malfunction Indicator Lamp (MIL) may be illuminated and Diagnostic Trouble Code (DTC) P0505-8F and P2282-00 stored in the Engine Control Module (ECM); misfire DTC P030x and P1315 may also be stored in the ECM.

**Cause:** This may be caused by the intake manifold vacuum plug having fallen out.

5. **NOTE: Make sure tie strap is seated below the flange.**

Install the nylon tie strap between the retaining ring and the face of the locking ring:

- Pull the tie strap tightly around the retaining ring.
- Cut off any excess tie strap material.
