Subject: 49 CFR Part 579.5 Monthly Communications – January 2016

**INDEX OF SERVICE BULLETINS,  
NOTICES, AND COMMUNICATIONS TO DEALERS**

| <u>NO.</u> | <u>DESCRIPTION</u> | <u>DATE</u> |
|---|---|---|
| 2 | Customer Satisfaction Program 15B23:<br>Certain 2012-2014 Focus Electric Vehicles -<br>High Voltage Wire Harness Update and Reprogram<br>Powertrain Control Module | January 7, 2016 |
| 4 | Customer Satisfaction Program 15B39: Certain<br>2015 Model Year Transit Vehicles - Under Hood<br>Water Management Repair | January 21, 2016 |

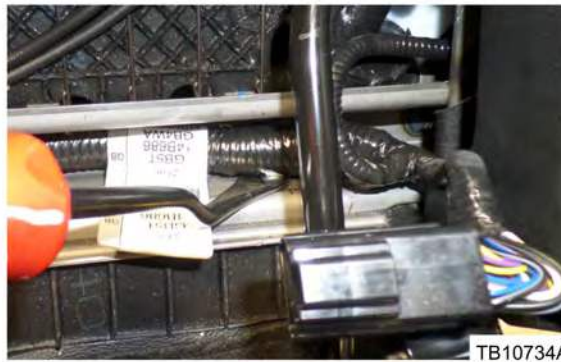
Figure 1 - Article 16-0001

1. Disconnect the battery. Refer to Workshop Manual (WSM), Section 414-01.
2. Fold both of the second row seats forward to gain access to connectors C3133 and C3134.
3. Remove the seat bottom covers from both sides. Refer to WSM, Section 501-10.
4. On the left and right side, disconnect the connectors and remove the connector and wiring harness pushpin from its mounting on the seat frames.
5. On both sides, follow the seat harness and locate the next harness retaining pushpin and remove it from its mounting position to allow for more harness movement. Cut and discard the protruding end of the pushpin. (Figure 1)

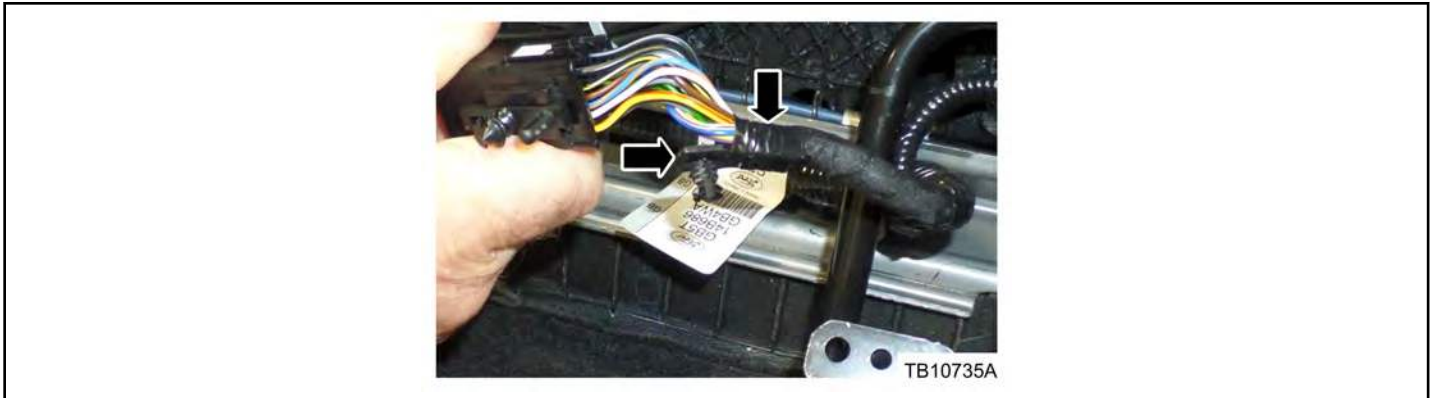
Figure 2 - Article 16-0001

6. On the male side of both connectors where the wiring harness is taped to the harness pushpin retainers, remove the retaining tape and the harness pushpin. Discard the pushpin. (Figure 2)

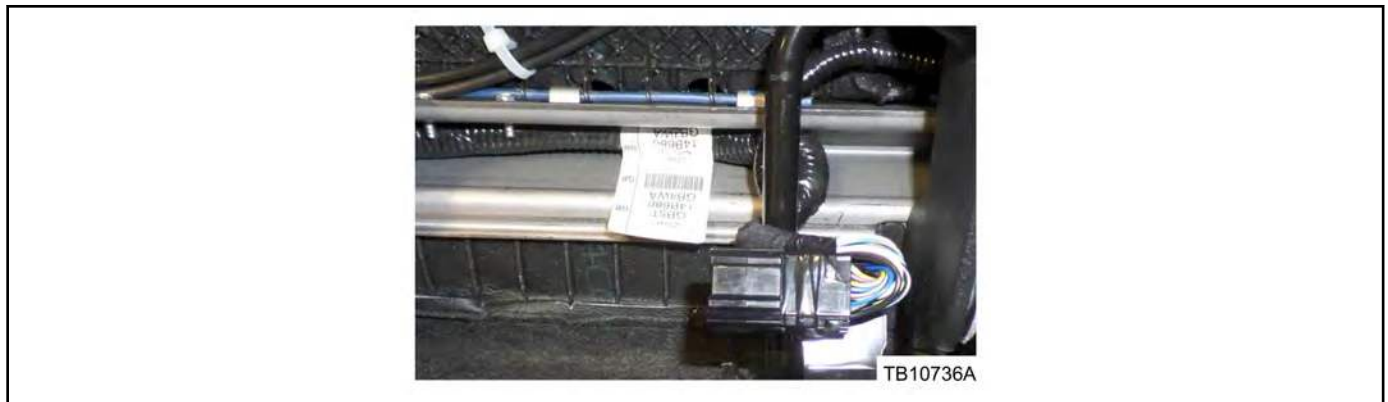
Figure 3 - Article 16-0001

- b. On the male connector create a 15-20 mm (1/2-3/4") loop with the wiring harness and secure the harness to the connector using electrical tape. Make sure the wire loop does not contact the seat trim. Wrap the harness and connectors 3 times to provide harness stress relief and to prevent damage to the connector terminals when the seat is folded forward. (Figure 3)

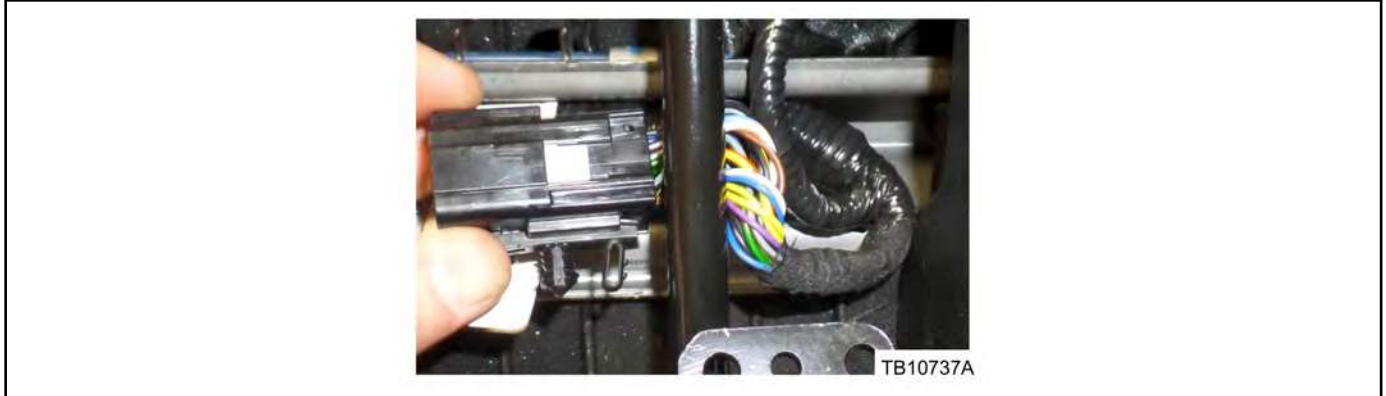
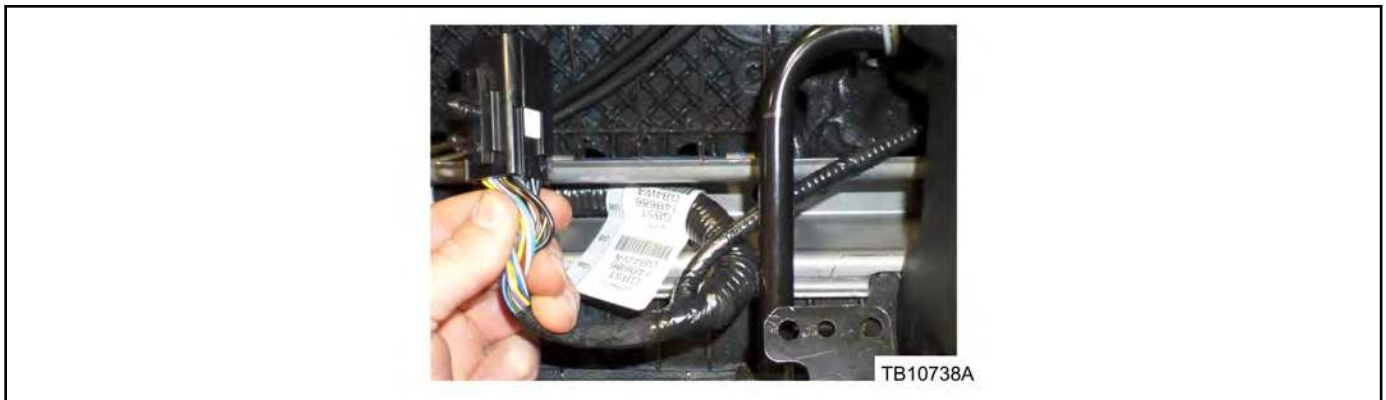
- e. On the passenger side, take the connector and route the seat harness to the other side of the black bar. (Figures 4 and 5)

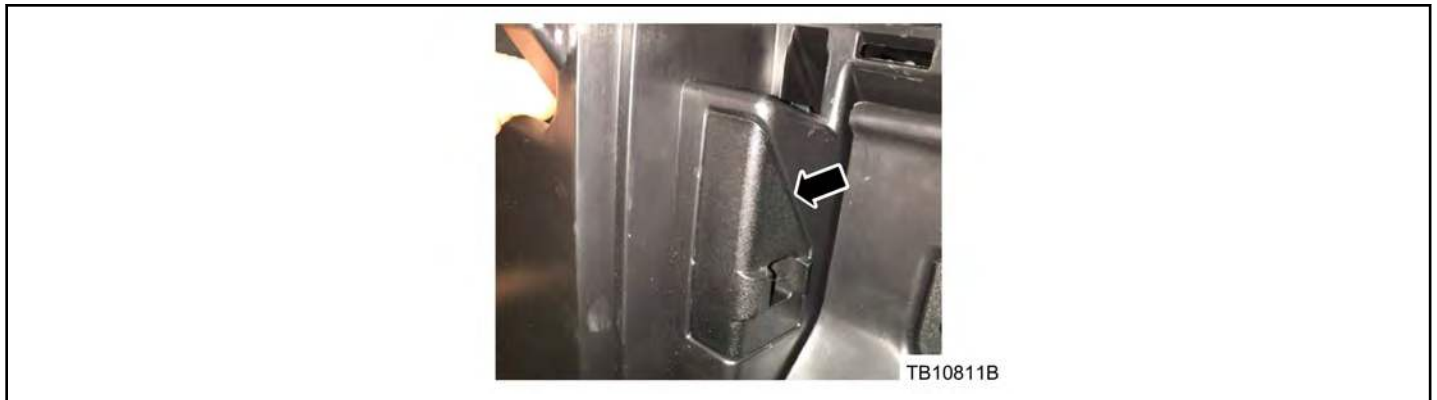
Figure 2 - Article 16-0005

3. Inspect the glove compartment center hooks to make sure they are properly attached to the hinge line of the instrument panel. (Figure 2)

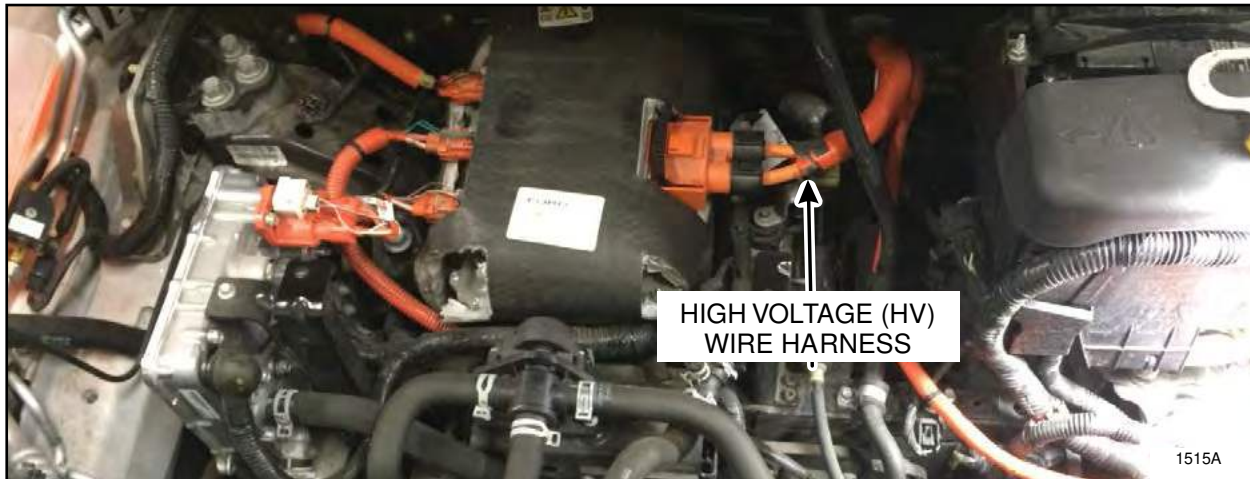
**FIGURE 1a**

1. Remove the two engine cover retainer pins, then remove the engine cover.
2. Inspect the HV wire harness. See Figure 1a.

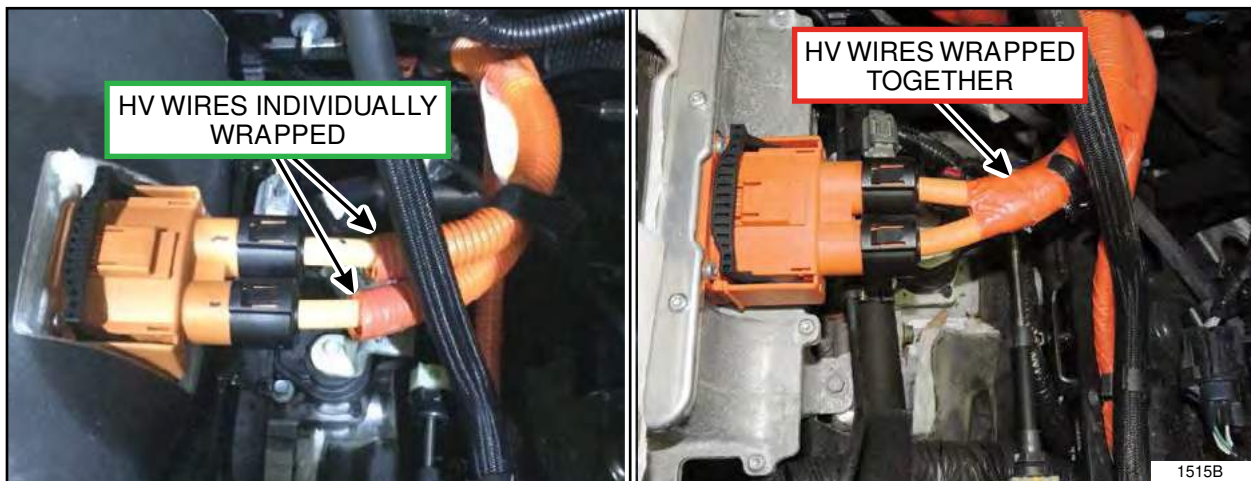
**FIGURE 1b**

3. Are the HV wires individually wrapped in convolute? See Figures 1b and 1c.
  - Yes - HV wire harness update is not required. Proceed to Module Reprogramming on Page 11.
  - No - Proceed to Update High Voltage Wire Harness on Page 3.

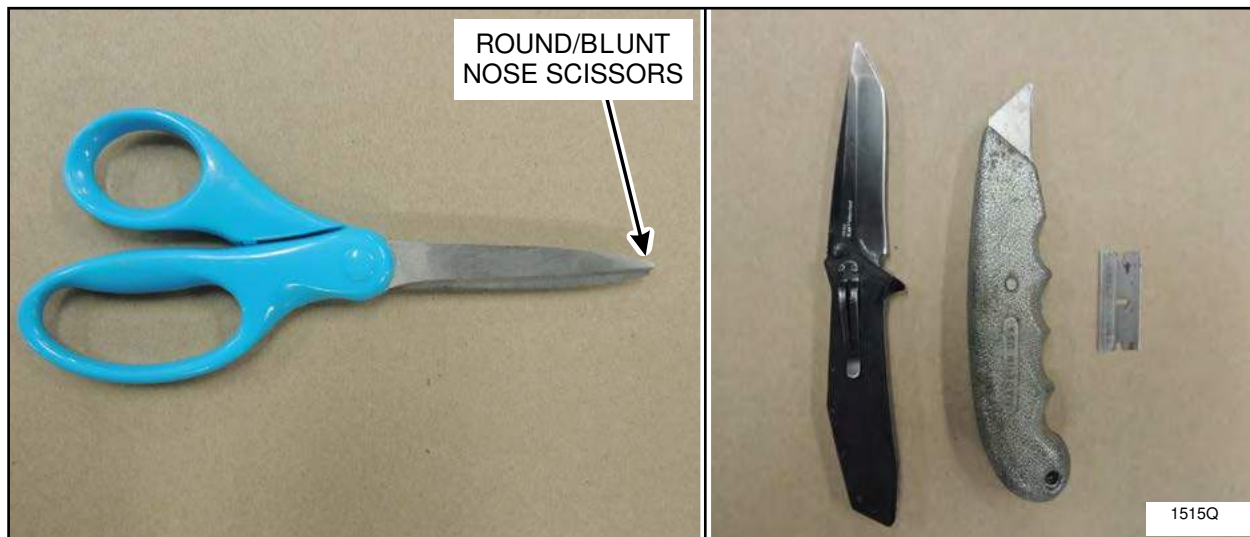
**FIGURE 3**

**NOTE:** Do not use a razor blade, utility knife or similar tool for cutting the convolute and tape. The HV wire harness can easily become damaged if round/blunt nose scissors are not used when performing this procedure. See Figure 3.

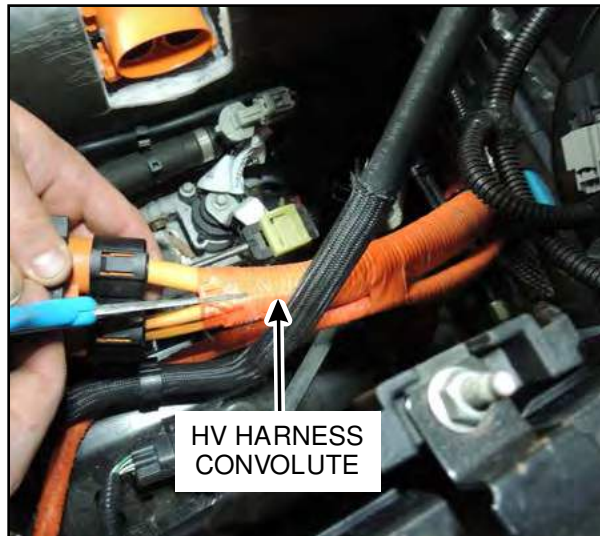
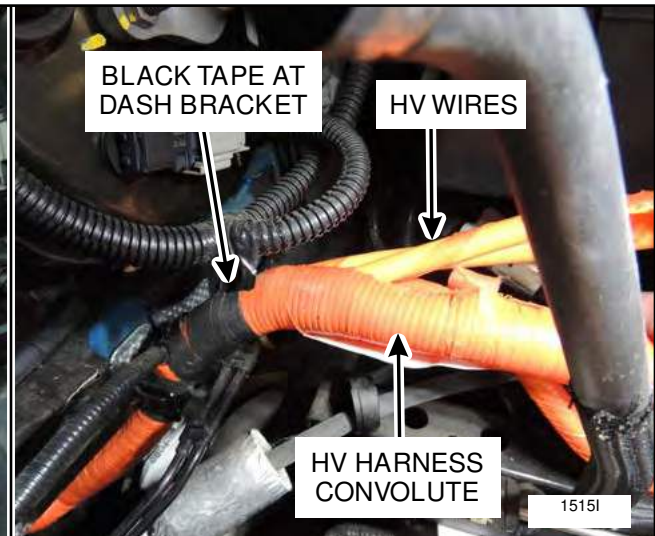
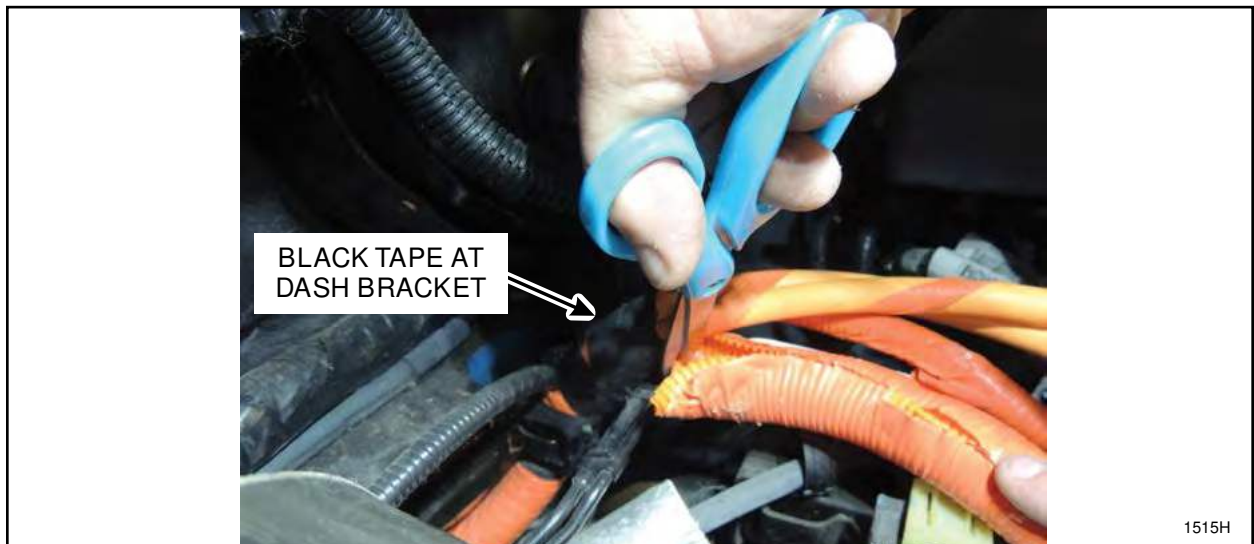
3. Using a pair of round/blunt nose scissors, cut the single convolute between the wires down to the black tape at the dash bracket and discard the cut convolute. Peel back the convolute as you cut for better visibility. See Figures 4a, 4b and 4c.

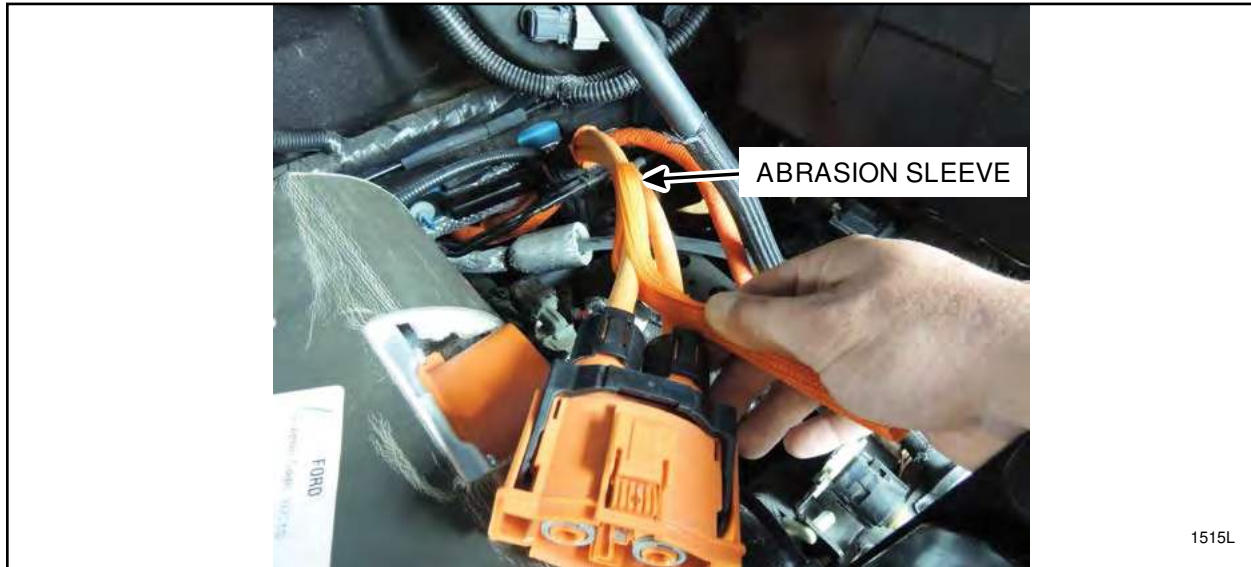
**FIGURE 5**

4. Install the abrasion sleeves individually over each HV wire. See Figures 5 and 6.

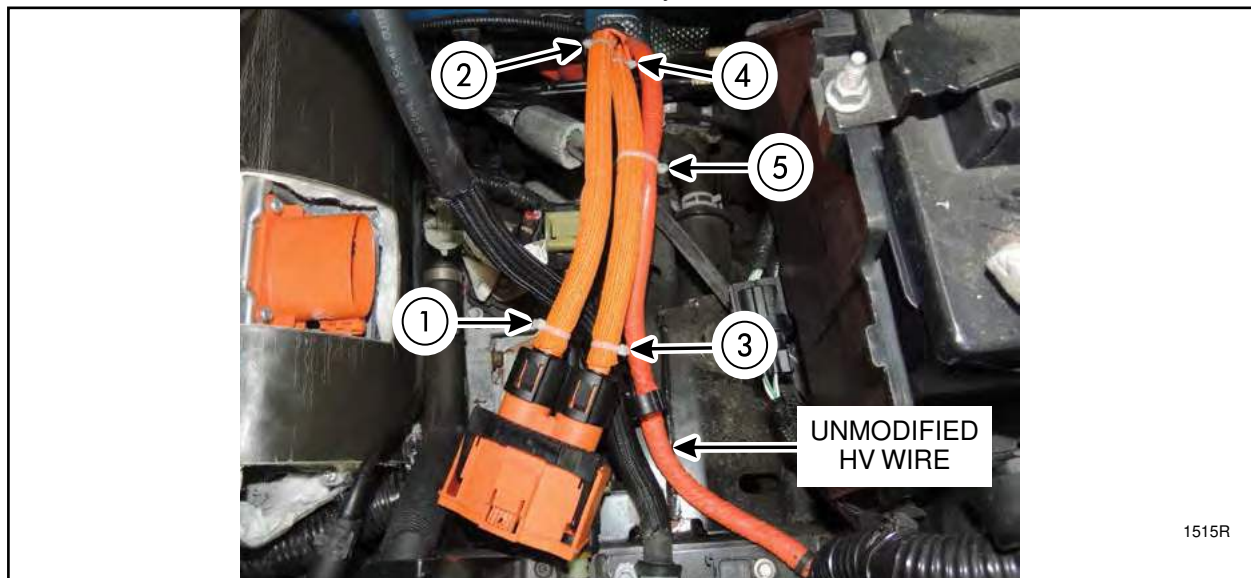
**FIGURE 6**

5. Install the supplied tie-straps to the HV wire harness in the sequence shown. Tie-strap "5" secures the unmodified HV wire to the nearest modified HV wire. Install the tie-straps so the straps are facing away from each other. Cut off excess length of the tie-straps. See Figure 6.

**NOTE:** The unmodified HV wire must be secured to only one of the modified HV wires.

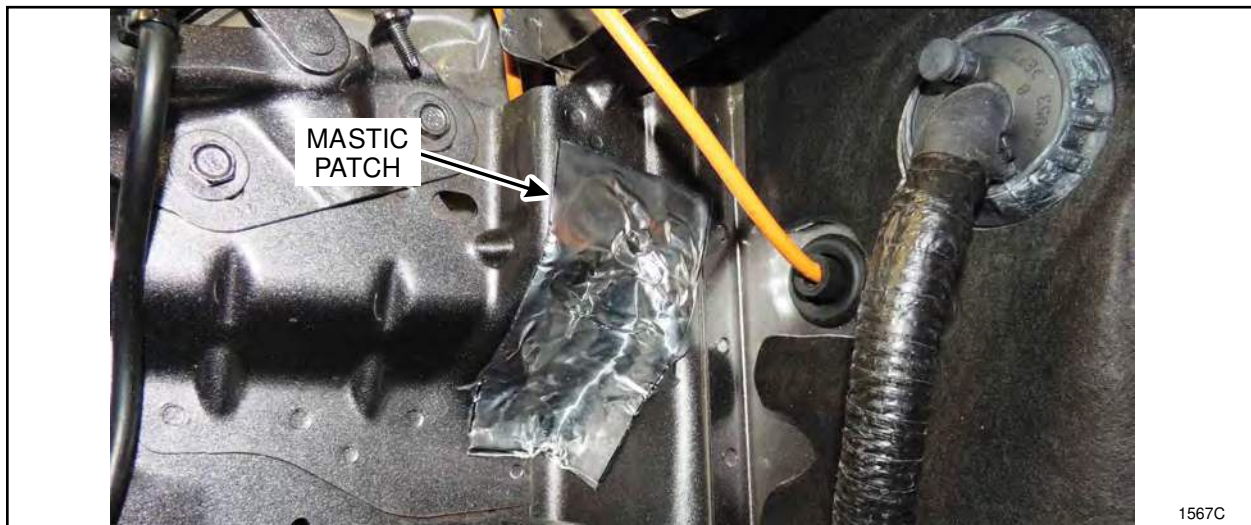
FIGURE 10

11. Cut the supplied mastic patch to 8 cm x 13 cm (3 in x 5 in) and apply the patch to the body joint. See Figure 10.

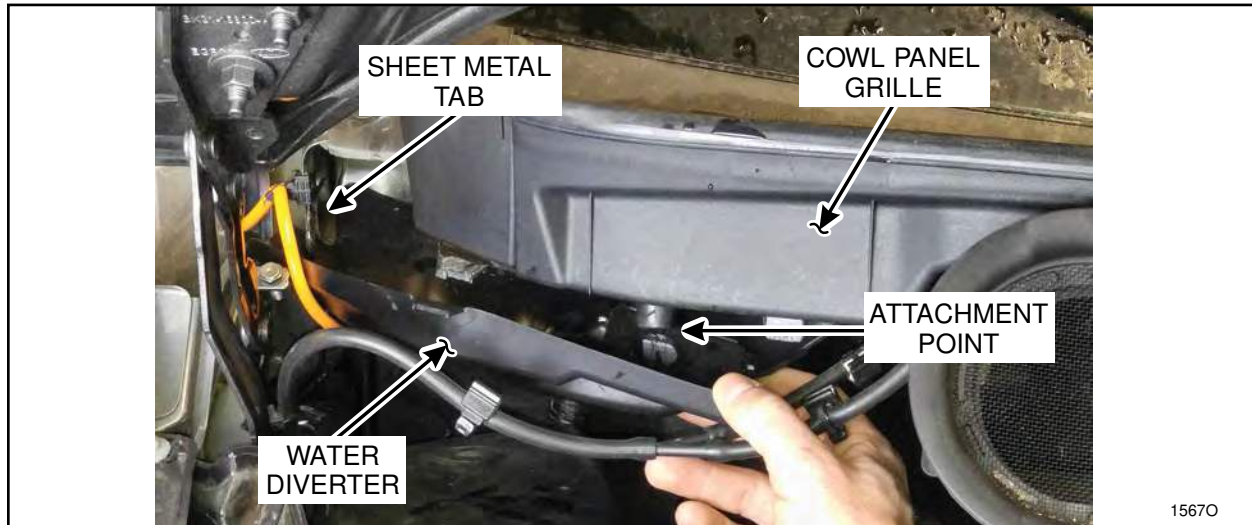
FIGURE 12

18. Reinstall the cowl panel grille. Please follow the WSM procedures in Section 501-02.
19. Install the supplied water diverter on the passenger side of the vehicle. See Figure 12.
  - a. Install the outboard end of the diverter into the sheet metal tab behind the hood hinge.
  - b. Snap the diverter up onto the cowl panel grille.

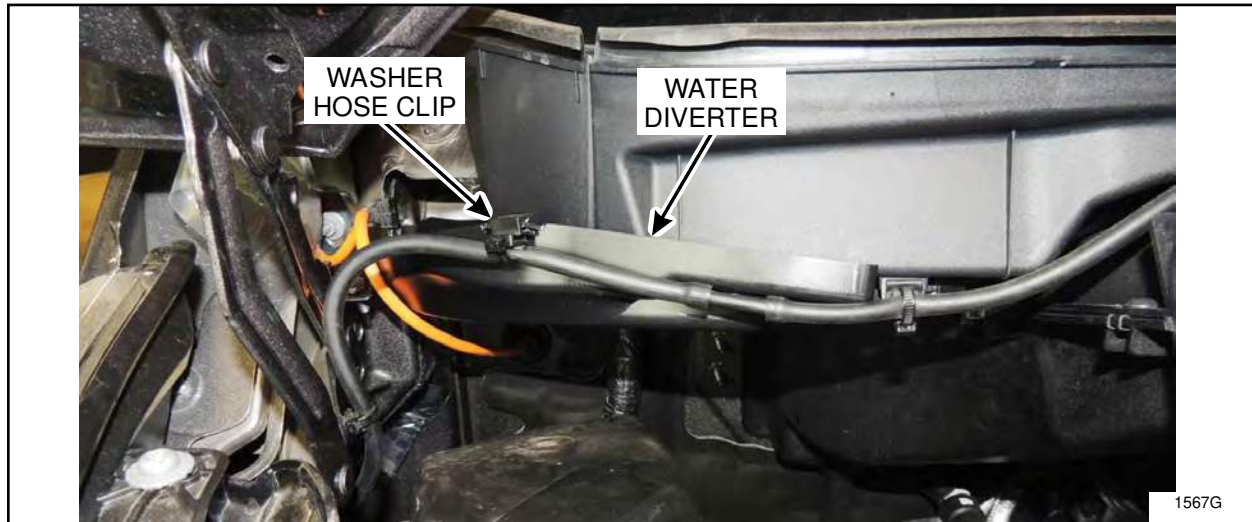
FIGURE 13

20. Route the orange antenna wire in front of the diverter and route the washer hose under the inboard end of the diverter. Attach the washer hose clip to the front edge of the diverter. See Figure 13.
