**Wayne E. Bahr, Global Director**  
Automotive Safety Office  
Sustainability, Environment & Safety Engineering

Subject: 49 CFR Part 579.5 Monthly Communications – February 2016

**INDEX OF SERVICE BULLETINS,  
NOTICES, AND COMMUNICATIONS TO DEALERS**

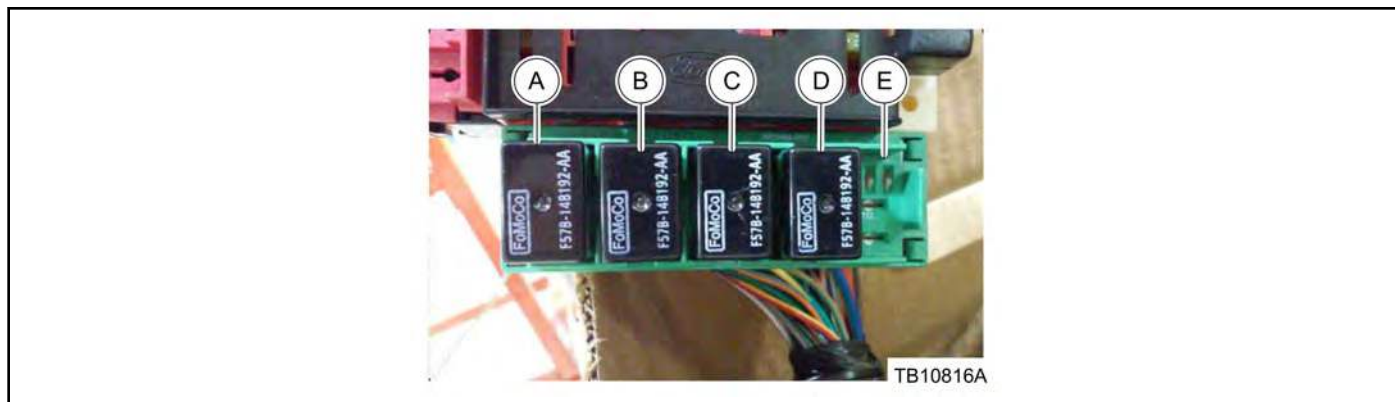
Figure 1 - Article 16-0014

Some 2011-2015 F-59 Commercial Stripped Chassis vehicles built on or before 5/29/2015 may experience hazard lighting, turn signal operation or trailer tow (TT) lighting that is not functioning properly. Vehicle vibrations may internally damage the relays that control the lighting circuits.

- A - Trailer Tow Right Turn
  - B - Trailer Tow Left Turn
  - C - Right Turn
  - D - Left Turn
  - E - Empty
3. Install new 4-terminal relays in the CJB in positions A, B, C and D. (Figure 1)

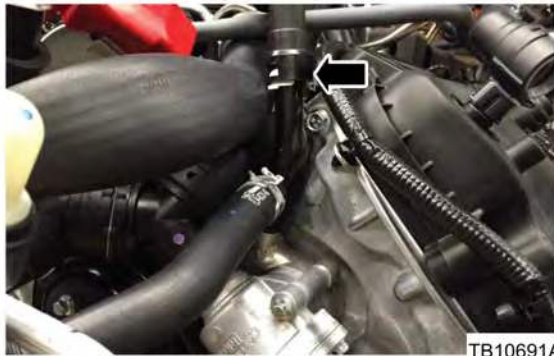
Figure 1 - Article 16-0019

1. Check the engine build date. Refer to Workshop Manual (WSM), Section 303-01. Was the engine built on 11/20/2014 and through 1/26/2015?
  - a. No - this procedure does not apply. Refer to WSM, Section 303-03 for normal diagnosis.
  - b. Yes - proceed to Step 2.
2. Is the heater outlet hose disconnected from or leaking at the heater outlet tube on the coolant pump? (Figure 1)

- a. No - this procedure does not apply. Refer to WSM, Section 303-03 for normal diagnosis.
  - b. Yes - proceed to Step 3.
3. Drain the cooling system. Refer to WSM, Section 303-03.
4. Remove the air cleaner outlet pipe. Refer to WSM Section 303-12.
5. Remove the bolts and position the degas bottle aside.
6. Completely cover the accessory drive belts with waterproof plastic.
7. Disconnect the heater outlet hose from the heater outlet tube. (Figure 2A)

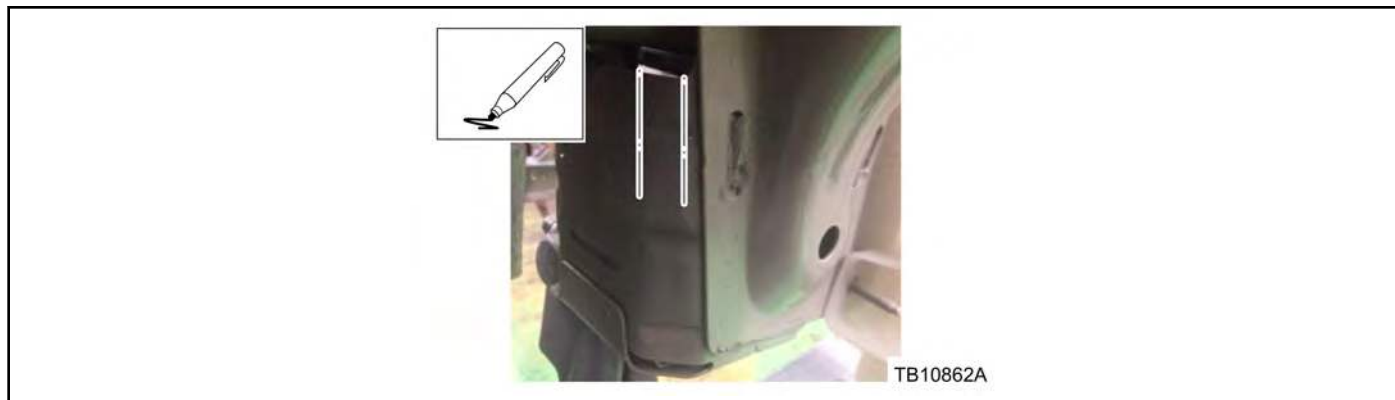
Figure 1 - Article 16-0021

The steps below will add an additional weld to eliminate the possibility of the barrel nut creak/pop noise.

1. Attach Rotunda Wireless Chassis Ears JSP97202 or equivalent. Does diagnosis with chassis ears indicate the noise is originating from the right front mounting bolt of the front subframe?
  - a. Yes - proceed to Step 2.
  - b. No - this article does not apply. Refer to Workshop Manual (WSM), Section 100-04 for normal diagnostics.
2. Disconnect the negative battery cable. Refer to WSM, Section 414-01.
3. Remove the right front wheel and tire assembly. Refer to WSM, Section 204-04.
4. Remove the right side fender splash shield. Refer to WSM, Section 501-02.
5. Locate the front subframe bolt mounting tower bracket on the right side frame member and mark 2 cut lines approximately 63 mm (2.50 in) long as shown. (Figure 1)

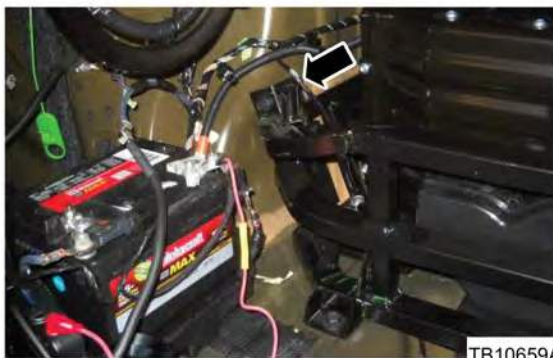
Figure 1 - Article 16-0023

4. Inspect the fan wiring from the high voltage battery pack, located at the interior left hand quarter panel, up to the fan motor(s) for damage or chafing on the metal bracket that attaches the battery cage to the vehicle body. Is chafing present? (Figure 1)

- a. Yes - repair the circuits as needed. Refer to Wiring Diagram, Section 5-1. After the repair, wrap the affected area with 3M™ Temflex™ Cotton Friction Tape or equivalent to prevent future concerns. Reinstall the driver's side trunk liner and battery access cover and proceed to Step 5.
  - b. No - wrap the affected area with 3M™ Temflex™ Cotton Friction Tape or equivalent to prevent future concerns. Reinstall the driver's side trunk liner and battery access cover, and proceed to Step 5.
5. Replace the Telematics Control Unit (TCU) module. Refer to WSM, Section 415-00.

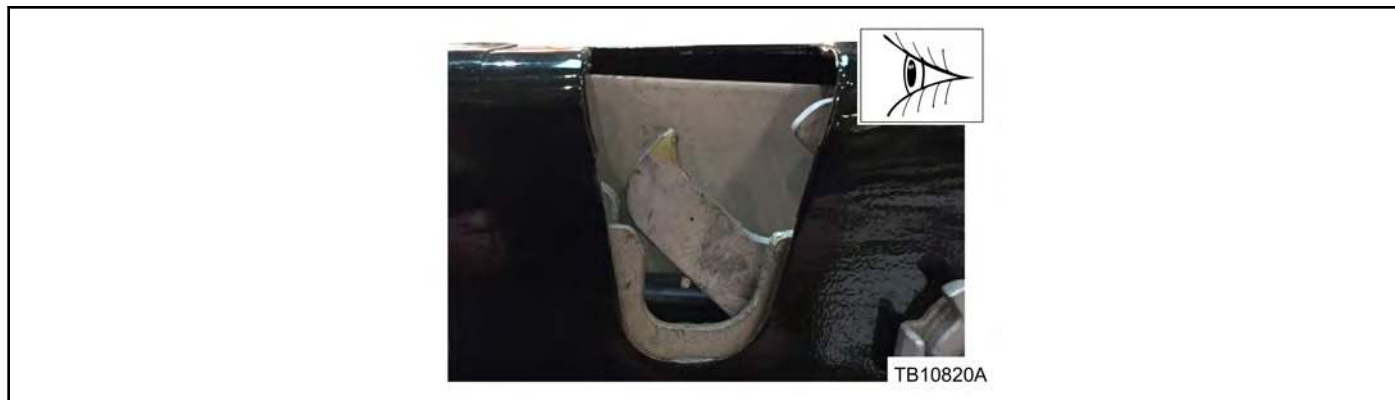
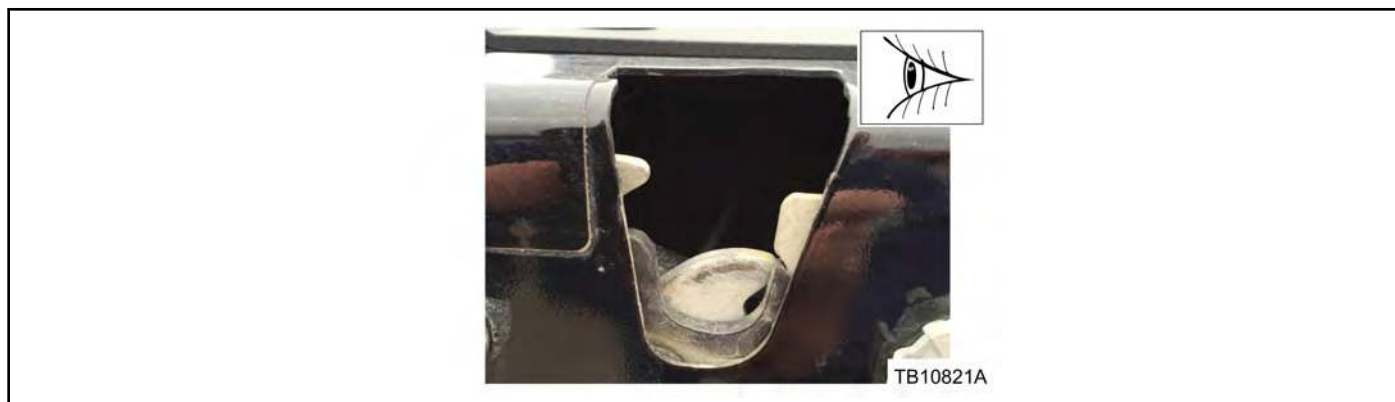
1. Inspect the left and right side tailgate latch assemblies. Is there a metal back on the inside of the latch? (Figures 1- 2)

- a. Yes - proceed to Step 6.
  - b. No - proceed to Step 2.
2. Replace the left and right tailgate latches and latch actuating rods. Refer to the Workshop Manual (WSM), Section 501-14.
