# Service Bulletin

Bulletin No.: 20-NA-178

**Subject:** Service Driver Assist and/or Take Steering Messages on Start-up, Advanced Driver Assist Systems (ADAS) Features Not Available with DTCs U1614, U1615, U1616 Set

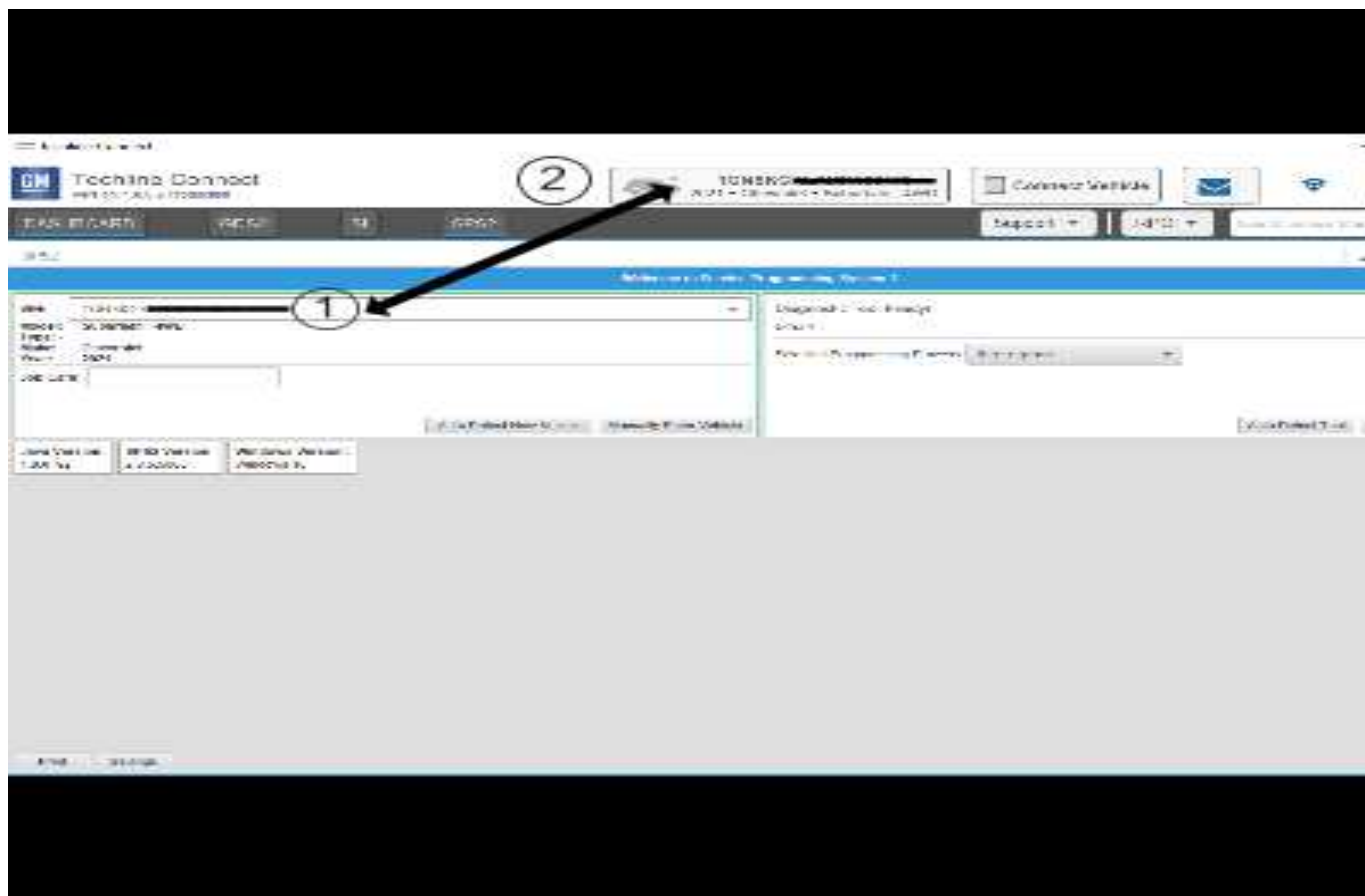
Caution: Be sure the VIN selected in the drop down menu (1) is the same as the vehicle connected (2) before beginning programming.

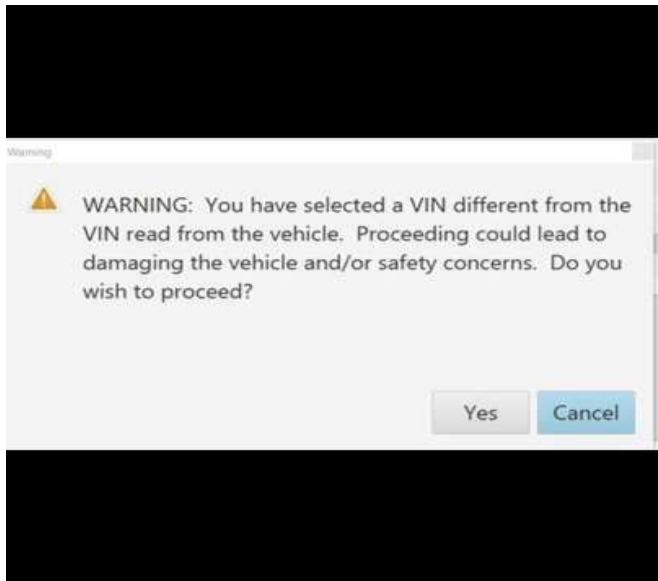
Important: If the vehicle VIN DOES NOT match, the message below will be shown.
