# Service Bulletin

Bulletin No.: 21-NA-209

**Subject:** Black Radio Display Screen (Triangle and Camera with the Slash Through it) with both DTCs U023C and B1A62 Setting Current in Video Processing Module (VPM)

| Brand: | Model: | Model Year: | | VIN: | | Engine: | Transmission: |
|---|---|---|---|---|---|---|---|
| Cadillac | Escalade<br>Escalade ESV | 2021 | 2021 | | | | |

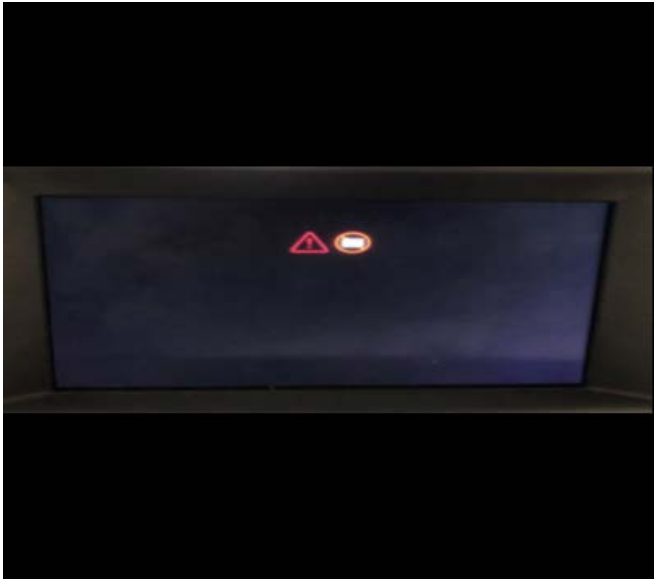
| Condition | <p>Some customers may comment on a condition present on the radio display where a black screen with a triangle and a camera with the slash through it is displayed.</p> <p>5902524</p> <p>Technicians may find two DTCs set current or in recent history:<br/> " DTC U023C – Loss of communication with the K157 Video Processing Module (VPM)<br/> " DTC B1A62 86</p> |
| Cause | The cause of the condition may be software anomalies in the VPM. |

| Correction | Technicians are to pull VPM fuse F28 and leave for one minute then reinstall. After completing the fuse pull then reprogram the VPM with the latest software released. |
