# Service Bulletin

Bulletin No.: 21-NA-266

Subject: Service Vehicle Soon Light Illuminated with DTC P0534 Set

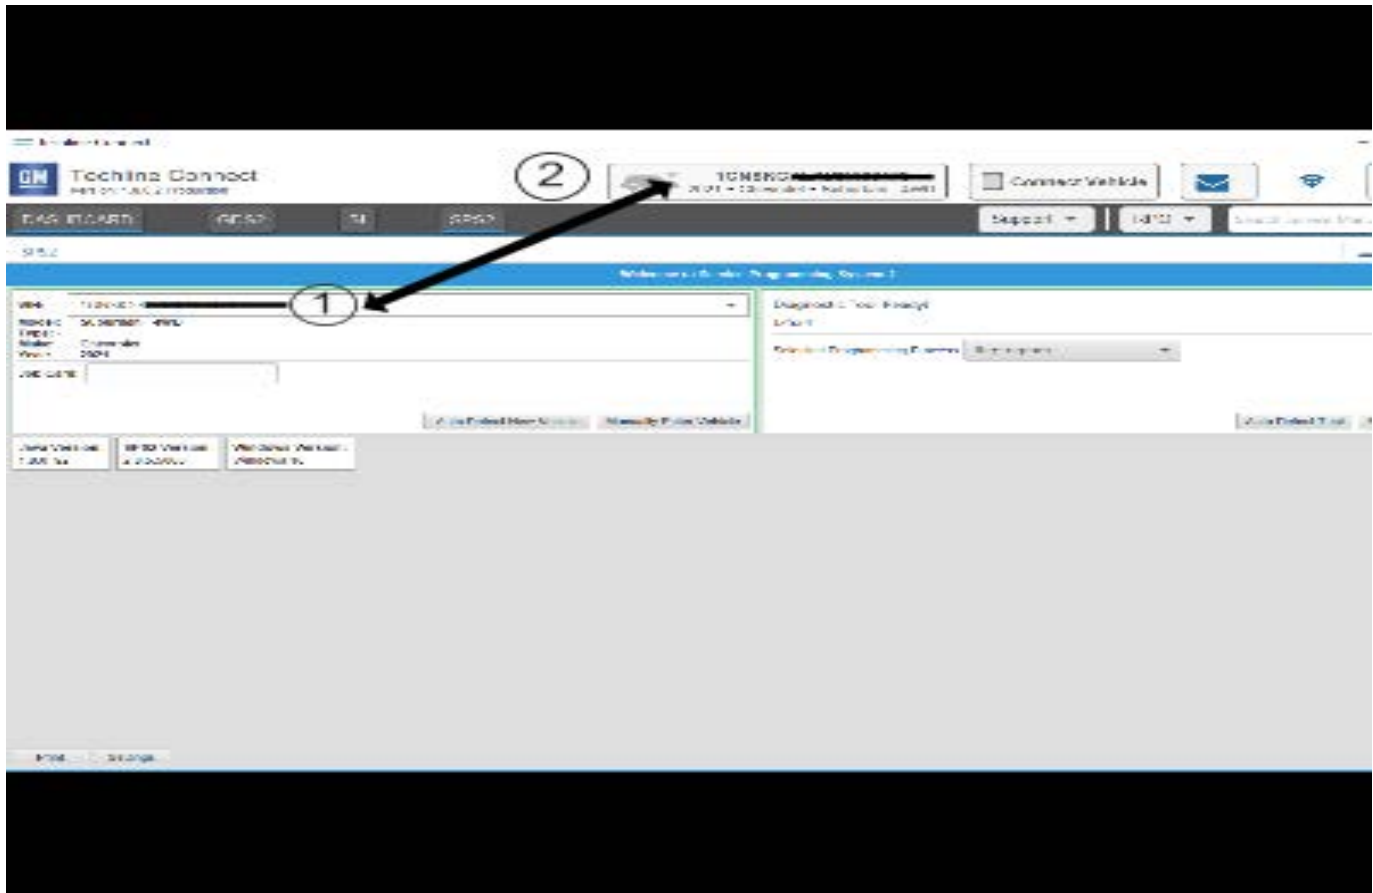
5743643

Caution: Be sure the VIN selected in the drop down menu (1) is the same as the vehicle connected (2) before beginning programming.

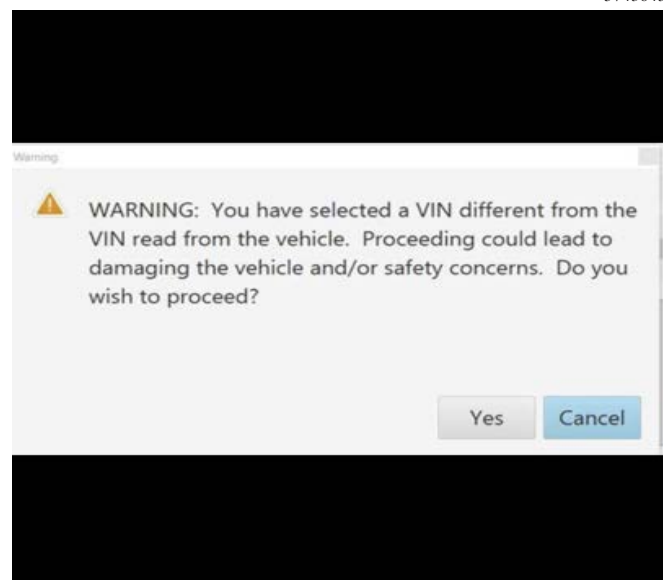
5877000

Important: If the vehicle VIN DOES NOT match, the message below will be shown.

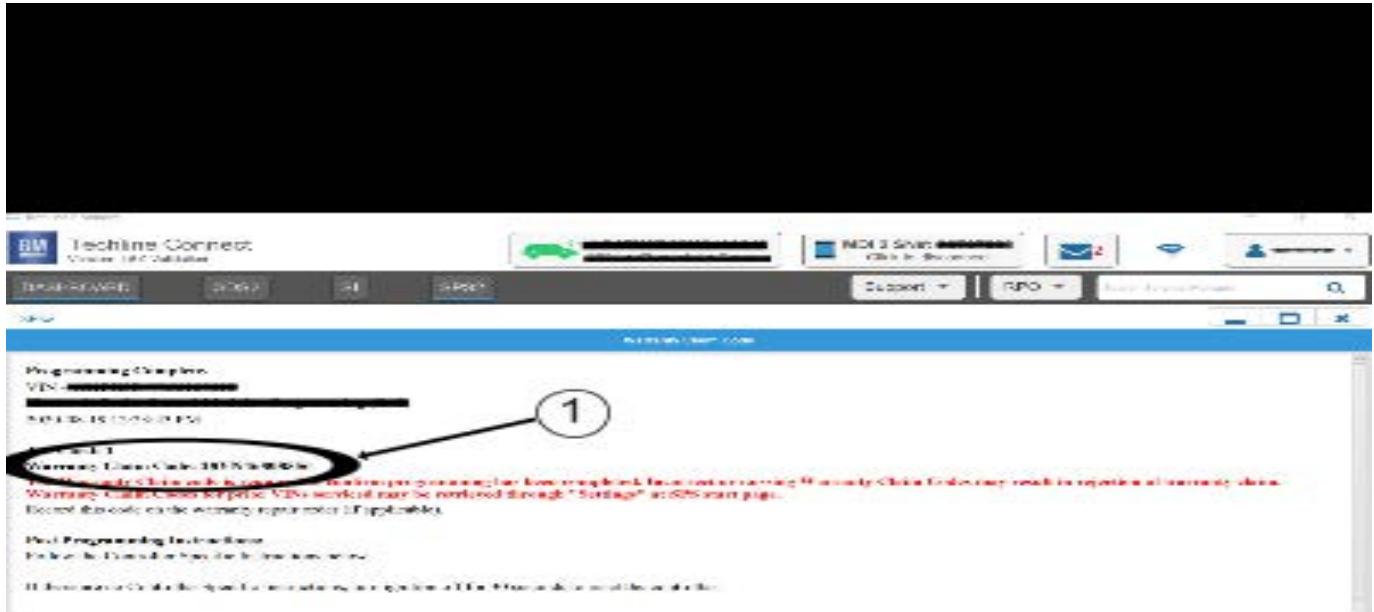
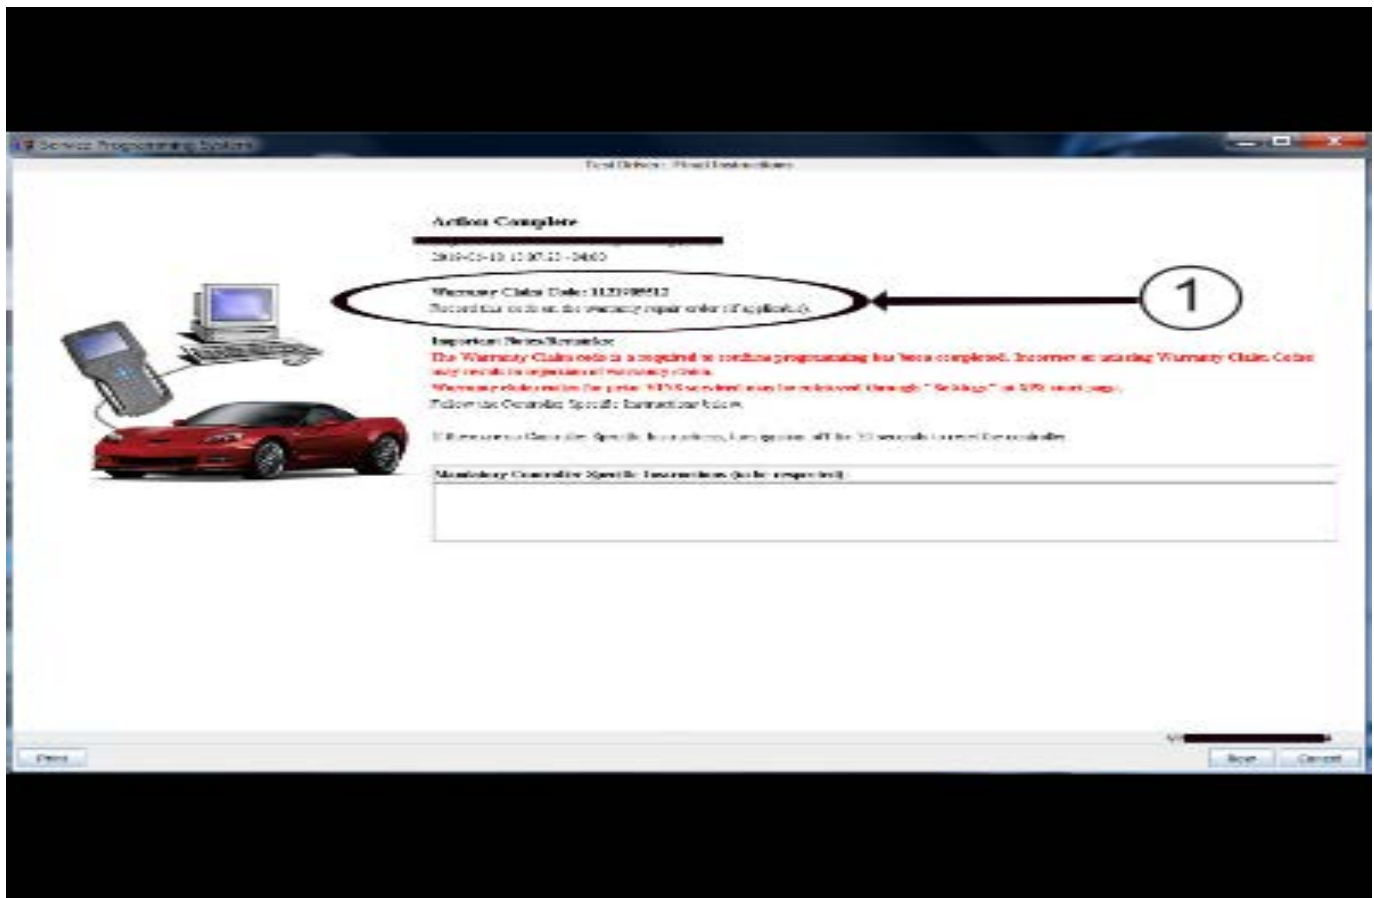
Important: To avoid warranty transaction rejections, you **MUST** record the warranty claim code provided on the SPS Warranty Claim Code (WCC) screen shown above on the job card. Refer to callout 1 above for the location of the WCC on the SPS screen.

- 2. Record the SPS Warranty Claim Code on the job card for warranty transaction submission.
