NUMBER  
PI1802Y/Z (Rev 6, 12/23/2021)

## PRODUCT IMPROVEMENT CAMPAIGN

### ENGINE REPLACEMENT INSTRUCTIONS FOR DTC P1326 (PI1802Y/Z)

This bulletin provides information related to the Technical Service Bulletin previously published [PI1802](#) titled "Knock Sensor Detection System - ECU Logic Improvement" equipped w/THETA II engine. Specifically, this bulletin provides instructions on which procedures to follow if, after installation of the KSDS, any one of the subject vehicles below returns to the dealer with Diagnostic Trouble Code (DTC) P1326 (Knock Signal Range/Performance).

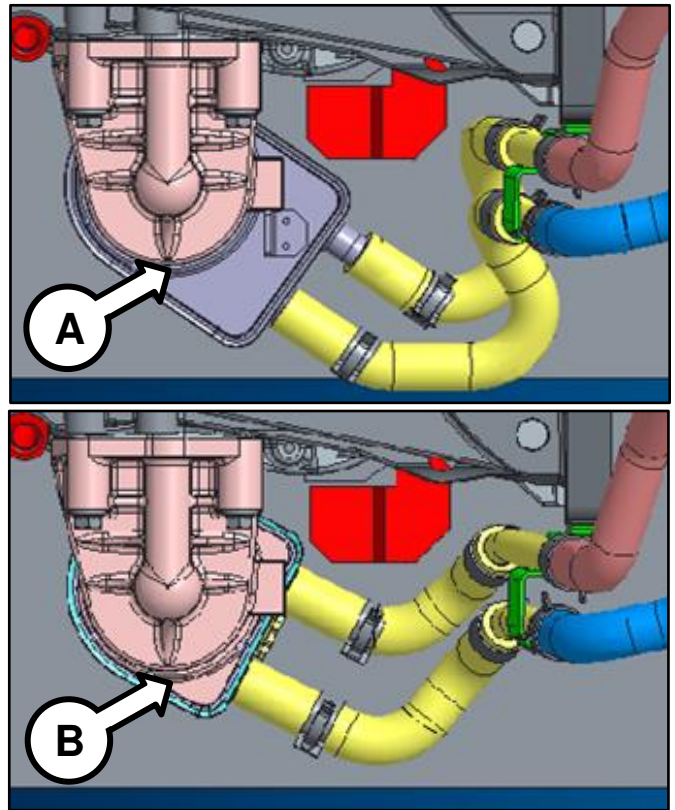
**Oil Cooler Tube Assembly:**

New engines may be supplied with a different oil cooler. Use steps below to determine the need for a replacement oil cooler tube assembly.

- If the new engine's (bigger) oil cooler (A) does not match the old engine's (smaller) oil cooler (B), replace the oil cooler tube assembly with the improved part. See parts table on page 16.
- If the new engine's (bigger) oil cooler (A) matches the old engine's (bigger) oil cooler (A), reuse the old engine's oil cooler tube assembly.
- If the new engine's (smaller) oil cooler (B) matches the old engine's (smaller) oil cooler (B), reuse the old engine's oil cooler tube assembly.

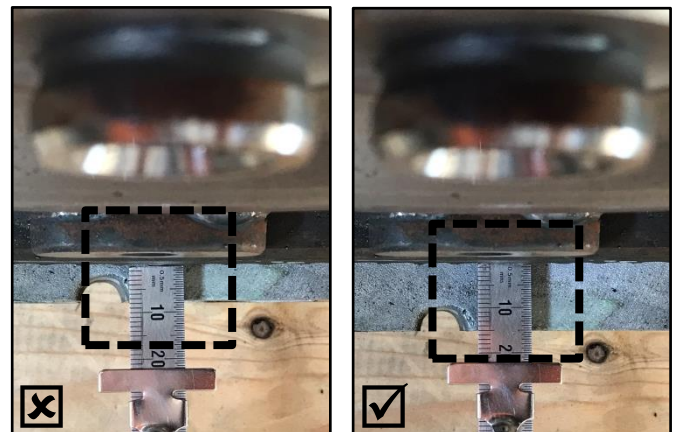
**Torque Converter**

Not Fully Inserted

Fully Inserted

- If the torque converter has moved from the fully inserted position, carefully push inward while rotating the torque converter until it is recessed approximately 9/16 – 5/8" (14 – 16mm) (☑) into the transaxle case when reinstalling the automatic transaxle.
