NUMBER  
PI1803Y/Z (Rev 6, 12/23/2021)

### ENGINE REPLACEMENT INSTRUCTIONS FOR DTC P1326 (PI1803Y/Z)

This bulletin provides information related to the Technical Service Bulletin previously published [PI1803](#) titled "Knock Sensor Detection System - ECU Logic Improvement" equipped w/THETA II engine. Specifically, this bulletin provides instructions on which procedures to follow if, after installation of the KSDS, any one of the subject vehicles below returns to the dealer with Diagnostic Trouble Code (DTC) P1326 (Knock Signal Range/Performance).

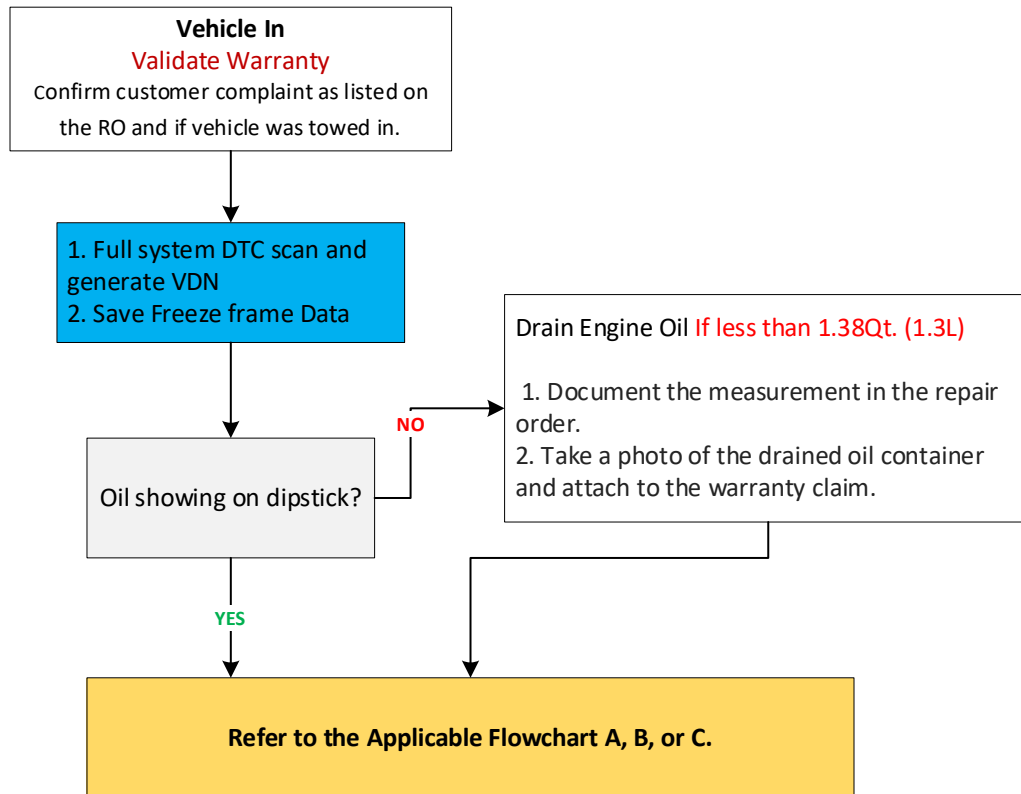
**Main Flowchart:**

Follow the applicable Main Flowchart below upon documenting customer complaint. Then follow the corresponding flowchart for one (1) of the three (3) following concerns:

- A. DTC P1326 Stored... (Page 3) - NO Engine Noise
- B. ENGINE NOISE... (Page 4)
- C. ENGINE, NO CRANK... (Page 5)

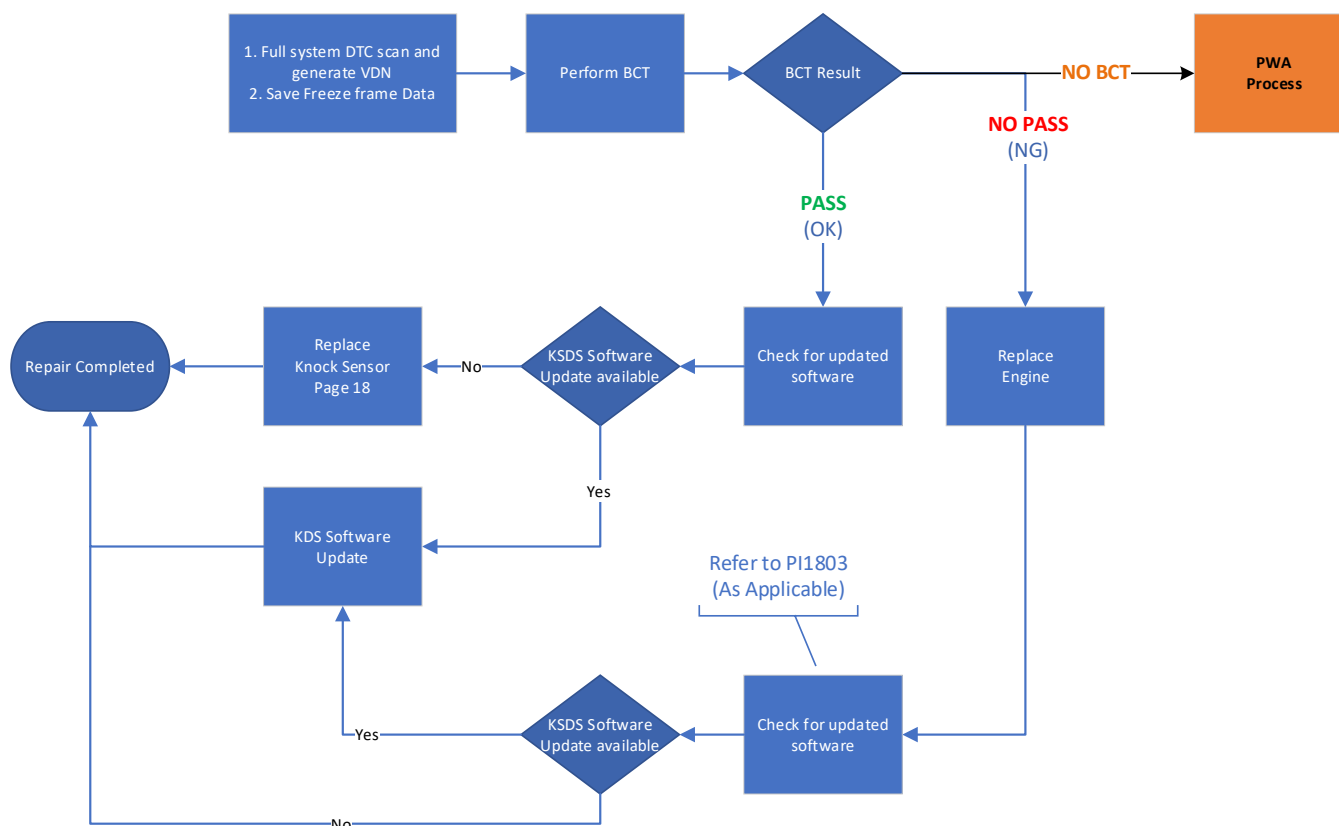
**SUBJECT: ENGINE REPLACEMENT INSTRUCTIONS FOR DTC P1326 (PI1803Y/Z)****Flowcharts:****A. DTC P1326 Stored**

Create PI1803Y Claim - No PWA Required (Pass/No Pass result)

Create PI1803Z Claim - PWA Required (No BCT result)

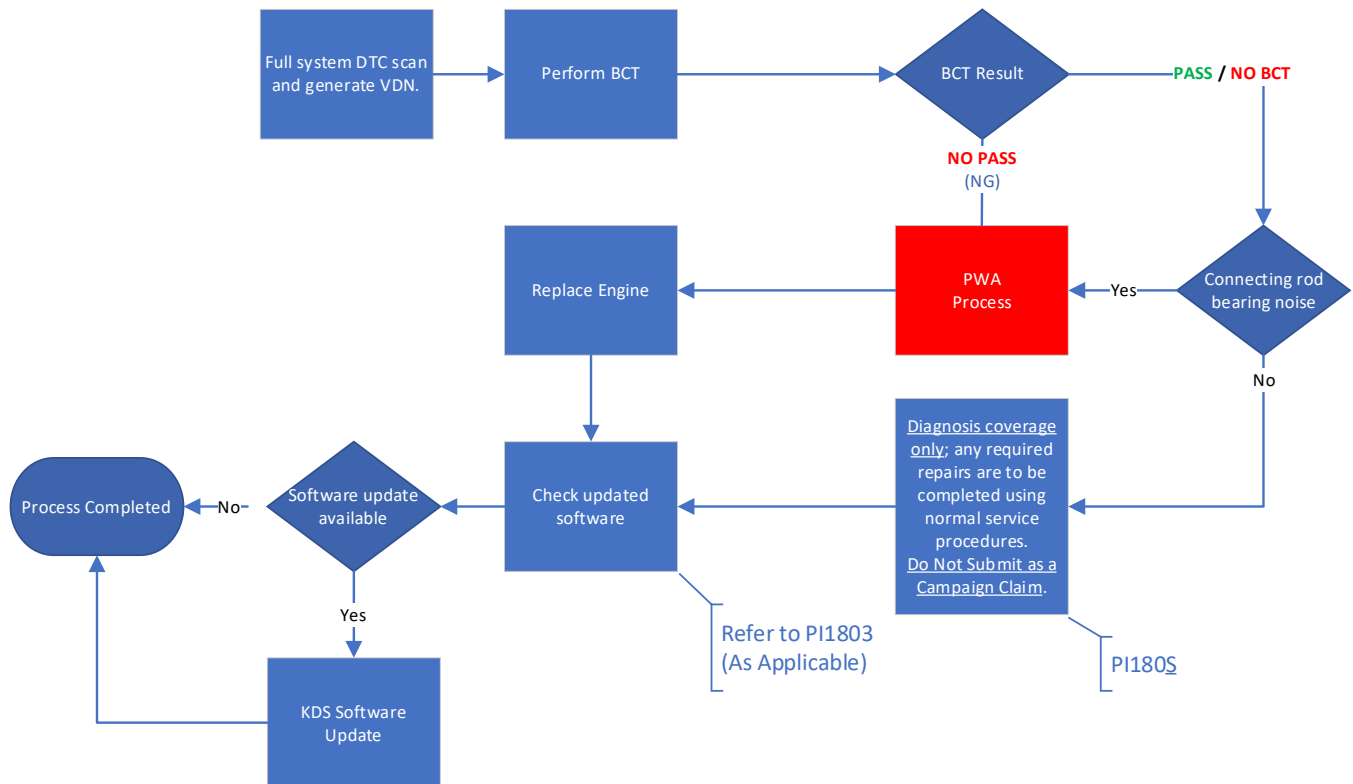
## B. Engine Noise

Techline PWA Required; Diagnosis only Campaign Possible

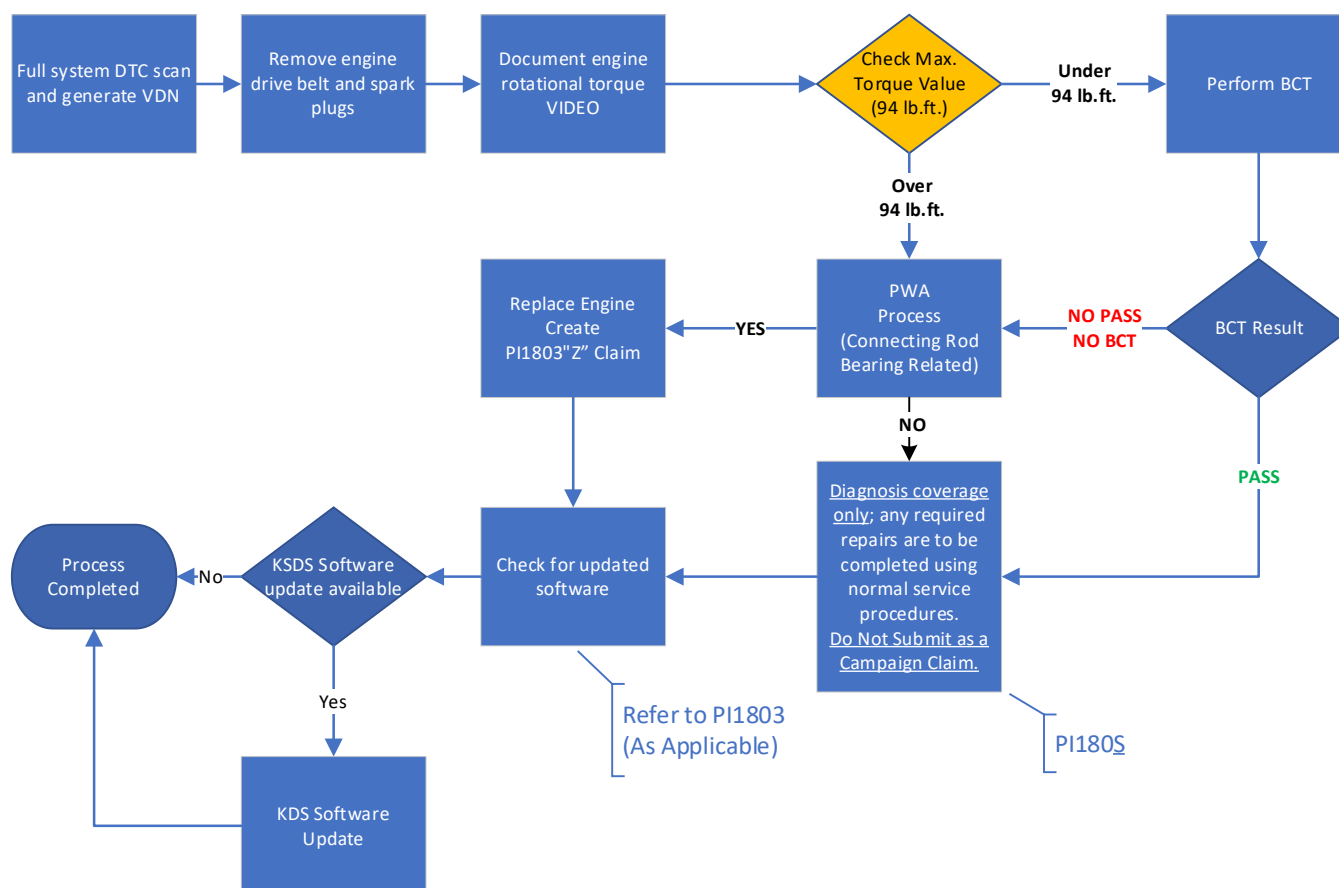
**SUBJECT: ENGINE REPLACEMENT INSTRUCTIONS FOR DTC P1326 (PI1803Y/Z)****C. Engine No Crank**

Techline PWA Required; Diagnosis only Campaign Possible

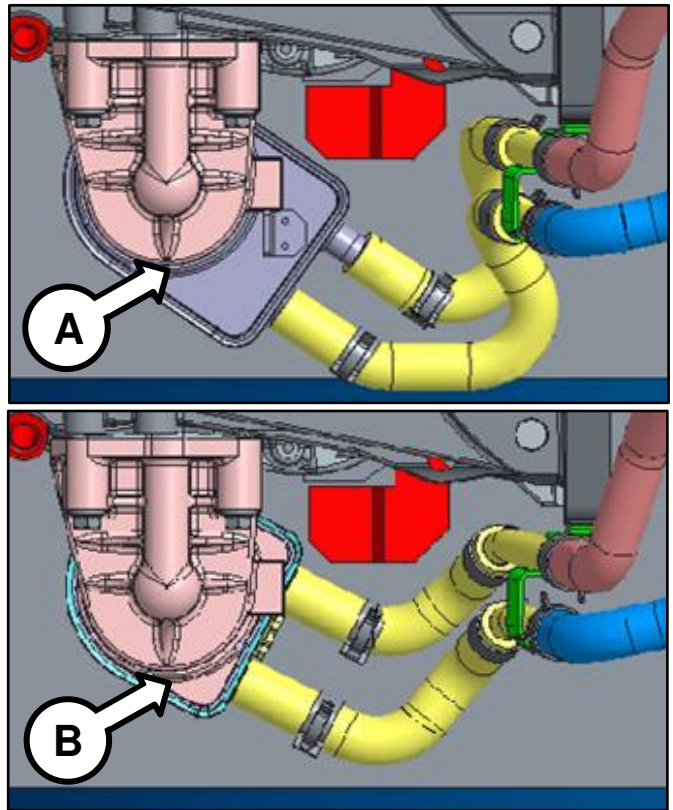
**Oil Cooler Tube Assembly:**

New engines may be supplied with a different oil cooler. Use steps below to determine the need for a replacement oil cooler tube assembly.

- If the new engine's (bigger) oil cooler (A) does not match the old engine's (smaller) oil cooler (B), replace the oil cooler tube assembly with the improved part. See parts table on page 23.
- If the new engine's (bigger) oil cooler (A) matches the old engine's (bigger) oil cooler (A), reuse the old engine's oil cooler tube assembly.
- If the new engine's (smaller) oil cooler (B) matches the old engine's (smaller) oil cooler (B), reuse the old engine's oil cooler tube assembly.
