## Technical product information

| <b>Topic</b> | W12 TSI - Engine MIL light illuminated with numerous DTC's within 0001 including - P032700 and/or P033200 |
| <b>Brand</b> | Bentley |
| <b>Transaction No.</b> | 2065398/1 |

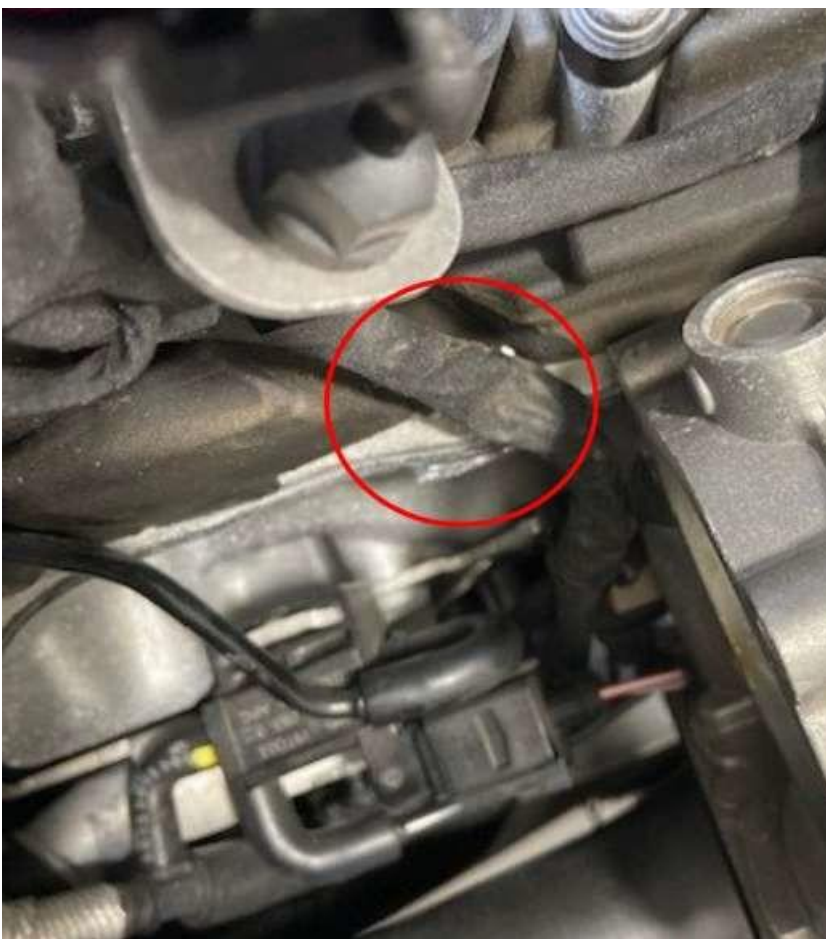
The symptom/issue can relate to a section of the engine wiring harness which has been damaged due to contact with the Bank 1 cylinder head as shown in Figure 1

- The issue to date has only been evident on Bank 1 - within address 0001 (Engine control module 1)
- NOTE: in the event the DTC's or symptoms relate to Bank 2, please raise a DISS query and await feedback before conducting any further work
