Preliminary Information

PIP5246A (EREV) Reduced Propulsion with P0C17 P1B03 Or P0C01 (Drive Motor 1 Only)

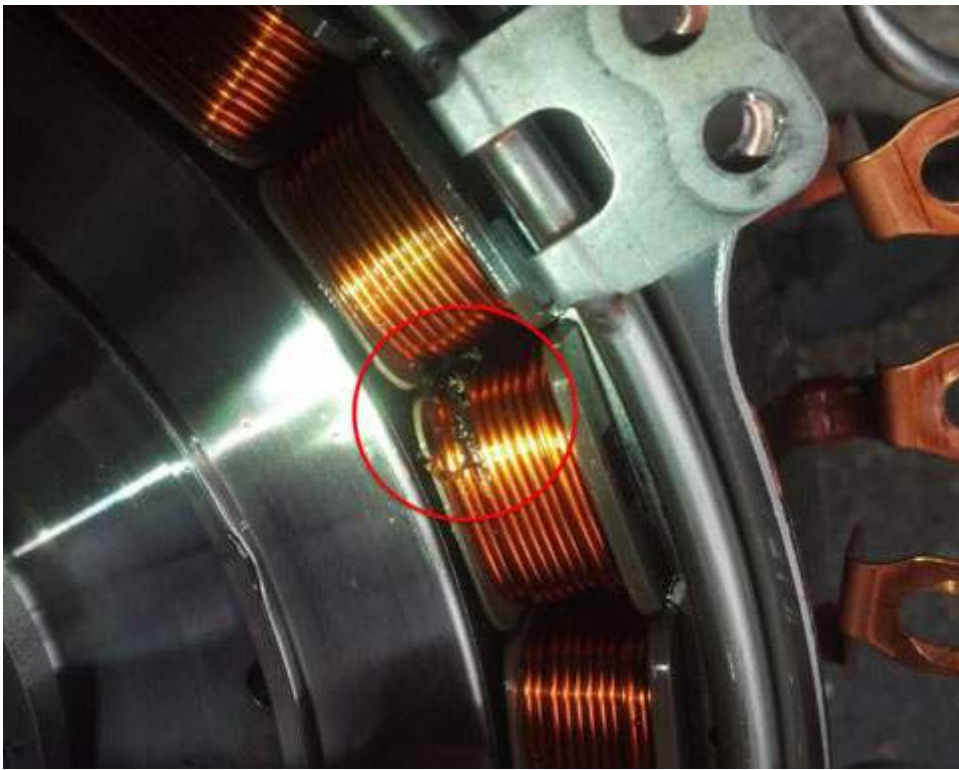
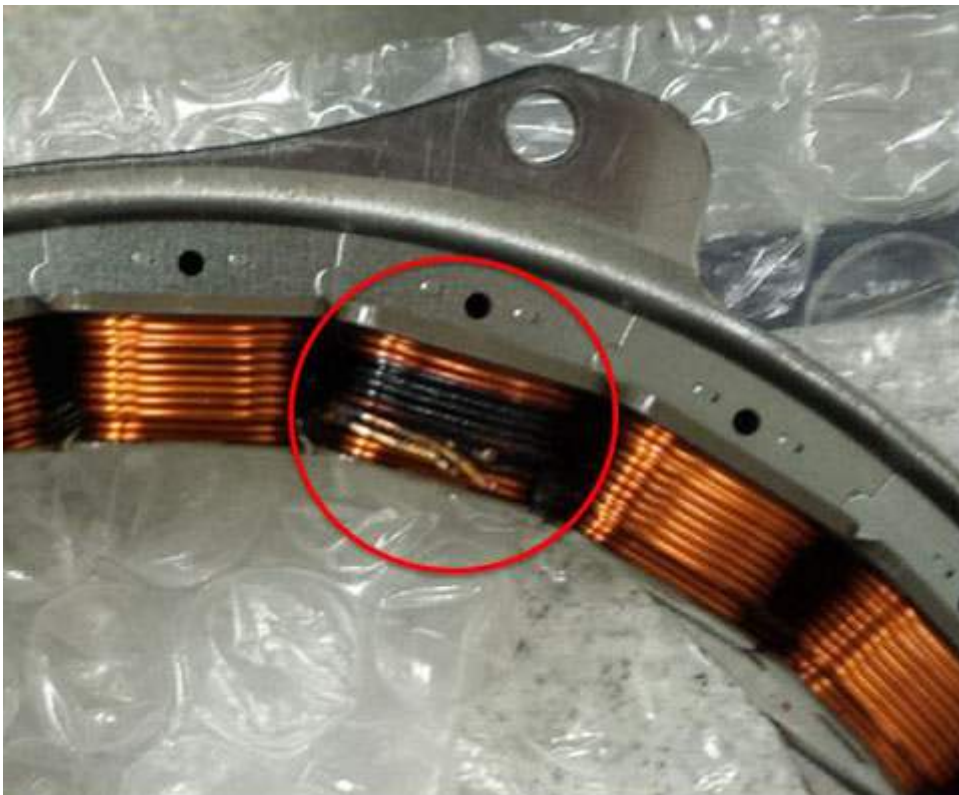
Some customers may comment that the Check Engine Light (CEL) illuminated with an "Engine Unavailable" and "Propulsion Power is Reduced" messages on the DIC. The customer may also comment there is rough operation especially with the engine running. The most common DTC for this condition is P1B03.

Some SI diagnostic procedures may not comprehend the possibility of the Motor 1 Stator as the cause of these DTCs. If one or more of these diagnostics are set, especially on a vehicle with a lifetime fuel economy below 50 mpg and above average annual mileage, inspect the Motor 1 Stator for damage as shown in the pictures below.

**If no damage is found, replace all of the following parts: Motor 1 Position Sensor, Transmission Internal Harness, and Motor 1 Stator (damage may be on windings below the top layer). Replacing the Drive Motor Generator Control Module should only be ordered if the condition persists after replacing these parts.**
