# Preliminary Information

## PIP5826B MIL illuminated with DTC P0521

### Models

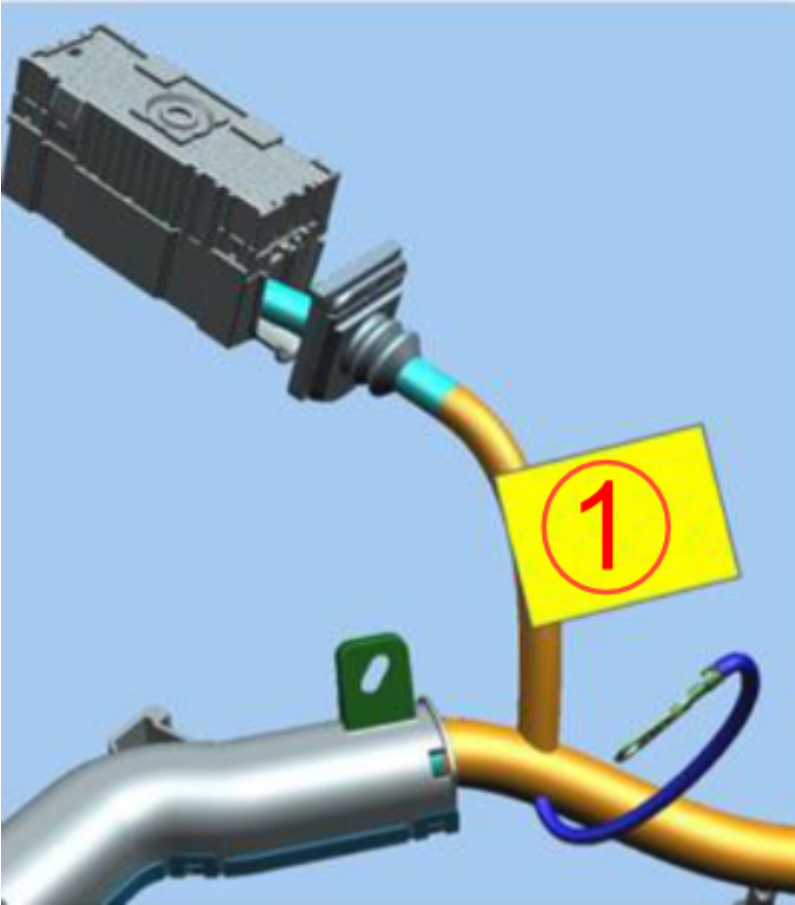
Branch for X50A Fuse Block - Underhood.

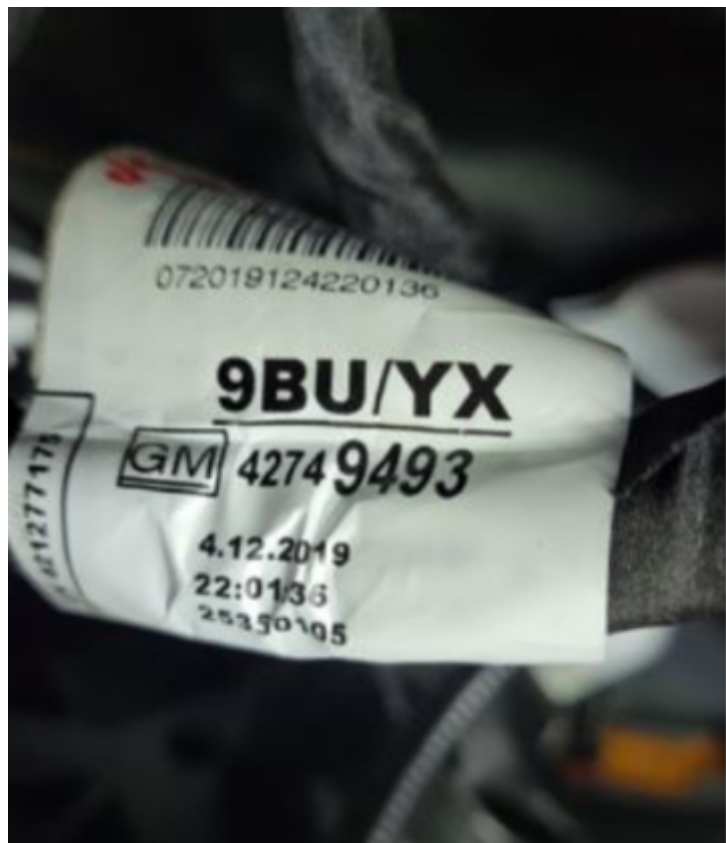
Engine wiring harness part number tag.

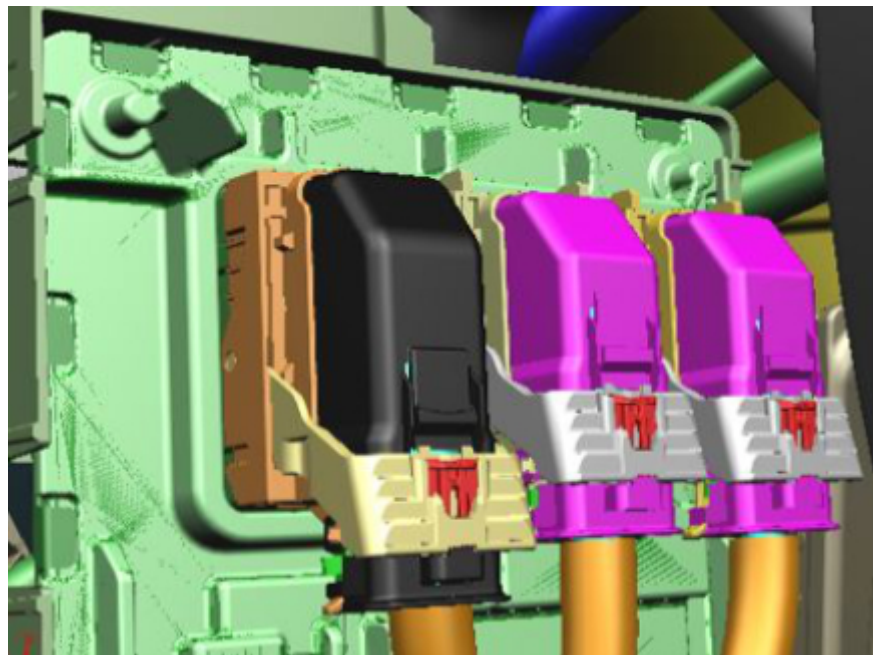
If the part number is one of the following (42737310, 42737311, 42749493, 42749494), inspect the three ECM connectors for proper locking lever and CPA lock positions. (refer to picture below).

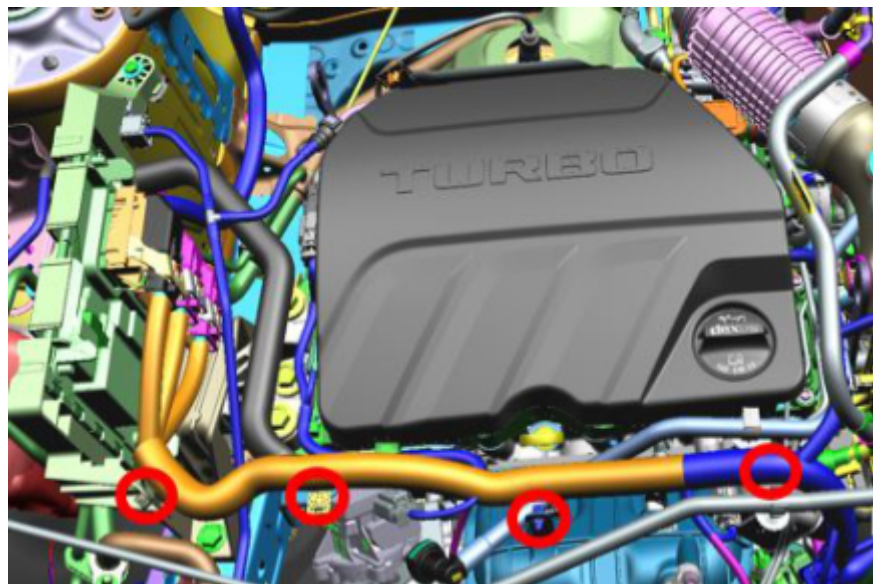
Inspect the 4 clips circled below for broken Tie Straps and proper retention of the main engine wiring harness.

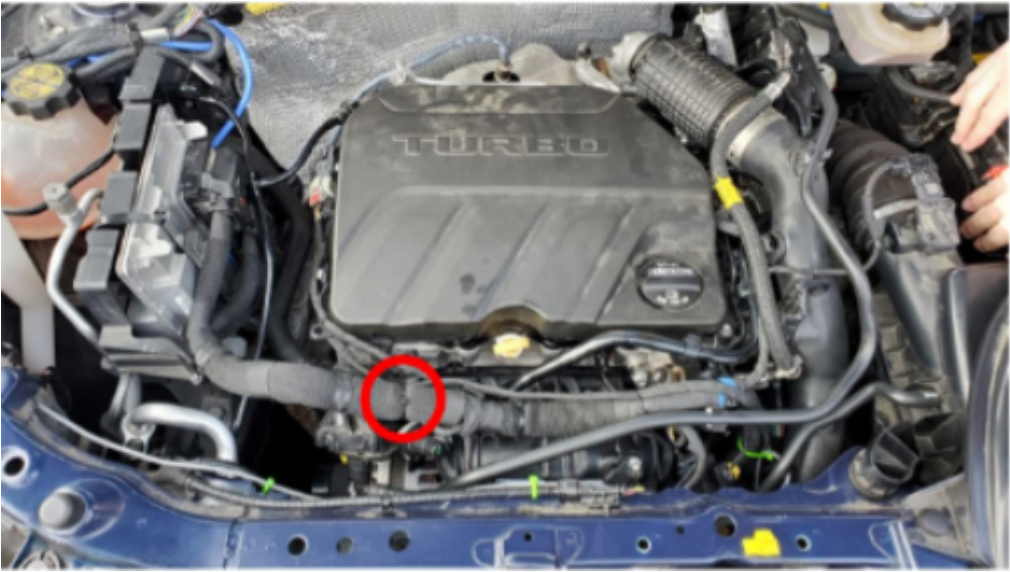
Once duplicated, open the hood and bend the harness back and forth at the circled location shown below while monitoring for the engine oil pressure to change.

A change in the engine oil pressure reading either up or down in PSI, isolates the issue to the Special three wire Splice in this location of the main engine wiring harness.

Open the engine wiring harness in the location circled above to access the three wire special splice for Low Reference circuit 548 BK/GN.

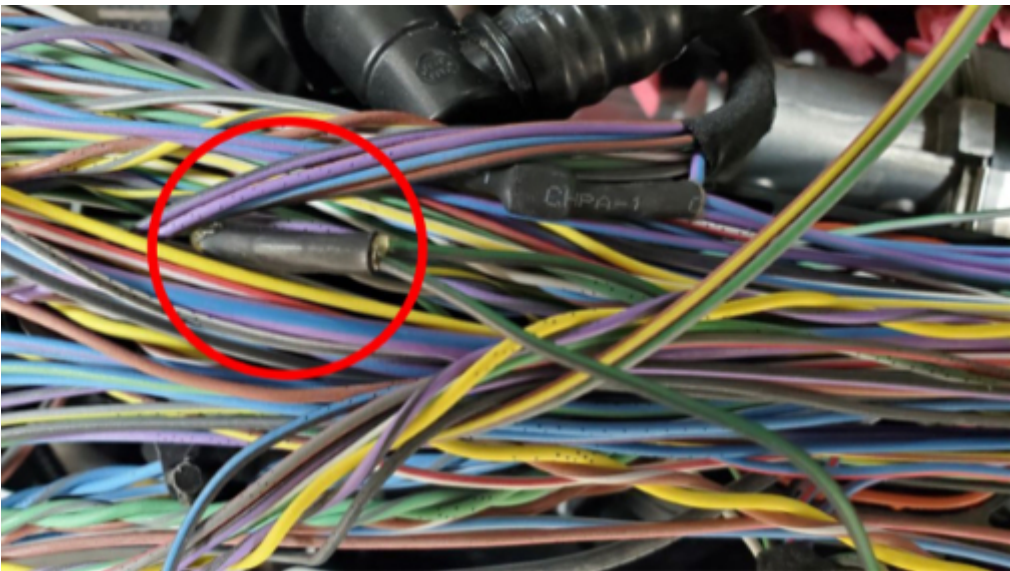
Remove the Heat Shrink and splice clip to expose all three legs of the special splice.

Inspect each leg for broken wire strands and correct any issues.

Slide the appropriate size heat shrink tube on one branch of the circuit.

Install a new splice clip, solder the three legs, and seal with the heat shrink.
