**TECHNICAL SERVICE BULLETIN****Illuminated ABS Indicator, Engine Will Not Turn Off And/Or Various Electrical Symptoms - BJB Cover Not Fully Seated****22-2004**11 January  
2022

This bulletin supersedes 21-2176. Reason for update: Concern Carryover to New Model

| <b>Ford</b><br>2020-2022 F-Super Duty |

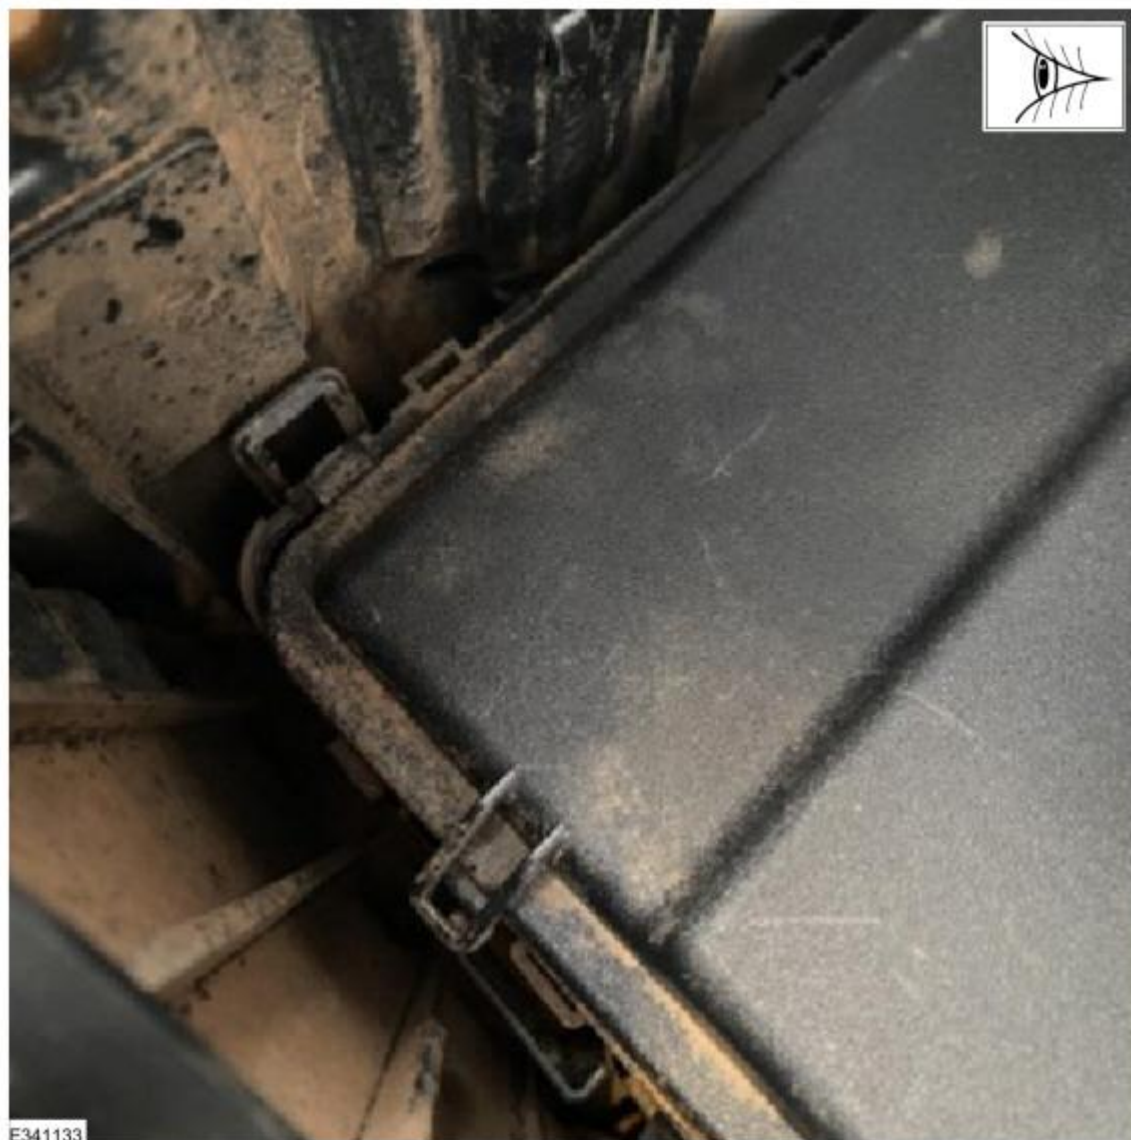
1. Visually inspect the BJB for signs of water/moisture intrusion. Are there signs of water/moisture intrusion into the BJB and/or broken cover tabs/locking fingers?

Figure 1 - Example of moisture intrusion with BJB cover on

## 2. Replace the BJB assembly.

- (1). Remove the battery and battery tray. Refer to the Workshop Manual, Section 414-01.
- (2). Remove the BJB cover.
- (3). Loosen the two BJB connector bolts and remove the battery power cable nut. Disconnect the battery power cable from the BJB.

- (4). Release the BJB from the two locking tabs on each side of the BJB.
- (5). Lift the BJB to allow access to both BJB connectors. Disconnect both connectors and remove the BJB.

- (6). Remove the cover from the new BJB and connect both connectors to the new BJB.
- (7). Install the new BJB into both locking tabs.
- (8). Attach the battery power cable and tighten the battery power cable nut to 10.5 Nm (93 lb-in). Tighten the connector bolts to 5.4 Nm (48 lb-in).

- (9). Install the new BJB cover making sure the cover tabs/locking fingers are installed correctly.
- (10). Install the battery tray and battery back into the vehicle. Refer to WSM, Section 414-01.
