# Technical Service Bulletin

LIFTGATE SWITCH DOES NOT WORK

Bulletin No.: 09-004/22

Last Issued : 01/27/2022

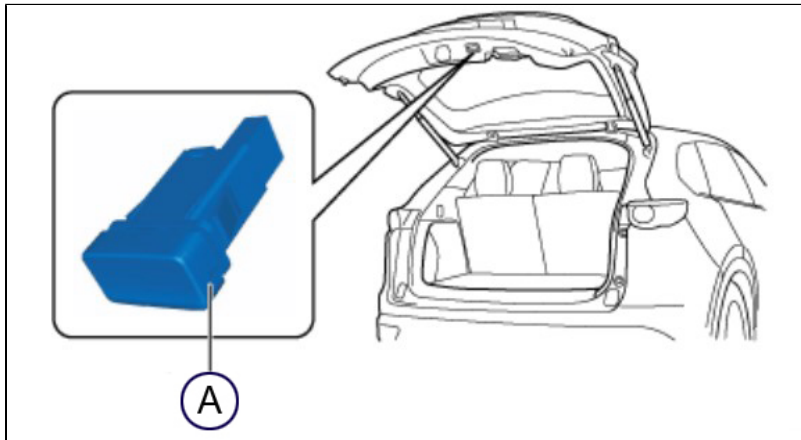
**NOTE:** CX-5 shown below

Some CX-5 and CX-30 customers may find that the liftgate does not close when pressing the power liftgate (PLG) rear switch (A) located on the interior liftgate trim. This may be caused by PLG switch corrosion. Water from a high pressure car washer and/or condensation may drip onto the switch connector and cause corrosion.

Some Mazda3, CX-30 and MX-30 customers may complain that the vehicle door locking system does not work when the door lock switch on the liftgate interior trim is pressed. DTC B11C4:23 (BCM - liftgate lock switch circuit malfunction) may be stored. This may be caused during a high pressure car wash and/or condensation. Water may enter through the rear center brand emblem base component and drip onto the switch connector causing corrosion. The rusted connector may also cause a battery drain.

To eliminate this concern, the PLG rear switch has been modified with a waterproof connector.

To eliminate this concern, the rear center brand emblem base has been modified to prevent water entry (Mazda3) and the rear harness has been modified to prevent water infiltration (Mazda3, CX-30 and MX-30).
