# Technical Service Bulletin

**SCBS WARNING LIGHT WITH DTC U045A:68 AND/OR PARKING  
SENSOR INDICATOR FLASHING WITH DTC B1B36, B1B38,  
B1B40 AND/OR B1B42**

**Bulletin No.: 15-002/22**

2017-2021 CX-5 with front parking (ultrasonic) sensor

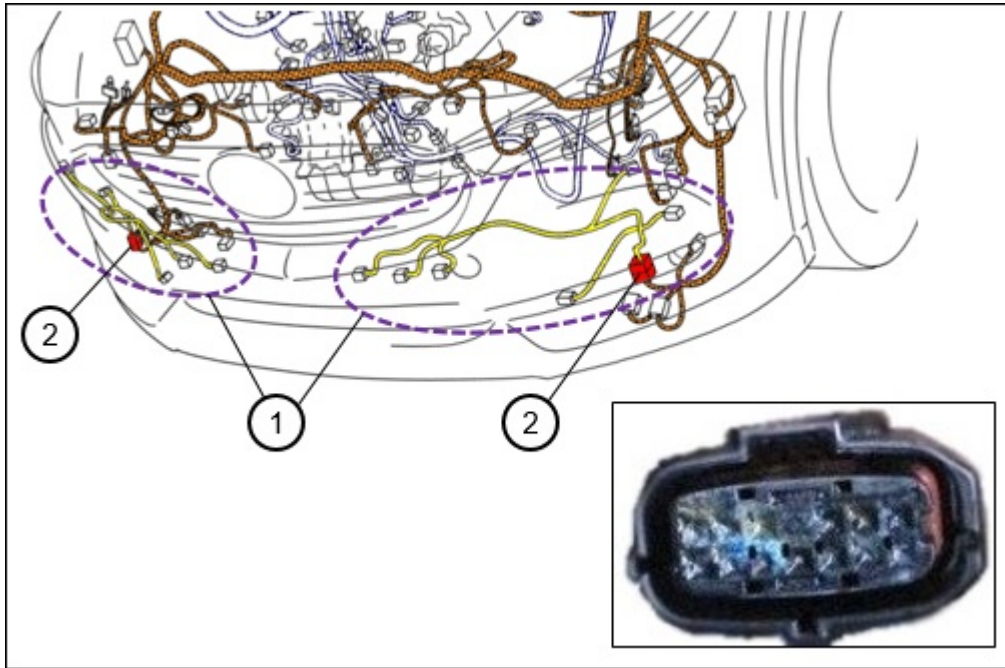
Due to insufficient waterproof performance of the front harness short cords (1), water may enter in and accumulate in the C-11 (LH) or C-12 (RH) connectors (2) causing a short circuit between wires and an improper signal being sent from the parking (ultrasonic) sensor to the parking sensor unit.

Sample picture shows C-11 connector with water entry and terminal corrosion.

To eliminate this concern, the production process of the front harness short cord has been improved to increase waterproof performance.

3. Disconnect the C-11 (LH) or C-12 (RH) connector and check for water entry.
  - If there is any water entry in C-11 or C-12 connector, go to next step.

- If there is no trace of water entry, this Service Information is not applicable. Diagnose for other causes according to the instructions on MGSS.
4. Replace the front harness short cord (1) of the affected side with a modified one.
