# Technical Service Bulletin

**96 Audi adaptive light system malfunction, DTC C12B3FA stored in the control module for driver assistance systems**

**96 22 75 2054202/5 January 31, 2022. Supersedes Technical Service Bulletin Group 96 number 19-47 dated December 9, 2019 for reasons listed below.**

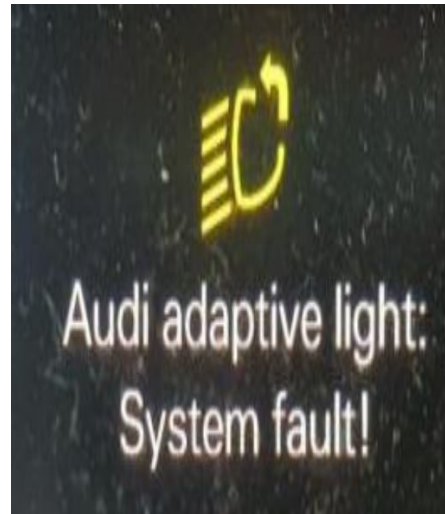
- Audi adaptive light: system fault (Figure 1).
- Audi pre sense: system fault
- Adaptive cruise assist: restricted
- Adaptive cruise assist: predictive control currently restricted

*Figure 1. Instrument cluster message.*

- DTC C12B3FA (front camera for driver assist systems - communication fault) with symptom code 221189.

If the software level of the control module for driver assistance is **0295 or below**:

Please follow **TSB 2063497**.

Otherwise, if the software level of the control module for driver assistance is **0364 or below**:

Please follow **TSB 2063502**.

1. Delete the DTC.
2. After deleting the DTC the concern is fixed and is unlikely to reoccur.
