## Y1A Taycan

## On Board Charger (OBC) Fault P31D200 "Charging Socket – Overtemperature"

**Bulletin #: 2104.2**

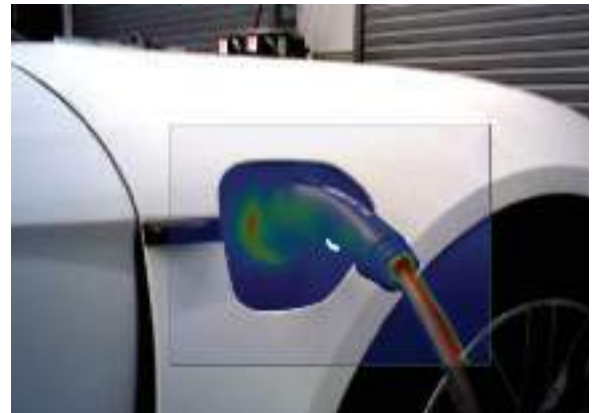
Figure 2

Pins and conductors within the vehicle cable charge handle reach high temperatures while charging for several hours on AC power. The charging socket temperature sensor in the vehicle charge port detects a high temperature and charging is stopped. This topic remains under investigation. This document will be updated with additional information when available.

Measure temperatures around the vehicle cable after at least 1 hour of full-power AC charging (208-240V, 40A setting). Check the temperature of the cable sheath below the vehicle connector, at the vehicle cable handle, and at the charge port of the vehicle. Compare the measured temperatures to another known-good charging cable used in similar conditions and with similar settings.

Check if high temperatures at the vehicle cable charge handle follow the vehicle cable by charging another vehicle using the same hardware.
