# Technical product information

| <b>Topic</b> | Bentayga V8 Kovomo - Engine MIL light on - DTC "O2 Sensor Signals Swapped Bank 1 Sensor 2/ Bank 2 Sensor 2 |
| <b>Transaction No.</b> | 2065664/1 |

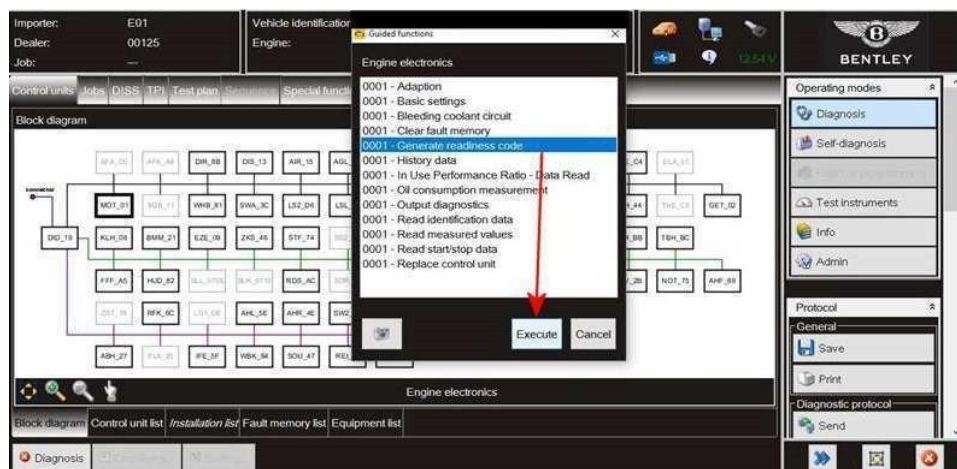
DTC P004100: "O2 Sensor Signals Swapped Bank 1 Sensor 2/ Bank 2 Sensor 2 is evident within address 0001 (Engine control unit) and MIL light active after attempting to conduct a readiness test

- Referring to Figure 1 - Select Guided functions from 01 - Engine Control Module 1
- Select Generate readiness code
- Select Execute and follow the readiness code procedure to completion as per all on screen prompts
