GLOBAL SAFETY FIELD INVESTIGATIONS  
DCS4918  
URGENT - DISTRIBUTE IMMEDIATELY

Subject: N182193520 - Service Update  
Valve Body Solenoid Connection Not Seated

Models: 2019 Cadillac CTS  
2018-2019 Chevrolet Camaro  
2018-2019 Chevrolet Colorado  
2019 Chevrolet Corvette  
2018-2019 Chevrolet Express  
2019 Chevrolet Silverado 1500 (New Model)  
2019 GMC Canyon  
2019 GMC Sierra 1500 (New Model)  
Equipped w/8L45 or 8L90 (M5N/M5T/M5U/MQE) Auto Transmissions

## N182193520 Valve Body Solenoid Connection Not Seated

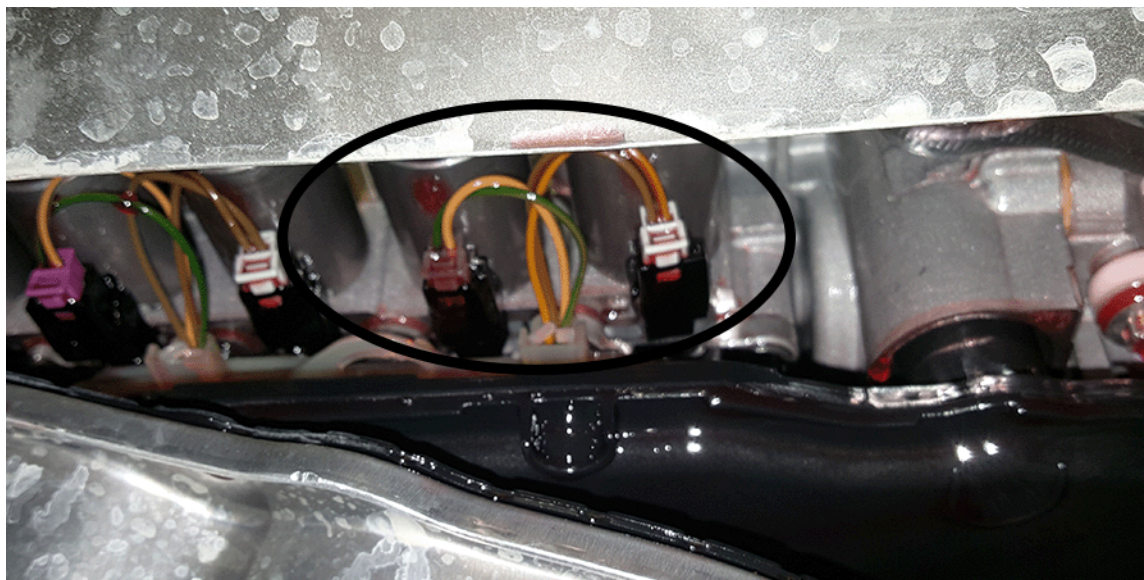
5180796

| <b>Condition</b> | On a small number of the vehicles identified above, the electrical connector to the transmission valve body solenoids may not be fully seated. DTC P2718 or P2720 may set resulting in the Check Engine indicator illuminating, and the transmission reverting to a "limp home" mode providing limited forward gear selection. |

2. Locate the two valve body solenoid connectors towards the front of the vehicle as shown above. Press firmly on each connector to ensure it is fully seated in the valve body solenoid.
3. Reinstall the Automatic Transmission Fluid Pan. Refer to *Automatic Transmission Fluid, Fluid Pan and/or Filter Replacement*.
4. Fill the transmission with fluid. Refer to *Transmission Fluid Level and Condition Check* in SI.
