# Special Coverage Adjustment

## N182188250 Loss of Continuity within Accelerator Pedal Position Sensor Circuit

**Release Date:** August 2019

**Revision:** 01

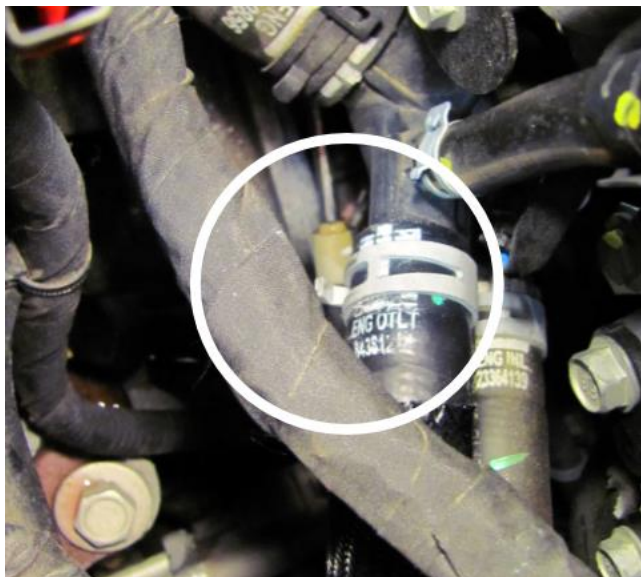
5309871

2. On Malibu (LFV engine) applications **only**, inspect the engine wire harness adjacent to the heater inlet hose for contact with the heater inlet hose clamp on the engine outlet portion of the hose as shown.

**Caution:** The heater hose clamp may be glued to the heater hose. If the clamp is glued to the heater hose, **do not** attempt to rotate the heater hose clamp, as heater hose damage may occur and clamp may have residual rubber material on it. Instead, replace the heater hose and both clamps.

3. If contact is observed between the heater hose clamp and the engine wire harness, attempt to rotate the heater hose clamp tabs away from the engine harness, ensuring the clamp stays within the alignment guide markings.

- If the heater inlet hose clamp is **not** glued to the heater inlet hose, rotate the heater inlet hose clamp so the tabs are facing away from the engine wire harness. Ensure the clamp stays within the alignment guide markings. There should be at least  $\frac{3}{4}$  inch (19mm) of clearance between the heater hose clamp tabs and the engine wire harness.

- If the heater hose clamp **is** glued to the heater hose, replace the heater inlet hose and both heater hose clamps, being sure to clock the heater inlet hose clamps so the tabs are facing away from any adjacent engine wire harnesses. Ensure the clamp stays within the alignment guide markings. Refer to *Heater Inlet Hose Replacement (LFV)* in SI.

- If any damage is observed to the engine harness, repair the harness and the affected circuits. Refer to *Wire to Wire Repair* in SI. Rewrap the harness in the affected area with PET tape in addition to clocking the hose clamp away from the harness to ensure another rub-through event is no longer possible.
