# SERVICE BULLETIN

EC21-023

NTB22-001

## DTC P0300 AND/OR P0301(2/3/4/5/6) IS STORED DURING A COLD START

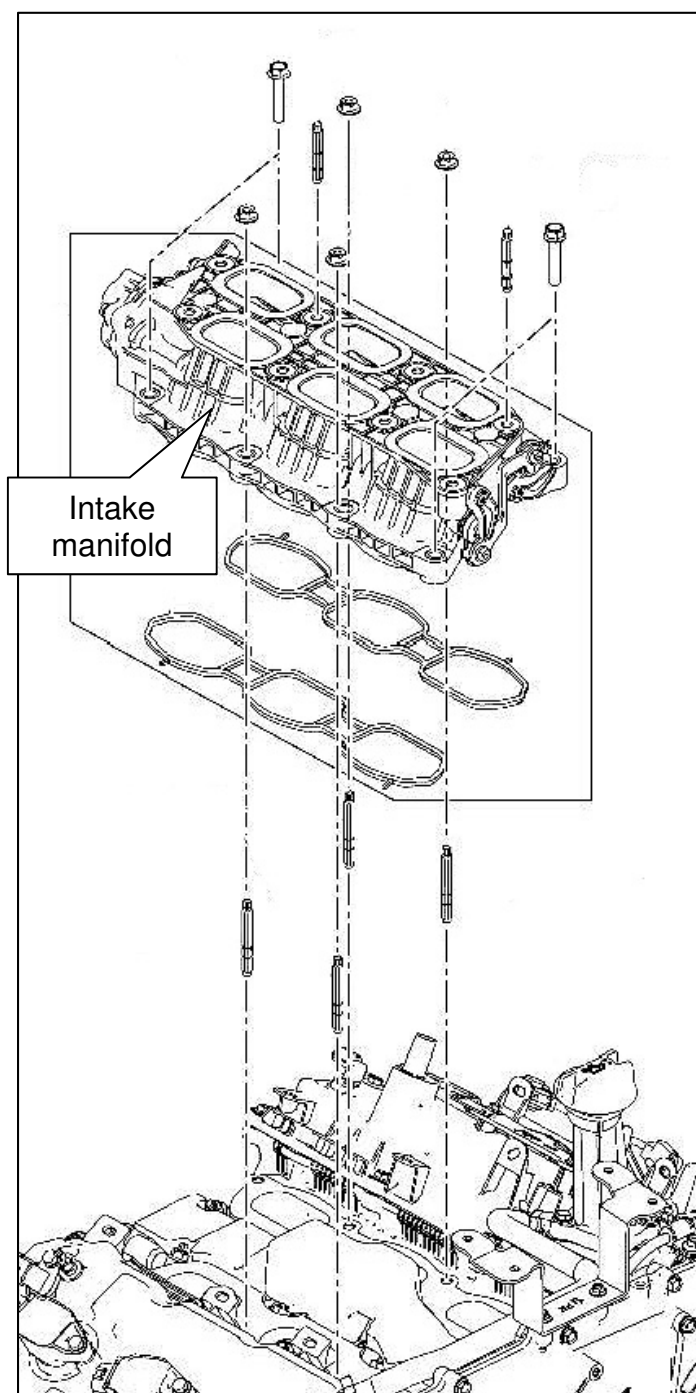
Figure 1

The DTC only stores during a cold start.

4. Replace the intake manifold (Figure 1) with one listed in the **PARTS INFORMATION** on page 4.
- Refer to the ESM: **ENGINE > ENGINE MECHANICAL > VQ38DD > REMOVAL AND INSTALLATION > INTAKE MANIFOLD**
