# Service Bulletin

Bulletin No.: 21-NA-218

**Subject:** Diagnostic Tip on Reduced Propulsion (EREV), Malfunction Indicator Lamp (MIL) Illuminated - DTC P0C17, P1B03 and/or P0C01 Set (Drive Motor 1 Only)

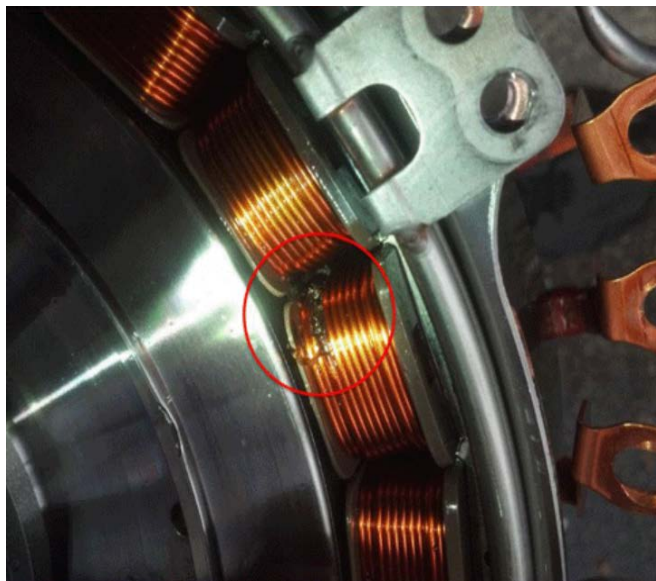
4040531

Some SI diagnostic procedures may not comprehend the possibility of the Motor 1 Stator as the cause of these DTCs. If one or more of these diagnostics are set, especially on a vehicle with a lifetime fuel economy less than 50 mpg (greater than 4.7 L/100 KM) and above average annual mileage, inspect the Motor 1 Stator for damage as shown in the pictures below.

If no damage is found, replace all of the following parts: Motor 1 Position Sensor, Transmission Internal Harness, and Motor 1 Stator (damage may be on windings below the top layer). Replacing the Drive Motor Generator Control Module should only be ordered if the condition persists after replacing these parts.
