Preliminary Information

PIP5791A DTC P2B60 Engine Coolant Flow Control Valve Position Sensor Circuit Performance

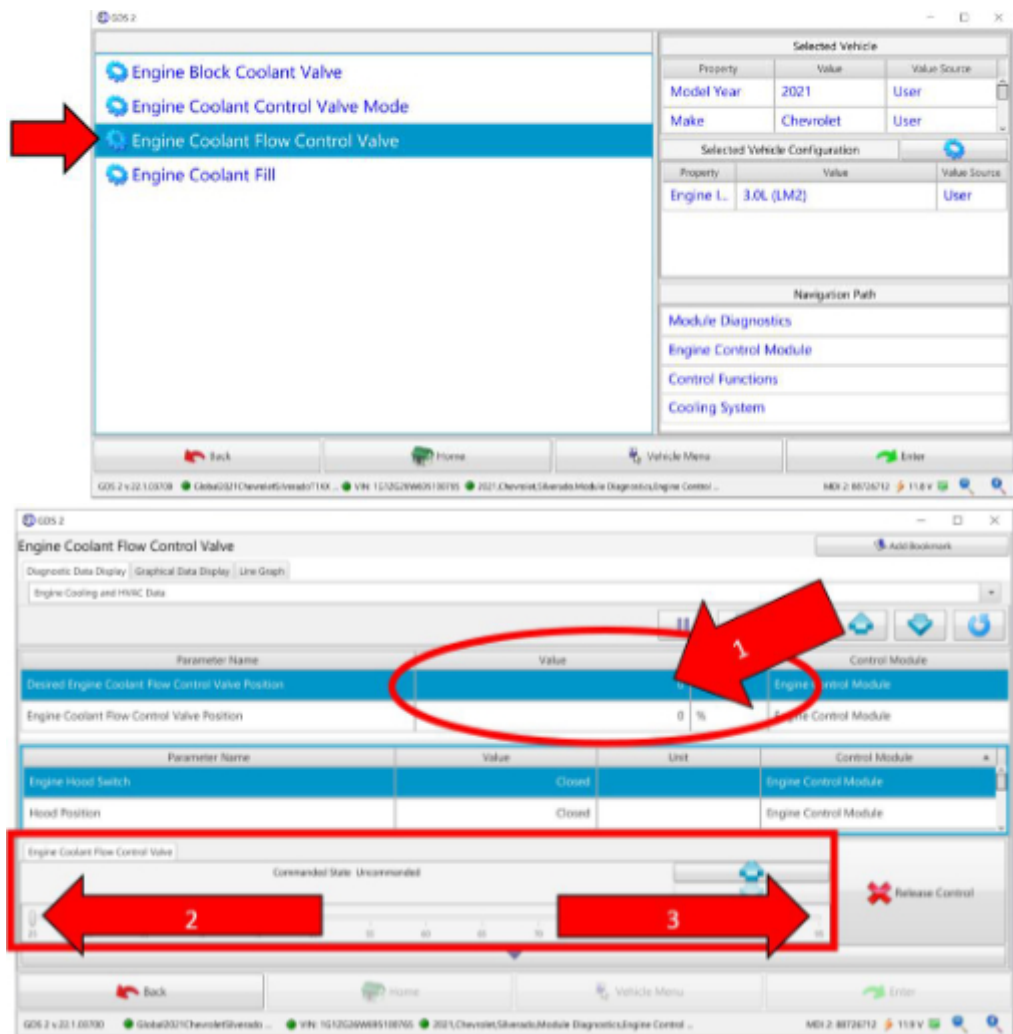
Slide the command from 25% (2) to 95% (3) (for Pickups), making sure to wait until the Engine Coolant Flow Control Position (1) indicates 95% and slide it back to 25% (2). Exercise the valve 3 times to verify it is functional. The “Engine Coolant Flow Control Valve Position” value should move to the desired value just commanded.

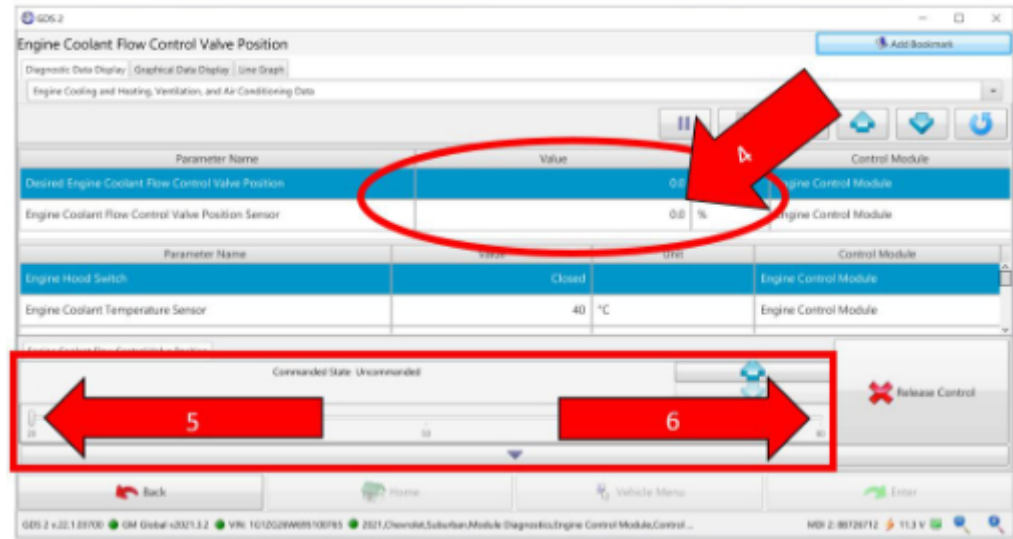
The GDS tool will have a slide range of only 20% - 80% (5 and 6) for an SUV. Please perform the same 3-time-slide action for SUV and verify the Coolant Flow Control Valve position parameter (4) matches the desired position you commanded.

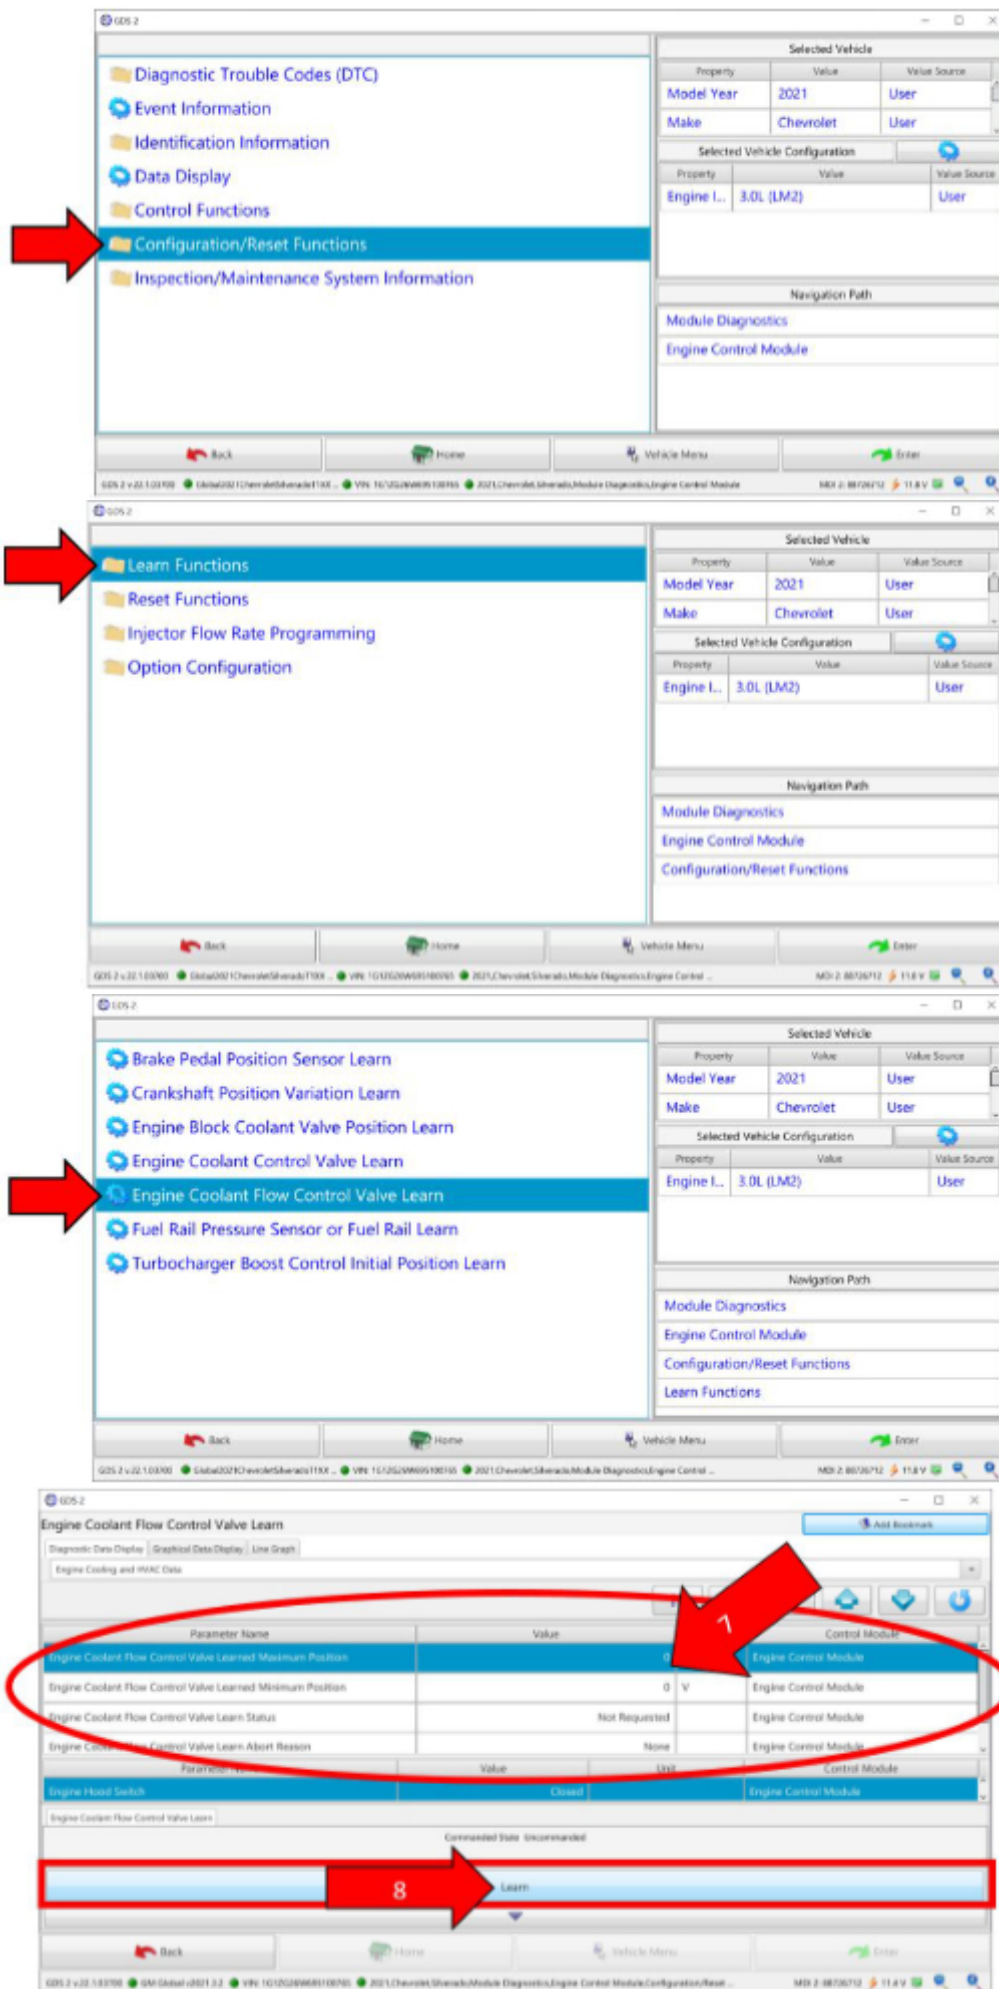
If the valve is responding properly to the command, clear the P2B60 code and perform the Engine Coolant Flow Control Valve learn function as illustrated below:

To perform the learn function: Press the “Learn” button and wait until the progress completes.

After the learn is completed, clear the codes and return the vehicle to the customer.
