## TECHNICAL SERVICE BULLETIN

### Illuminated ABS Indicator, Engine Will Not Turn Off, Will Not Shift Out Of Park And/Or Various Electrical Symptoms

**22-2044**

**Ford**  
2020-2022 Super Duty

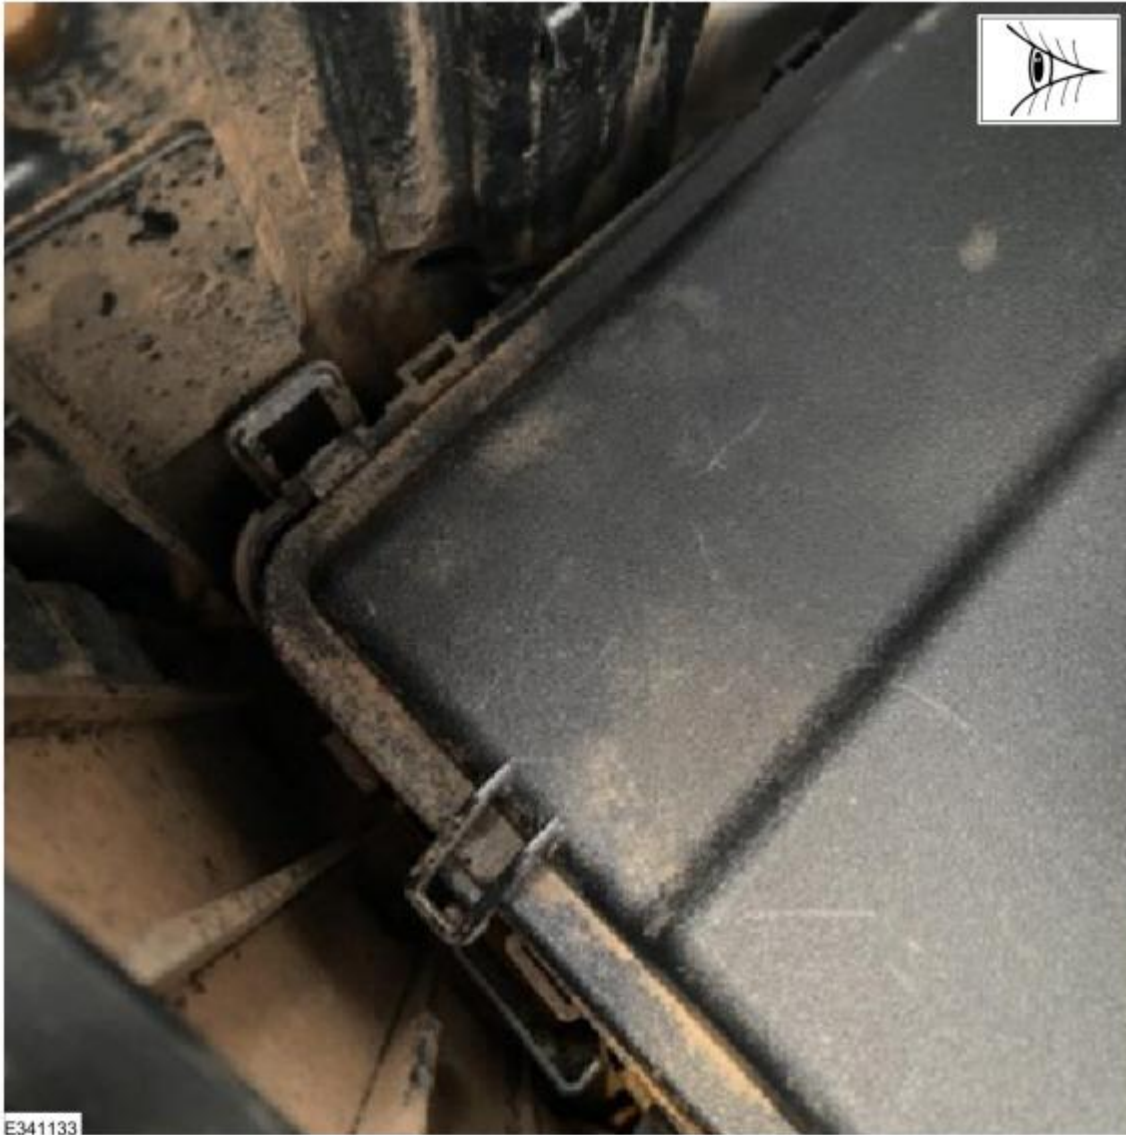
1. Visually inspect the BJB for signs of water/moisture intrusion. Are there signs of water/moisture intrusion into the BJB and/or broken cover tabs/locking fingers?
  - (1). Yes - proceed to Step 2.
  - (2). No - this article does not apply. Refer to Workshop Manual (WSM) for symptom based diagnostics.

Figure 1 - Example of moisture intrusion with BJB cover on

## 2. Replace the BJB assembly.
