# Technical Service Bulletin

**20 MIL on or difficulty refueling, DTC P045100, P044100, P202500, and/or P045300 are stored in the ECM 20 22 41 2050276/7 February 8, 2022. Supersedes Technical Service Bulletin Group 20 number 20-26 dated April 23, 2020 for reasons listed below.**

| Model(s) | Year | VIN Range | Vehicle-Specific Equipment |
|---|---|---|---|
| A6, and A7 | 2016 – 2018 | All | 3.0 liter engine |

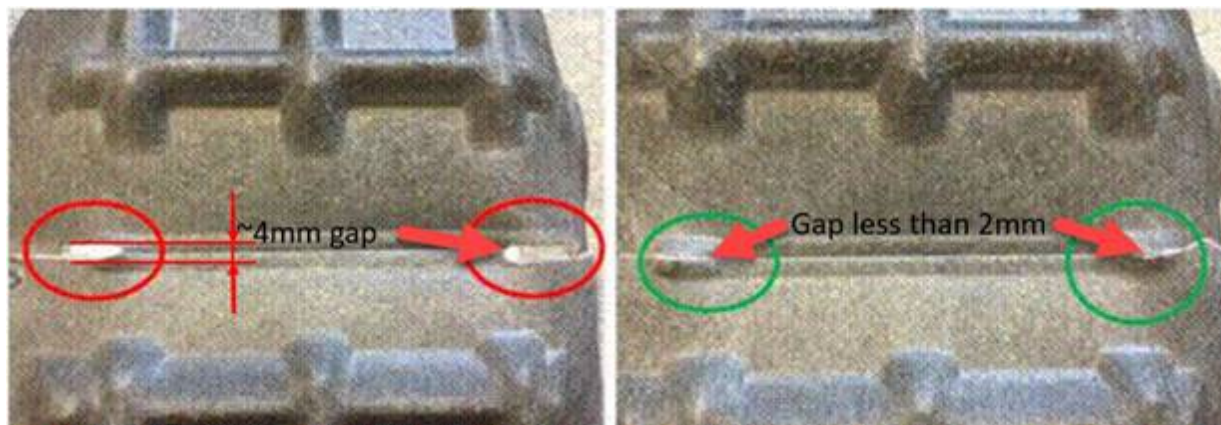
*Figure 1. How to determine which steps to take Version 1 (~4mm gap) or Version 2 (gap less than 2mm).*

1. If the updated wheel liner has not yet been installed. Then install the updated wheel liner, which has closed slots around the NVLD filter.
  - Remove the EVAP canister, ventilation tube, and NVLD pressure switch.
  - Remove all components mounted on the EVAP canister.

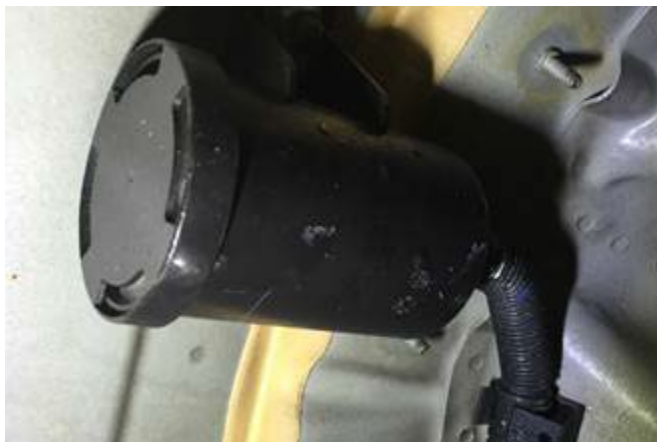
*Figure 2. Ventilation tube of the EVAP canister.*

- If it weighs more than 2650 grams, replace the EVAP canister + attached filter, ventilation tube (Figure 2), and NVLD pressure switch (J909).
- If it weighs less than 2650 grams, then replace the ventilation tube and the J909.

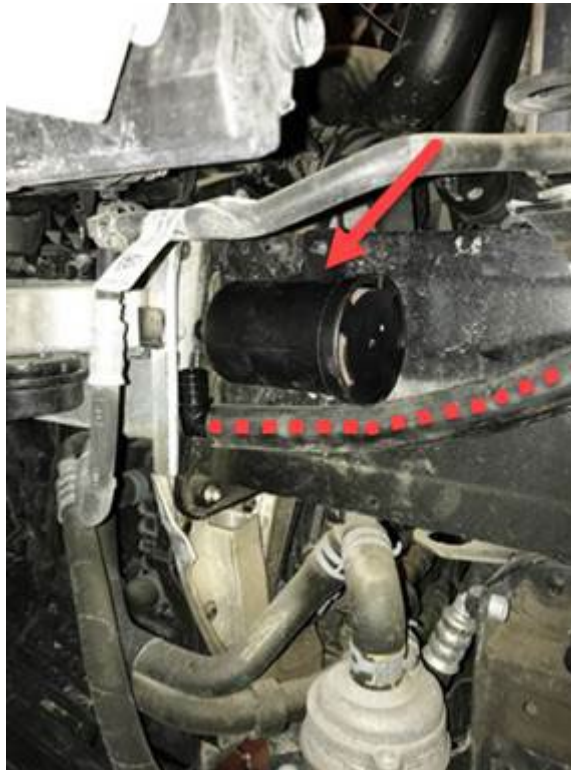
*Figure 3. Installing the new NVLD filter.*

1. Replace the EVAP canister only if the weight is greater than 2650 grams.
  - Install a new J909.
  - Install the NVLD filter (new part number, Version 2) in the engine compartment on the left frame rail just in front of the ABS module, secure with M6 nut. (Figure 3).

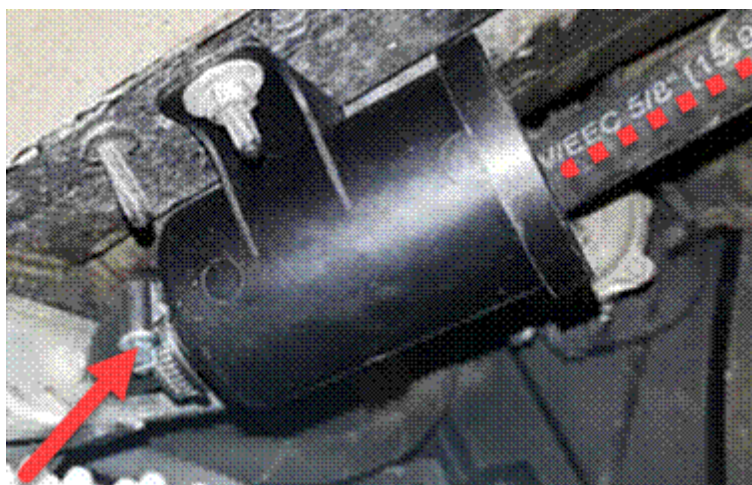
*Figure 4. Connecting the NVLD filter.*

2. Connect the filter to the 5/8" ID rubber hose via 1x plastic elbow and 1x rubber elbow (Figure 4).

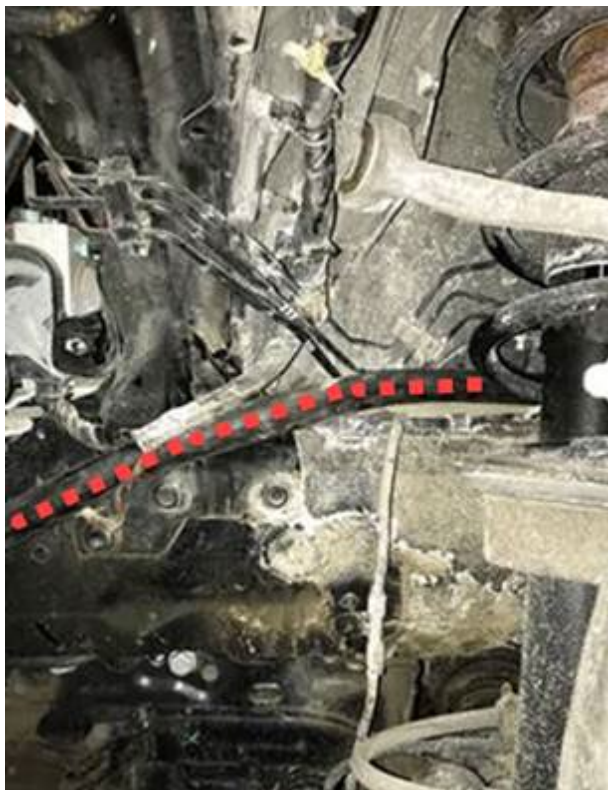
*Figure 5. Route the 5/8" ID rubber hose from the new filter position to the J909.*

3. Route the 5/8" ID rubber hose behind the strut and brake lines from the new filter position to the J909, along the orange battery cable (Figures 5 and 6). Then secure with zip ties.

5/8" ID rubber hose needs to be routed in a way that there are no sharp bends to prevent kinking.

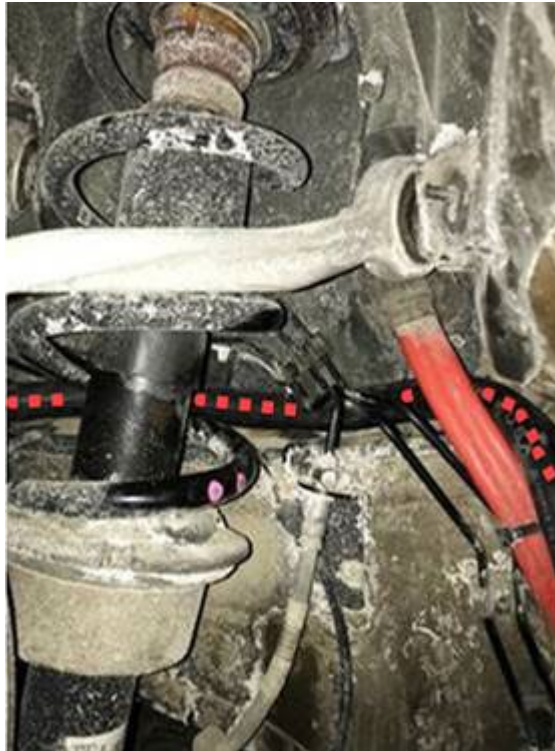
*Figure 6. Routing the rubber hose.*

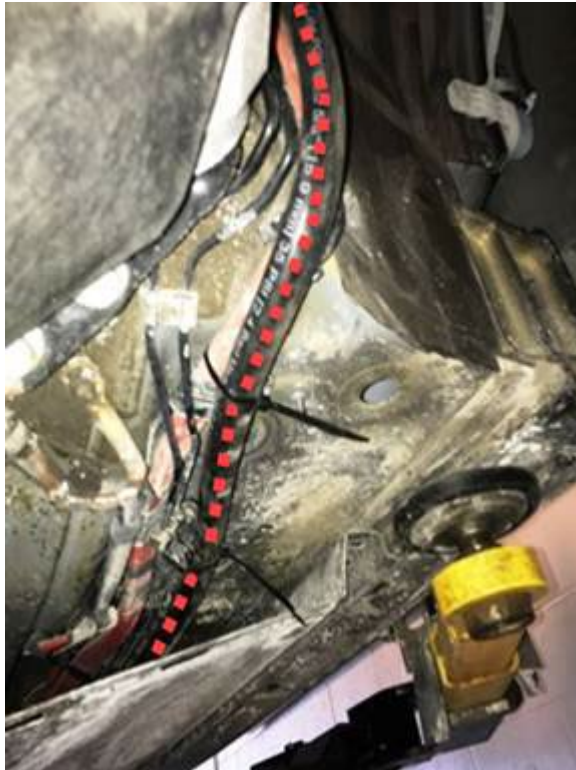
*Figure 7. Where to zip tie the rubber hose to the battery cable.*

4. Routing details to the J909, along the orange battery cable. Add zip-ties every 12 inches (Figure 7).

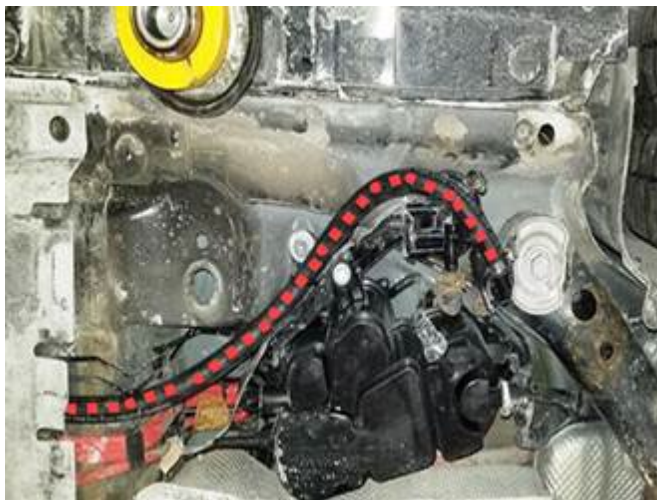
*Figure 8. Connecting to the J909.*

5. Before connecting 5/8" ID rubber hose to 90 degree connector, cut to length, as needed. Connection details to the J909 are shown in (Figures 8 and 9).

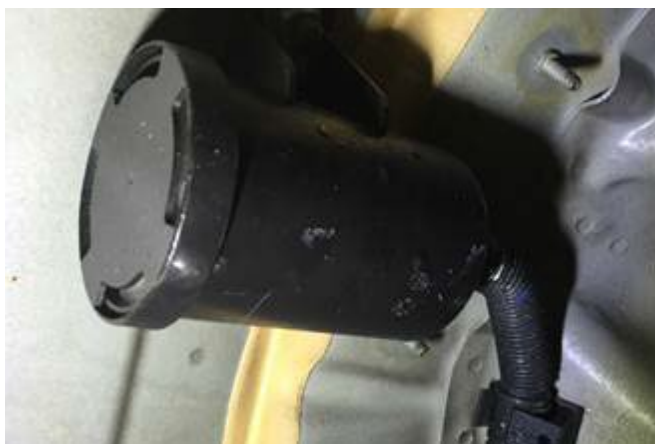
*Figure 10. Remove original NVLD filter.*

6. Remove original NVLD filter assembly.  
(Figure 10).
