## Technical product information

| <b>Topic</b> | Fuel pressure regulator - DTC P242200 with symptom code 14536 evident within address 0001 |
| <b>Brand</b> | Bentley |
| <b>Transaction No.</b> | 2065926/1 |

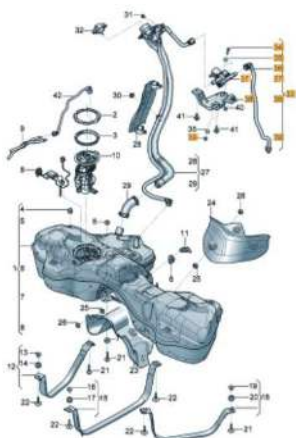
4M0 201 549A - Pressure regulator assembly and associated parts as shown below

- 1) Referring to Rep.Gr 20 - Replace the Pressure regulator assembly and associated components
- 2) Conduct a road test in EV Mode and/or Hybrid drive mode where possible
- 3) On return from road test - Check to confirm the issue is resolved and DTC P242200 is not evident within address 0001
