## Technical product information

| <b>Topic</b> | Bentayga V8 Kovomo - DTC P310B00 with Symptom Code 2638 - Check Engine Lamp - Fuel Pressure Regulation |
| <b>Transaction No.</b> | 2058484/6 |

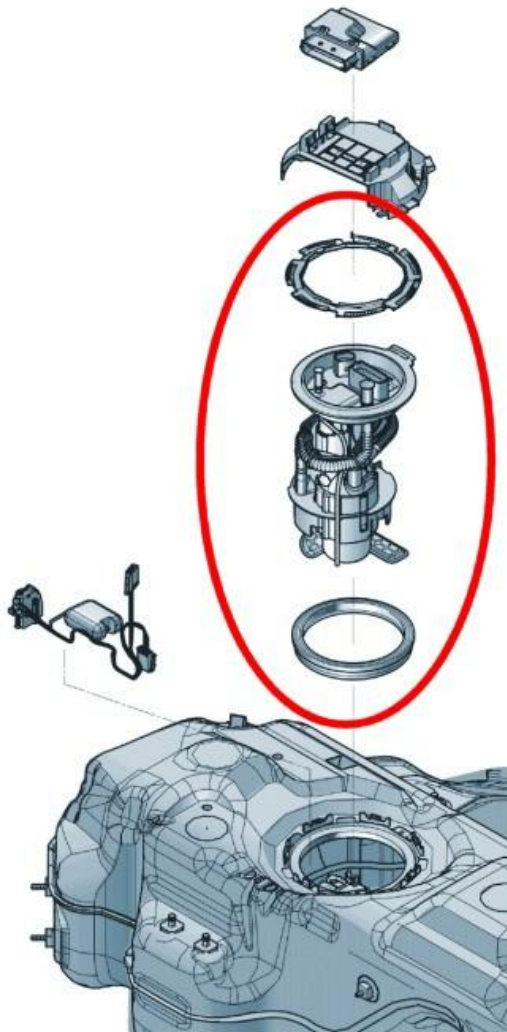
Figure 2

- Check Engine Lamp Illumination with DTC "P310B00 and symptom code 2638 with an "Adaption of Fuel Pump (FP)" figure of minus 100 to minus 200 kPa – *Figure 1* - the Fuel Delivery Module within the fuel tank should be replaced – *Figure 2*

- Refer to Repair Group 20 Fuel supply, gas operation / 4.0L V8 TSI / Fuel pump, fuel level sensors, and jet pump (RH) – To remove and fit.
