# Technical Service Bulletin

## 90 Audi connect user management option greyed out or SOS and Roadside with no function

90 22 46 2052299/4 February 22, 2022. Supersedes Technical Service Bulletin Group 90 number 18-05 dated October 23, 2018 for reasons listed below.

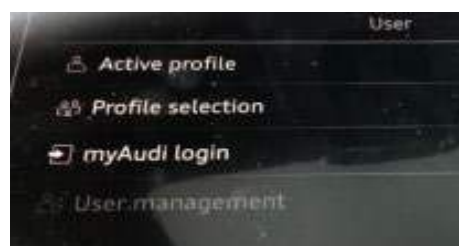
- The Audi connect “User management” screen is greyed out and the customer cannot complete the key user pairing (Figure 1).

Figure 1. User management.

- **DTC P169A00** (Transport mode active) is stored in the engine control module (ECM), J623 (address word 0001).
- **DTC U13EB00** (Emergency call module and communication unit Flight mode activated) is stored in the emergency call module and communication unit, J949 (address word 0075).

In order to activate the ConBox LTE data connection, the vehicle must be taken out of transport mode using the VAS 6154. The older diagnostic heads (e.g. VAS 5054 or previous) cannot properly address this control unit over diagnostics due to the new diagnostic protocol. If the VAS 6154 is not used, then the ConBox will remain in transport mode (Flight mode) and will set a DTC of P169A00 (Transport mode active). Additionally, the gateway module will set a DTC of U142100 (Control module for emergency call module and communication unit no communication).

Change the adaptation for flight mode in diagnostic address 0075 at, *Self-diagnosis >> Go to address 0075 >> Adaption values "Basis connect function" >> Flight mode >> Deactivate.*

Hit "Apply".

Cycle the ignition off and then back on.

Within Self-diagnosis go to DTC readout for diagnostic address 0075 and clear the DTC.

Verify the SOS light is green and/or the Audi connect User management option is now selectable.

If the issue persists then disconnect the tester, roll the windows up, close all doors, and lock the vehicle for 2-3 minutes to allow the car to go through a sleep cycle, then retry steps 4-6 if necessary.

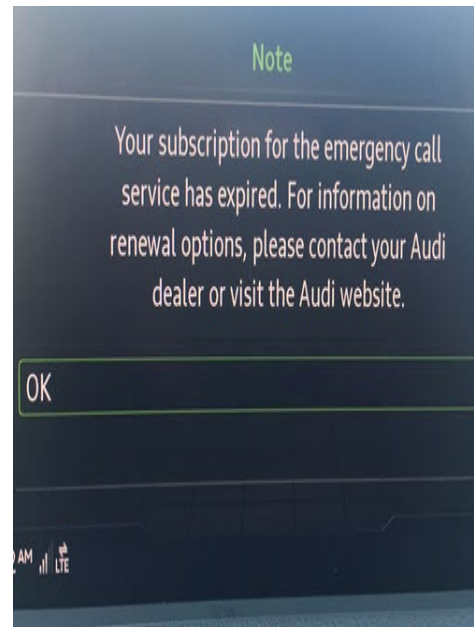
- The SOS emergency button is red or flashing red. When the customer presses the button an error message of “Your subscription for the emergency call service has expired” (Figure 2) is seen.

*Figure 2. Error message in MMI.*
