# Preliminary Information

## PIP5834A Service 4wd message with DTC C119E

| Condition | Service 4wd message with DTC C119E symptom 5A Stored in the TCCM |
| Cause | Transfer case clutch set up |

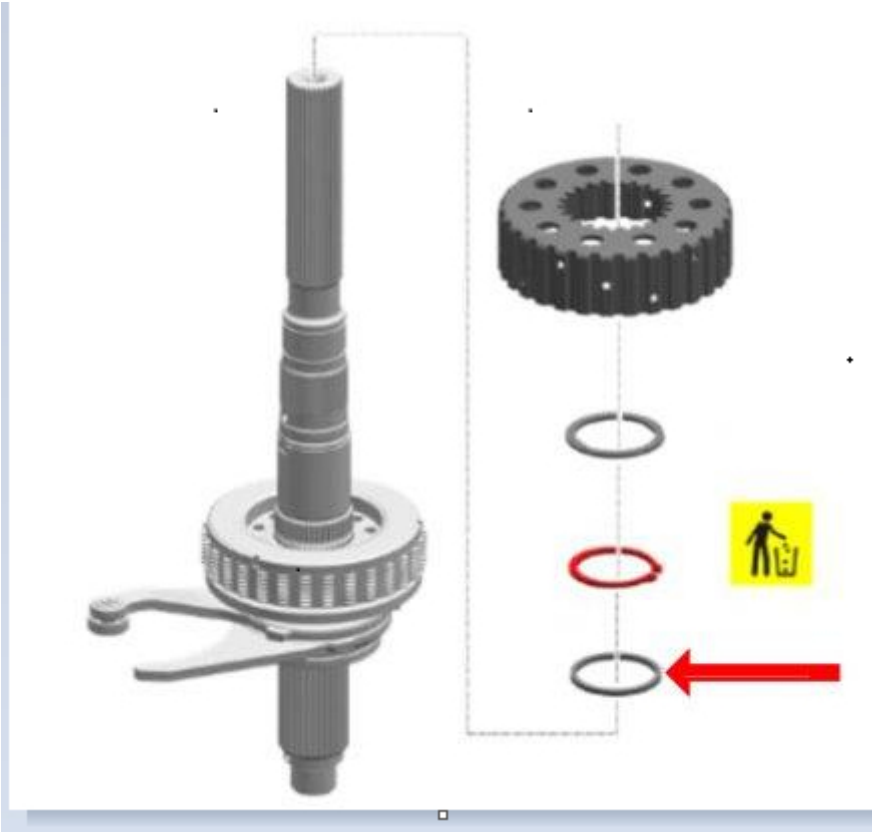
If the Transfer Clutch High Value is below 5 degrees:

2: Disassemble transfer case using appropriate procedure to gain access to the clutch pack assembly. Do not take the clutch pack any farther apart that what is needed to get to the shim pointed at below.

Remove the existing shim, measure it and then replace it with the next smaller shim available. Example shim removed is 4.8 mm then a 4.6 mm should be reinstalled.

Do not attempt to use the tools listed in the document to measure clutch pack shim for this repair.
