# Technical Service Bulletin

**26 Noises are heard from the exhaust at idle, DTCs P047600, P048C00, P04A000, or P301B00 are stored in the ECM**

26 22 48 2058998/4 March 10, 2022. Supersedes Technical Service Bulletin Group 26 number 21-45 dated May 18, 2021, for reasons listed below.

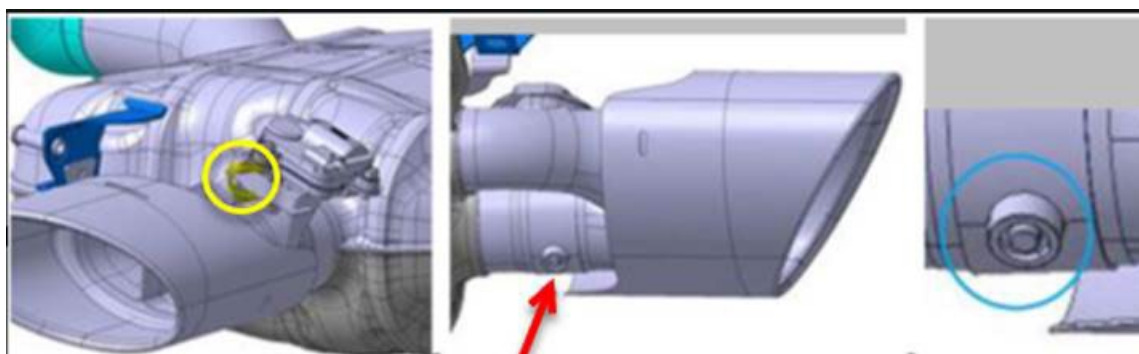
**Figure 2.** Old rear silencer.

- A. Old version (Figure 2): C-bracket (marked yellow) and moveable bearing (blue). **It is not compatible with an optimized control motor.** The complete rear silencer has to be replaced.

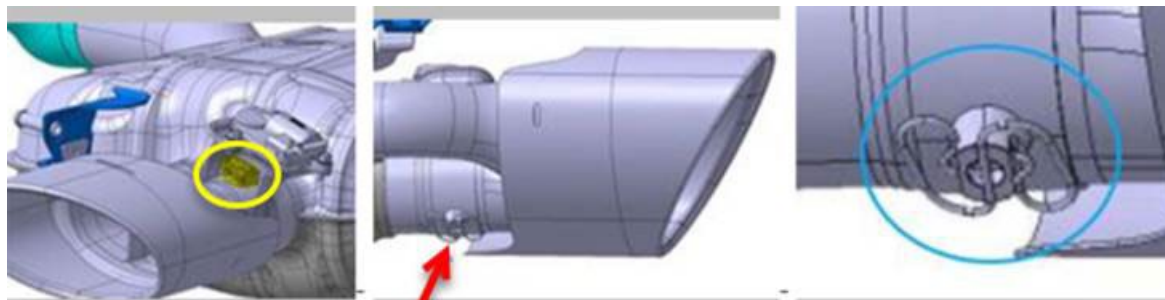
**Figure 3.** The optimized version of the rear silencer.

- B. Optimized version (Figure 3): claw coupling (marked yellow) with spring lock (blue). Check which version of the control motor is fitted: If the control motor fitted is not the new version (part number 8S0 133 246 D), replace it individually on the exhaust flap with the concern.
