# Service Bulletin

Bulletin No.: 18-NA-246

**Subject:** Malfunction Indicator Lamp (MIL) Illuminated - DTC P0172, P06DE and/or P0521 Set (North America Vehicles Only)

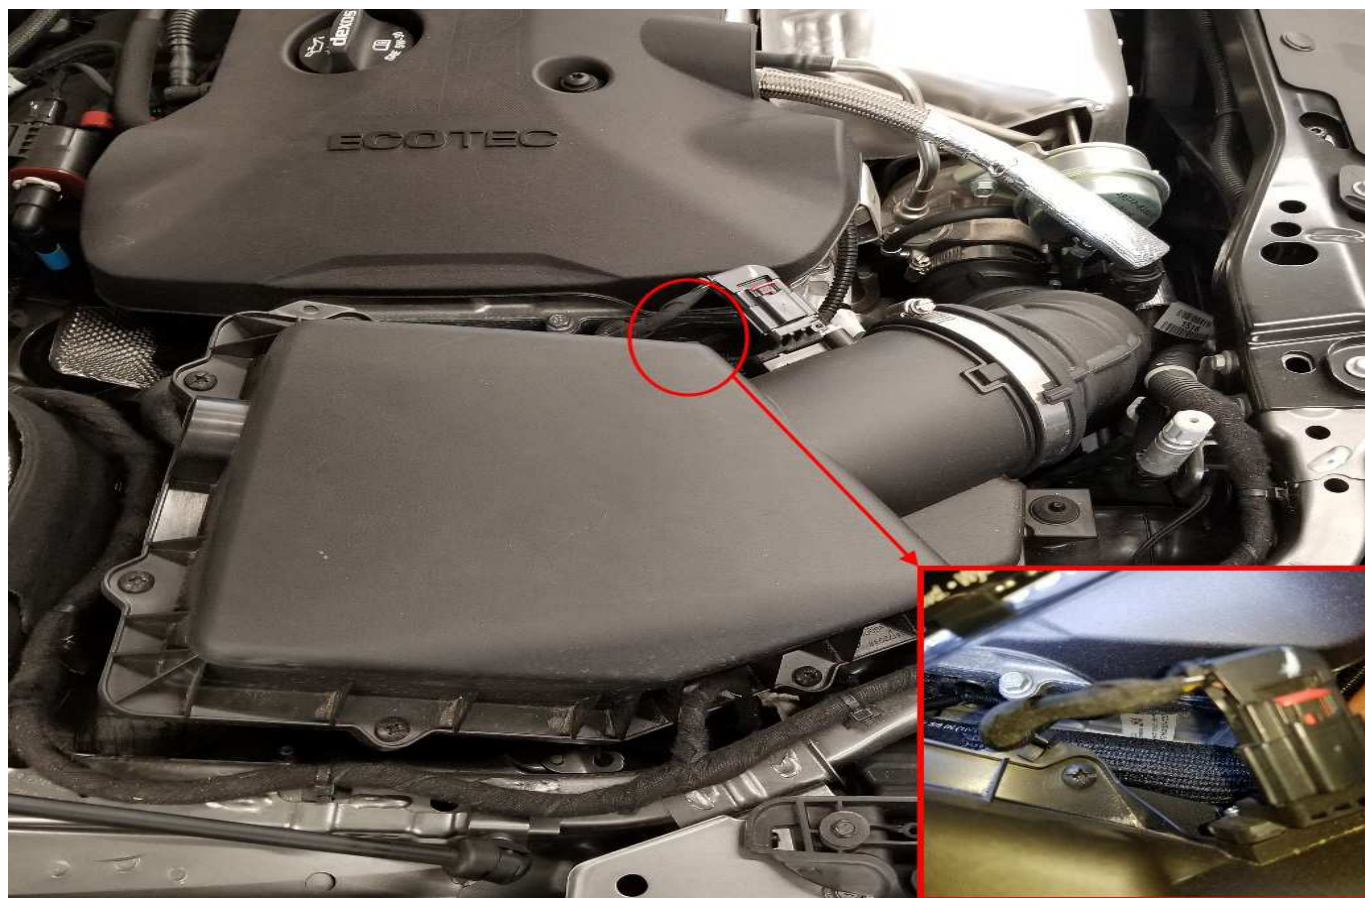
5336568

Vehicles built after May 7, 2019 may already have the updated PCV installed. Inspect the Engine Julian Date by reviewing the EUN on the front engine cover.

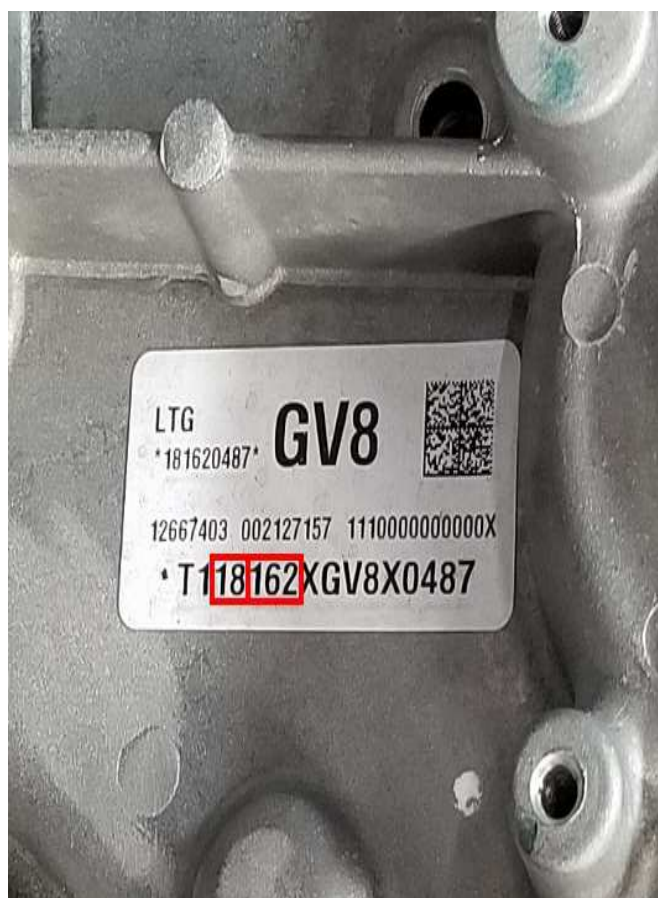
5336723

- The first digit reflects the engine plant (in this case T = Tonawanda).
- The second digit reflects the shift (in this case 1 = First Shift).
- The third and fourth digits reflect the calendar year (in this case 18 = 2018).
- The fifth, sixth and seventh digits reflect the day of that calendar year (in this case 162 = 162nd day of 2018 calendar year (build date)).

If the engine you are working on was built on or after Julian Date 19127 (May 7, 2019), EUN# T119127 XHXTX0251, the PCV does not need to be replaced. The new revised PCV is already installed in the camshaft cover. Refer to SI for further diagnostics.

Engines built prior to Julian Date 19127 (May 7, 2019), EUN# T119127 XHXTX0251, have the old style primary PCV valve installed and will need to be replaced. Continue with service procedure below.

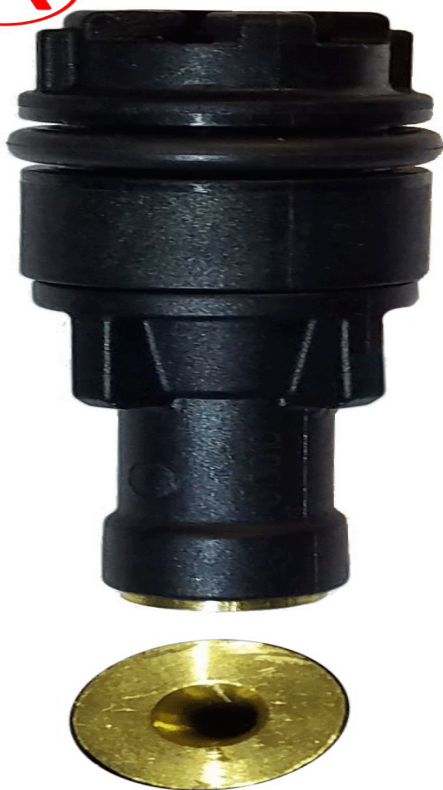
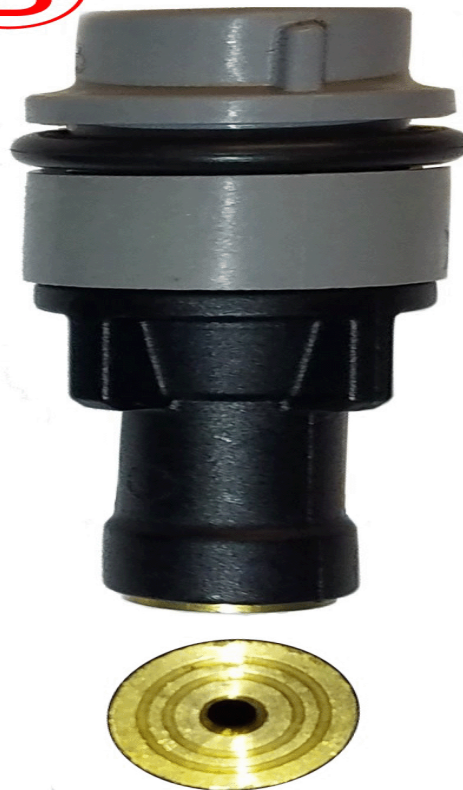
5207126

Note: The graphic above compares the old style primary PCV valve (A) to the new revised PCV valve (B).
