# Service Bulletin

Bulletin No.: 21-NA-036

**Subject:** Information on Malfunction Indicator Lamp (MIL) Illuminated – DTC P0300, P0302 and/or P0305 Set

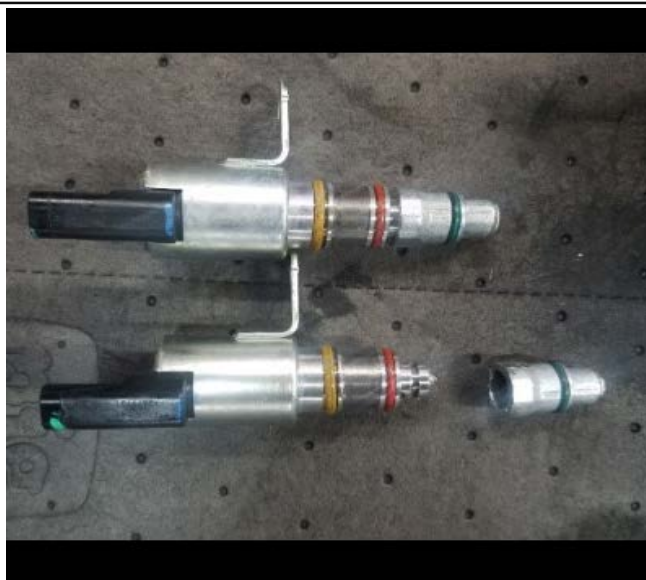
5732351

Refer to graphic above for a good solenoid end that came apart. This picture shows the solenoid both the way it should look on top and the way it looks pulled apart on the bottom.

⇒ If the solenoid is damaged, replace the solenoid.

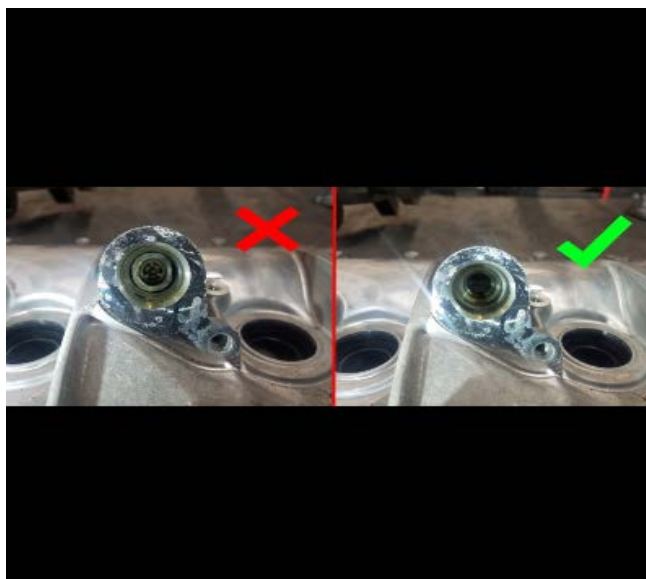
5732350

The graphic on the left shows the inside of the bore with the solenoid out, but with the end of the solenoid stuck in it. The graphic on the right shows how it should look.

" If you find a vehicle with the end of the solenoid stuck in the bore, it can usually be easily removed utilizing a pick tool or a pair of transmission snap ring pliers as it is only held in with the O-ring that came off with it.
