# Service Bulletin

Bulletin No.: 20-NA-209

**Subject:** Service 4WD Message Illuminated on Driver Information Center (DIC), DTCs C118D, C119B and/or C119C Set

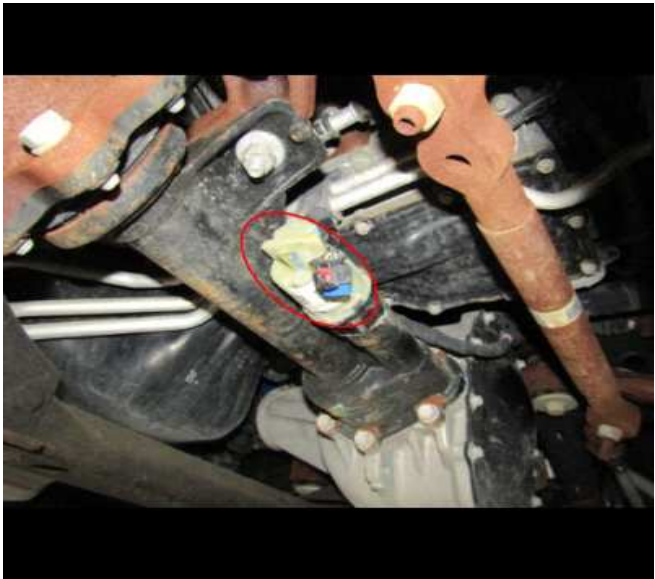
| Correction | <p>5660054</p> <p>Scan for DTCs and verify if C118D, C119B, and / or C119C are present. If any of the listed DTCs are present, inspect the front drive axle actuator electrical connector for signs of moisture, corrosion at the pins, or damage to the actuator housing.</p> <p>Note: Examples of damage to the actuator housing and the harness connector seal, are shown at the start of the Service Procedure below.</p> <p>Also inspect the electrical wire harness connector for any damage to the internal seal or signs of moisture and corrosion. If any of the listed conditions such as moisture, corrosion, or damage are present on either component, replace BOTH the front drive axle actuator and the electrical wiring harness that connects to the actuator.</p> |

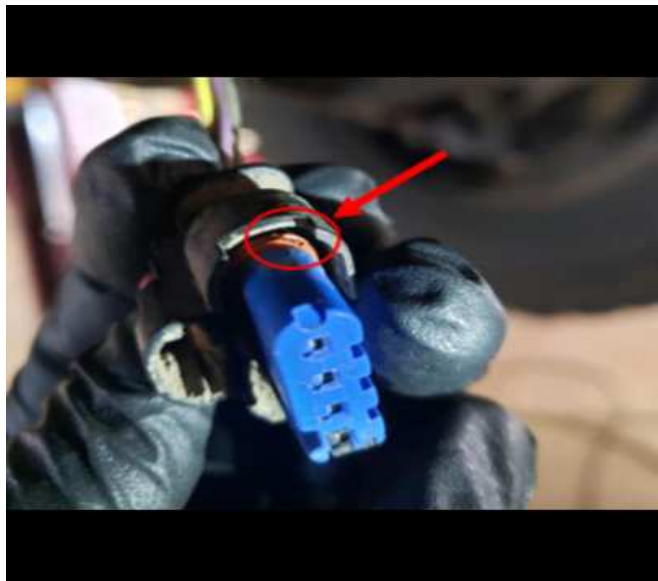
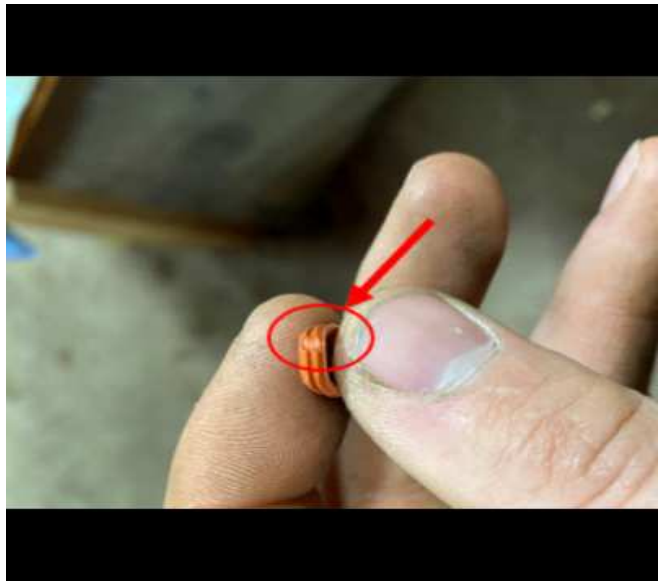
Electrical Harness Connector Seal Damage

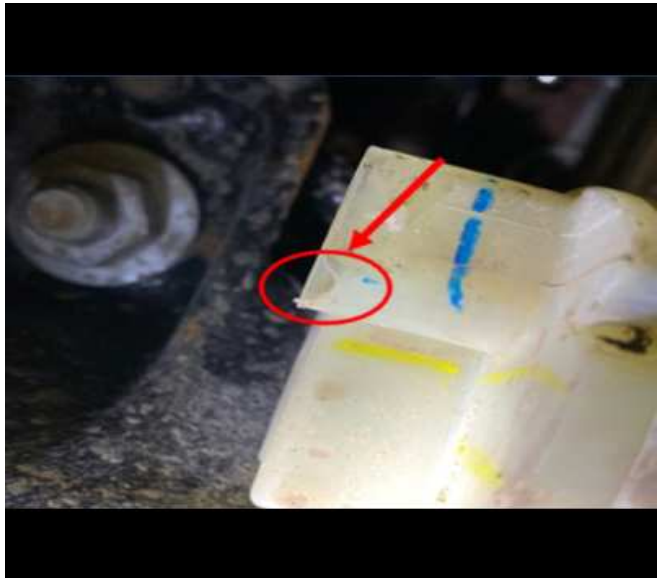
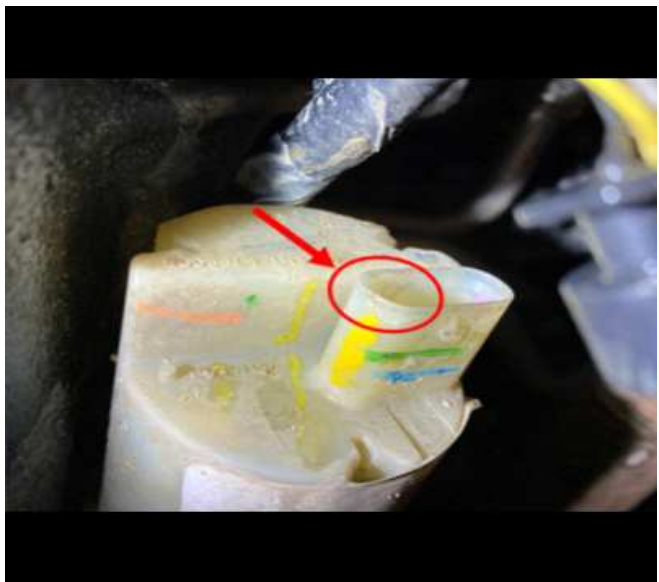
## Front Drive Axle Actuator Housing Damage
