## Technical product information

| <b>Topic</b> | Charging starts and stops when using a public charging unit |
| <b>Brand</b> | Bentley |
| <b>Transaction No.</b> | 2066502/1 |

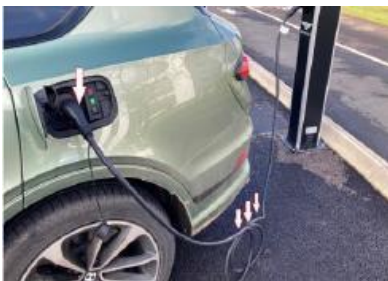
Referring to Figure 1 - Whilst charging the high voltage battery at a public charging unit and the vehicle is unlocked the charge socket locking pin retracts. The unsupported weight of the cable results in the cable relaxing within the charge socket, the charging issue is evident when the vehicle is locked, this is due to the locating pin being unable to lock into place resulting in the charging process being interrupted

If DTC logged is as shown within the Technical background section, the issue is likely to have occurred when the customer has used a public charging unit and cable. The issue can occur after the vehicle is unlocked, the weight of the public charging unit cable being used prevents a pin lock re-activation of the cable if the vehicle is then locked

- 5) Advise the customer that when using Public charging equipment, the charge cable should be supported until pin lock has been activated
