# Technical Service Bulletin

| SUBJECT:<br><br><b>ENGINE CRANK / NO START IN<br/>EXTREME COLD – DTC P062D</b> | | No: | <b>TSB-22-16-002</b> |
| | | MODEL: | <b>2022 Outlander</b> |

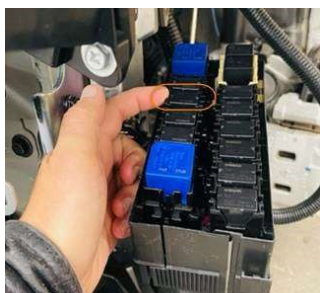
| Photo of front relay box behind front bumper | relay identification |

| Photo of front relay box behind front bumper | relay identification |
|---|---|
| | 2 ST cut relay |
| | 3 VINJ (INJ) relay |
| | 9 SR MTR (A/T) |
| | 10 SR MTR (A/T) |

6. Remove the relay box cover.
7. Turn IG-OFF and replace the 4 relays indicated below (INJ, ST CUT, SR MTR x 2).

8. Reinstall all components and tighten the torque of the relay box bracket to:  $5\pm1$  N·m.
