## Technical product information

| <b>Topic</b> | P245000 - EVAP System Switching Valve "A" Performance/Stuck Open DTC logged - V8 Kovomo |
| <b>Brand</b> | Bentley |

### New Continental GT/GTC and New Flying Spur - V8 Kovomo

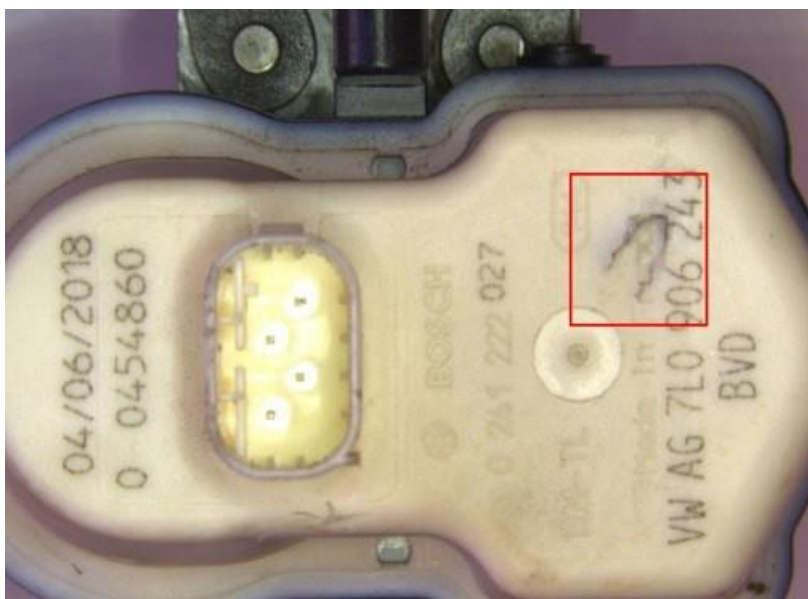
Figure 2

Additional request has been included within the Measure section (step 4) to inspect the leak detection pump (LDP) for impact damage when removed

- 1) Referring to the applicable wiring diagram conduct a wiring integrity check of the Leak Detection Pump wiring circuit and connectors
- 2) Perform a smoke test of the leak detection system - Monitor for any leaks
- 3) If no faults were found - Refer to Rep.Gr 20 - Replace the leak detection pump (V144)
- 4) Inspect the LDP for impact damage when extracted, the operative must provide feedback and photographic evidence (see example shown in Figure 2) via a new or existing DISS query
