# MIL ON With DTC P059A71

## Applicability

| YEAR(S) | MODEL(S) | ADDITIONAL INFORMATION |
|---|---|---|
| 2022 | Tundra | |

Some 2022 model year Tundra vehicles may exhibit a MIL ON condition with the Diagnostic Trouble Code (DTC) P059A71 (Active Grille Air Shutter “A” Actuator Stuck) present. The Engine Control Module (ECM) (SAE term: Powertrain Control Module/PCM) logic has been modified to reduce the possibility of this condition. Follow the Repair Procedure in this bulletin to address this condition.

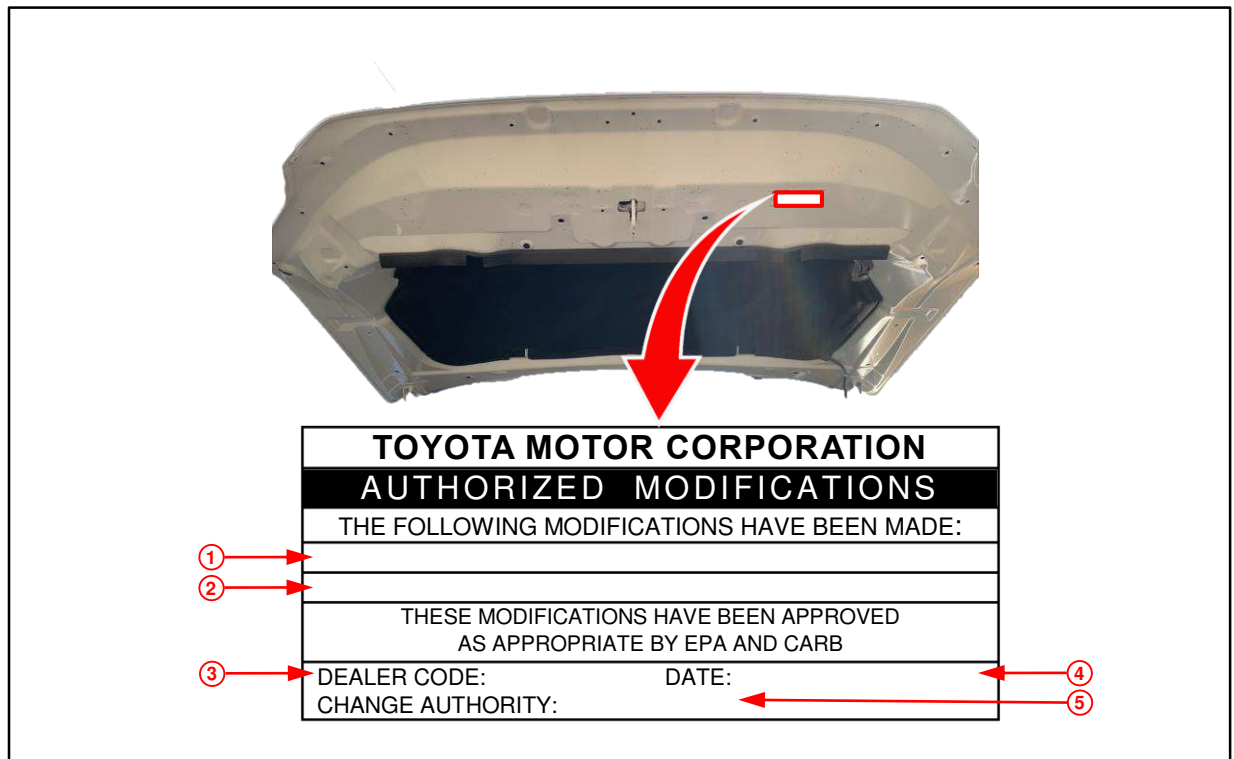
**Figure 1. Location of Authorized Modifications Label on 2022 Tundra**

2. Use Techstream to confirm if the ECM (PCM) calibration has been updated and check for the Authorized Modifications Label affixed to the vehicle in the location shown below.

4. Prepare and install the Authorized Modifications Label.
  - A. Using a permanent marker, enter the following information on the label:
    - ECM (PCM) part number [*Refer to the **Parts Information** section for the **NEW PART NUMBER***]
    - Calibration ID(s) [*Refer to the **Calibration Information** section for the **NEW CALIBRATION ID***]
    - Dealer Code
    - Repair Date
    - Change Authority [***This bulletin number***]
  - B. Install the Authorized Modifications Label onto the vehicle at the location shown in Figure 1. The Authorized Modifications Label is available through the MDC, P/N 00451-00001-LBL.
5. Test-drive the vehicle to confirm proper operation.
