## TECHNICAL SERVICE BULLETIN

### Parking Brake Fault Service Now Message In IPC - DTCs C2008, C2007, C1034, U0293 And/Or U0100 - Built On Or Before 15-Mar-2022

**22-2143**

| <b>Ford</b><br>2021-2022 Mustang Mach-E | Built on or before 15-Mar-2022 |

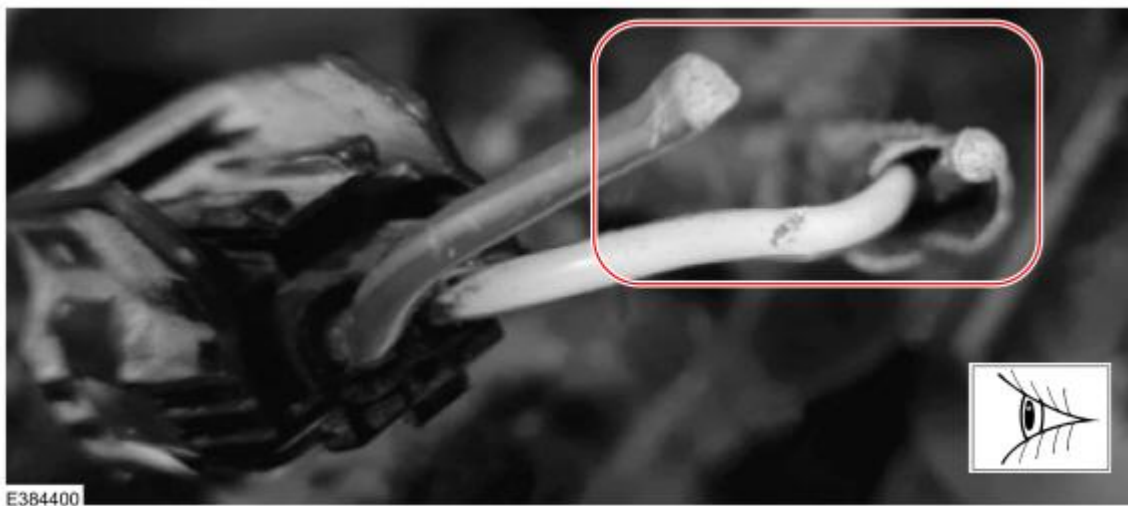
Figure 1

1. Remove both rear tires. Refer to Workshop Manual (WSM), Section 204-04A.
2. Remove the tape and the conduit on the wiring harness to both the left/right rear brake calipers.
3. Inspect the wiring for damage or open circuit. Is there a damaged or open circuit? (Figure 1)
  - (1). Yes - proceed to Step 4.
  - (2). No - proceed to Step 9.
