# Technical Service Bulletin

## 96 High beam assist or traffic sign detection limited, DTC C12B3FD may be stored in the DAS control module

96 22 77 2059201/5 April 14, 2022. Supersedes Technical Service Bulletin Group 96 number 21-63 dated March 12, 2021 for reasons listed below.

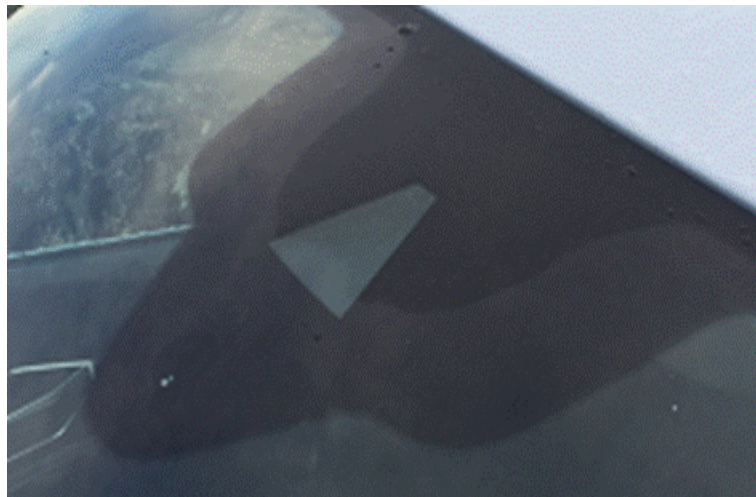
If the front camera recognizes a visibility restriction for more than 77 seconds, the DTC C12B3FD with symptom code 221284 is logged, except for in A3 vehicles, where no DTC is stored, and a message appears in the instrument cluster.

The viewing area of the front camera can be fogged up both on the inside and/or on the outside (Figures 1 - 2).

*Figure 1. Viewing area fogged up from outside.*

3. The customer cannot see this from the interior of the vehicle. Often it is enough to switch on the wiper system to fix the concern.

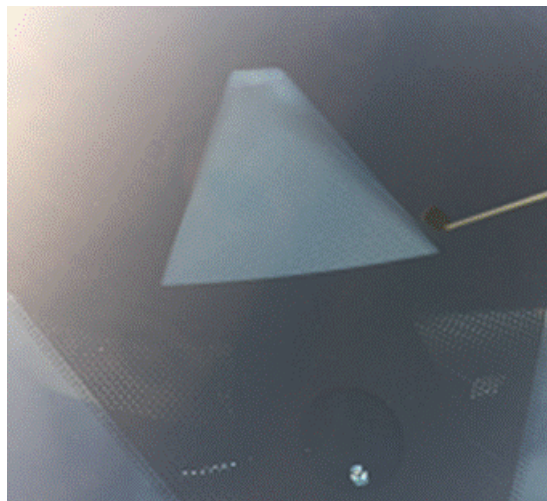
*Figure 2. Viewing area fogged up from inside.*

4. If the front camera is fogged up from the inside fairly often, it can help to remove its lens hood in order to clean and dry the viewing area of the camera.
