# Technical Service Bulletin

## 01 MIL on (DTC P0491 and P0492), stored at the same time

26 12 15 2026528/7 November 5, 2012. Supersedes Technical Service Bulletin Group 26 number 12-10 dated March 30, 2012 for reasons listed below.

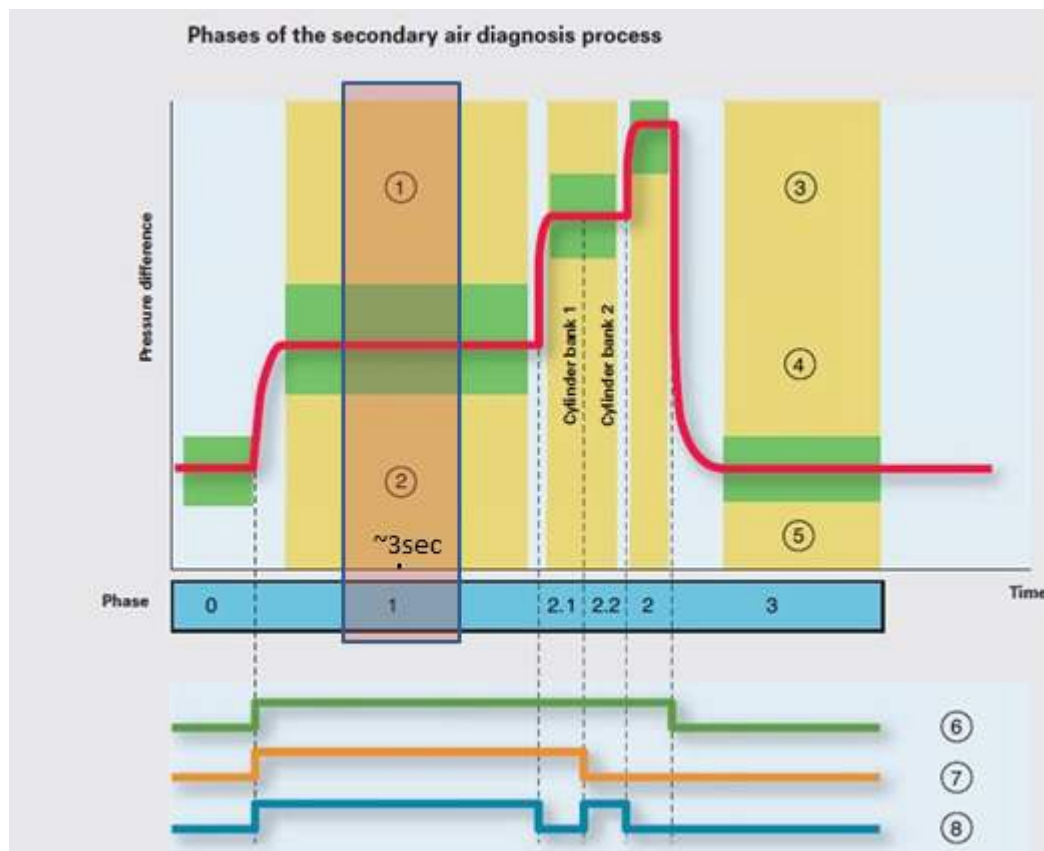
Figure 1. Pressure test graph

PRS\_SA\_DIF (note down value at 3sec of test - phase 1 of test, see *Figure 1. Pressure test graph*)

4. Call Technical Assistance Center (TAC) with the results (2 values).
