## Technical product information

| <b>Topic</b> | DTC P263500 with symptom code -10061 - Noise from within the fuel tank |
| <b>Brand</b> | Bentley |
| <b>Transaction No.</b> | 2066591/1 |

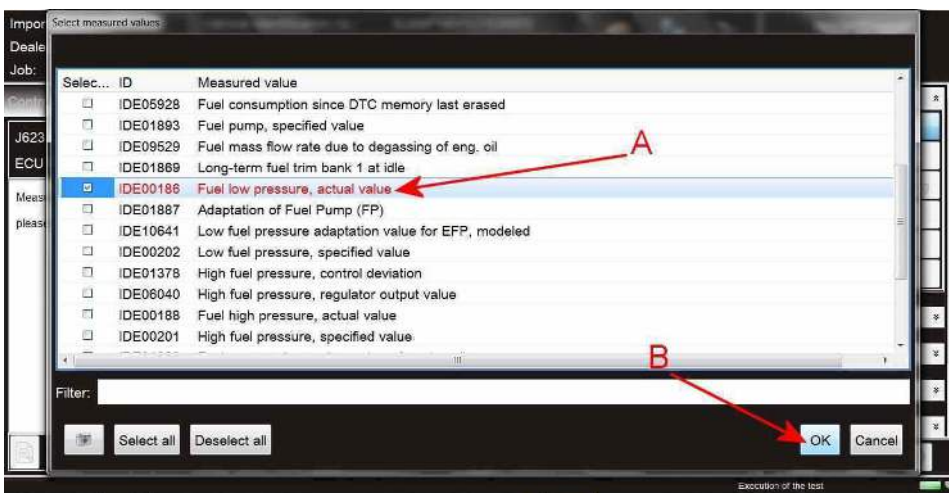
- The engine must be running and at operating temperature, Do Not switch off the engine until advised CAUTION: Ensure that suitable exhaust extraction is used whilst the engine is running within the workshop
- Using ODIS Carry out a full GFF of all control modules
- Clear all applicable DTC's
- Select Engine control module 1
- Select Guided functions - Read measured values
- Referring to Figure 2 (Point A) - Navigate to Measured value IDE00186 Fuel low pressure, actual value

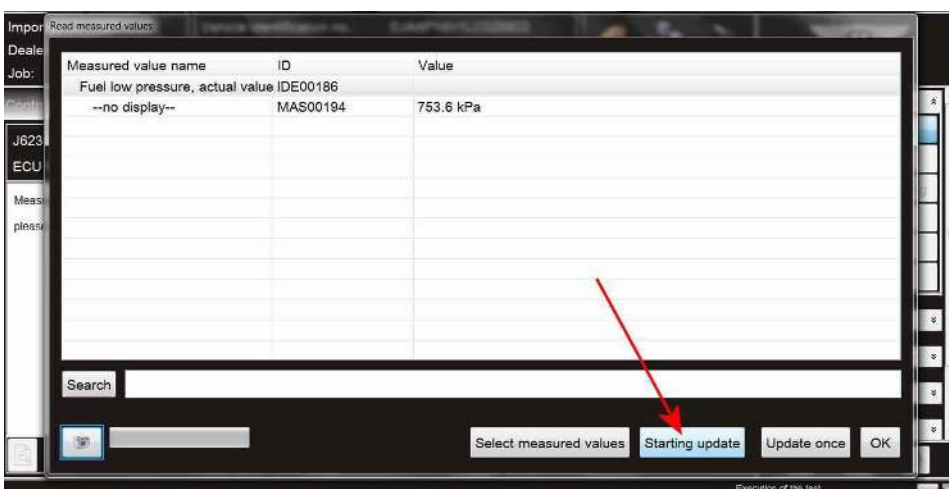
### 2) Referring to Figure 3 - Select Starting update

- Switch off the engine and leave the ignition on
- Monitor the pressure decay of the low pressure fuel system for 10 minutes

- Should the pressure drop below 300 kPa after 10 minutes and the fuel tank fuel pump is noisy (as per the video on the Bentley hub) the operative should replace the fuel pump as instructed within Rep.Gr 20 - Fuel pump, fuel level sensors, and jet pump (RH) - To remove and fit
